Defence Assessment Report

Sidmouth & East Beach Management Plan

Prepared for
East Devon District Council

May 2015

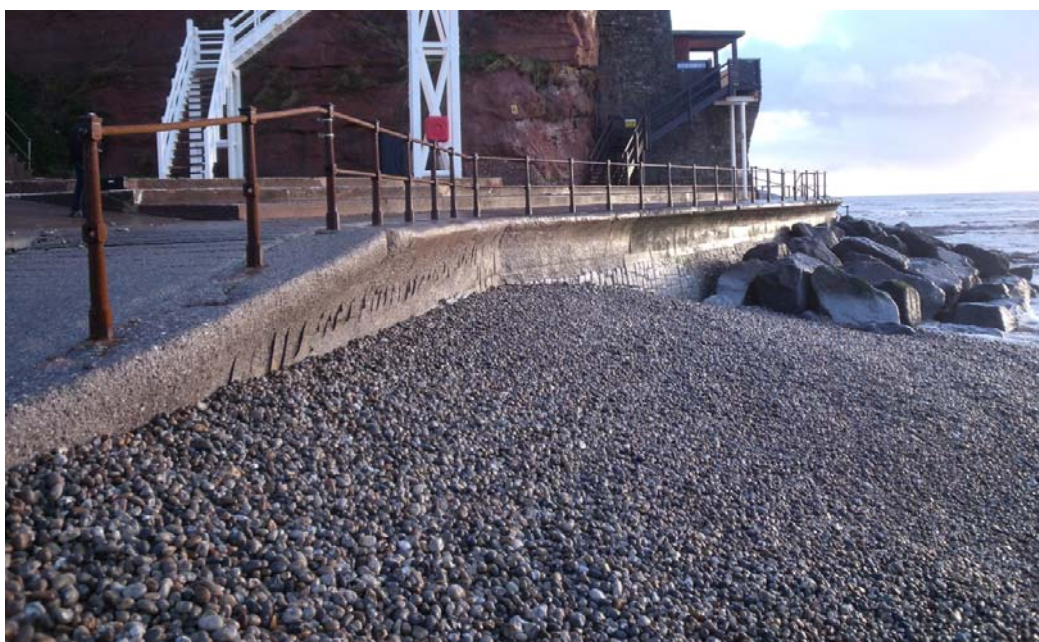
Figure 3-2 Frontage 1 access ramp, seawall and revetment

Condition Description: The seawall access ramp forms the start of the frontage. This structure was not protected by a rock revetment and has consequently suffered extensively over the years. The concrete ramp is heavily abraded, wave attrition has resulted in exposed reinforcement, damaged coping and concrete spalling evident.

Signs of scour were present on the seawall promenade with minor holes and pitting in the concrete. Cracking was observed in the crest wall which sits upon the seawall recurve (refer to Figure 2-8). The cracks were seen directly above rectangular promenade drainage outlets in a number of locations. Concrete coping damage had occurred at a couple of locations. Concrete spalling has occurred in the crest wall at expansion joint locations. There was evidence to suggest these had been filled with mortar, which does not allow expansion and may lead to further spalling. Some expansion joints did not contain the original bitumen sealant or a suitable replacement. This was also evident in the promenade slab expansion joints where bitumen sealant was either missing or the joint filled with mortar.

Condition Grade: 3 (Fair) – Defects that could reduce the performance of the asset.

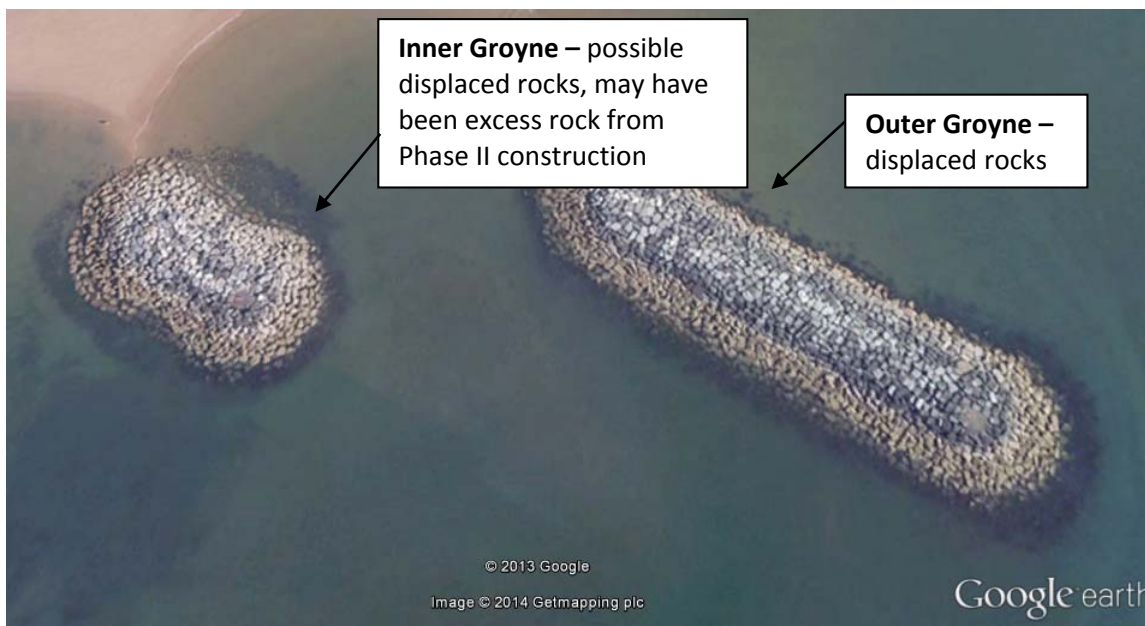
Figure 3-4 Frontage 2 offshore breakwaters showing good plan profile and displaced rocks

Condition Description: The assessment of these structures is limited as access was not possible during low tide on the day of the inspection. The condition assessment was therefore limited to observations from the shore using binoculars and camera. The rock angularity and packing appeared to be good. There was no visible evidence of exposed geotextile, shingle infilling, misalignment or scour. However, scour could only be assessed for the landward ends of each breakwater. There were a few displaced rocks observed on the eastern flank of the inner breakwater. Google Earth indicates there are also a few displaced rocks on the eastern flank of the outer breakwater, as shown in Figure 3-4 below. Figure 3-4 also shows the breakwaters plan shape is good when compared to the Phase II design drawings. This would indicate that no large settlement and flattening of the breakwater has occurred, which would be indicative of a breakwater beginning to progressively fail.

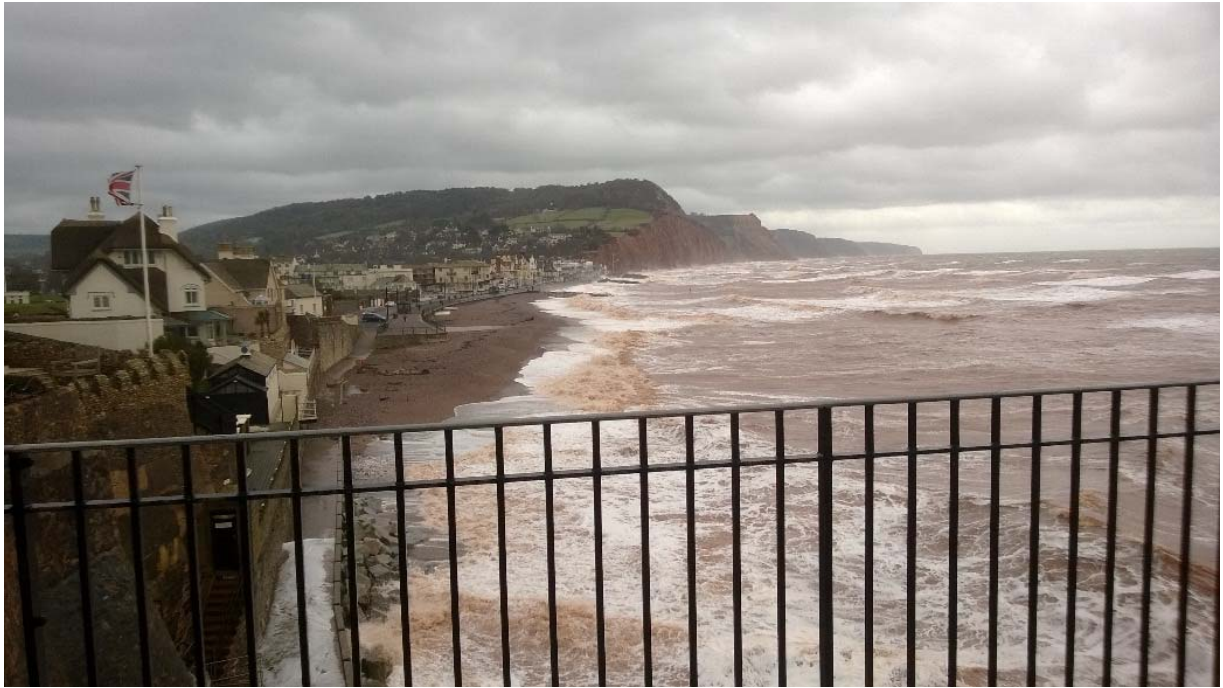
Figure 4-1 Overtopping during February storms of Frontages 2-6

Further to the analysis above, images were obtained from the recent storms on 3rd February 2014. These events were estimated to be extreme, in the order of 1 in 100 to 1 in 200 return period events. Figure 4-1 demonstrates the results of the overtopping analysis well. It can be seen that Frontage 2 is extensively overtopping during this event, whilst Frontage 3 is not overtopping due to the high beach levels. In the distance of the photo it can be seen that Frontages 4 to 6 are leading to overtopping with impulsive conditions, this is due to the lower beach levels when compared to Frontage 3. This further validates the results of the overtopping analysis. Figure 4-2 shows Frontage 1 extensively overtopping during the storm, further validating the overtopping analysis.

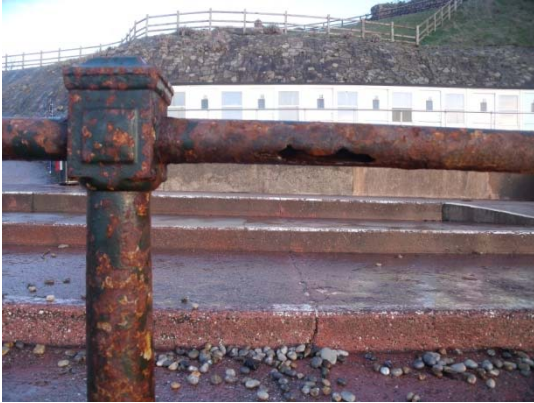
- The hand railing in a number of locations is corroded, with full thickness loss observed in some areas. There was evidence this has been replaced in places and not in others; replacement is advised for safety reasons.

Figure A1: Corrosion holes in hand railing

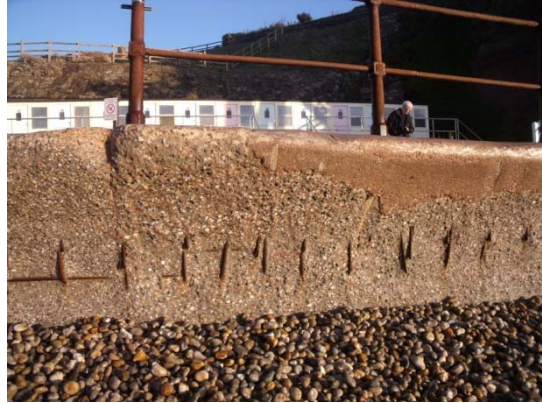
Figure A2: Exposed reinforcement and abrasion

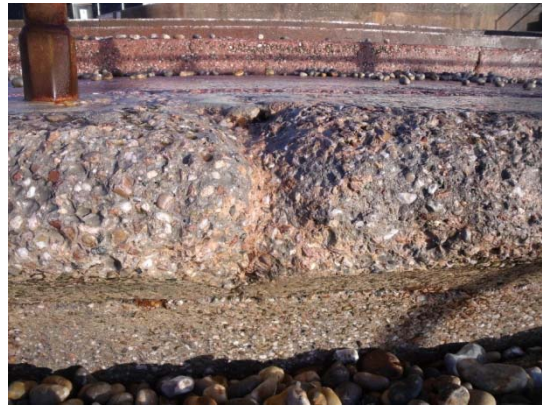
Figure A4: Damaged seawall coping

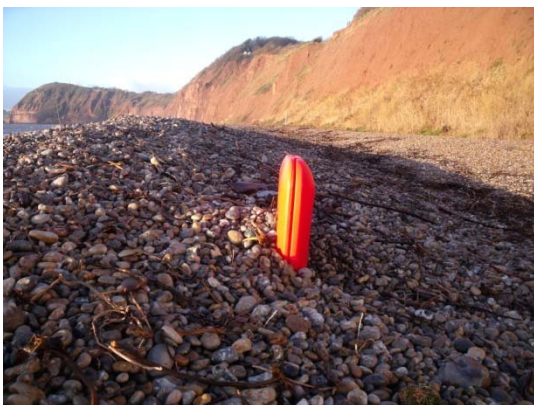
- A life ring was found partially buried due to it being situated on the beach. The beach level was likely to be higher than usual and pushed up to the bay's corner following the recent storms. However, knowing the dynamic history of the beach frontage, it is suggested this life ring be moved so as it can be easily accessed and used if required.

Figure A5: Buried life ring

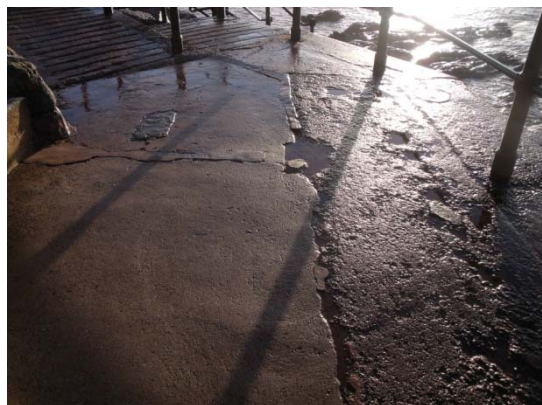
Figure A6: Scoured promenade

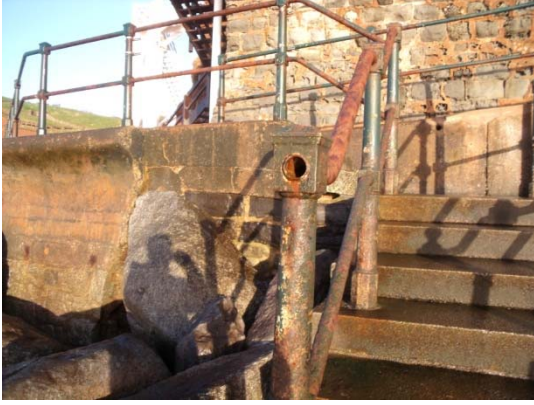
Figure A7: Corroded hand railing

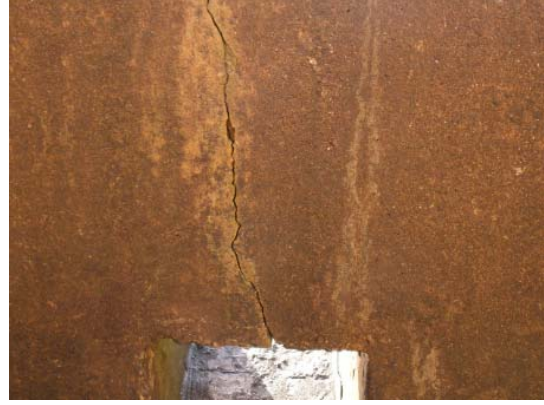
Figure A8: Cracking at drainage outlet

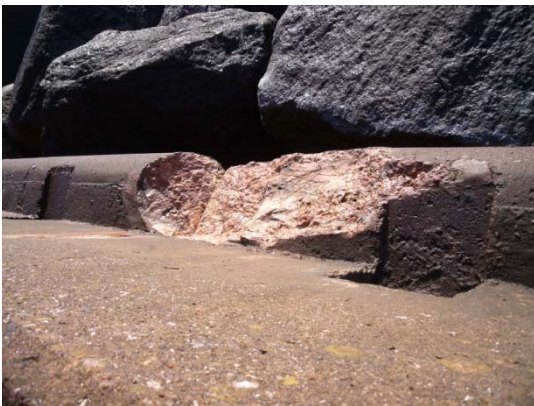
Figure A9: Coping damage

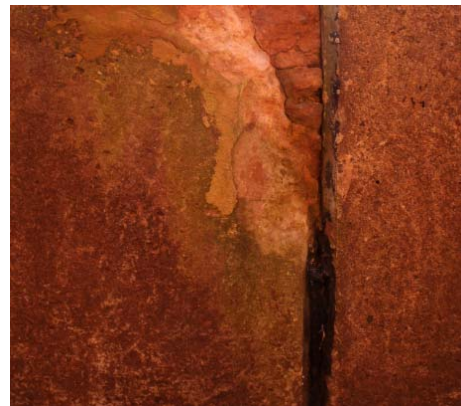
Figure A10: Spalling at expansion joints

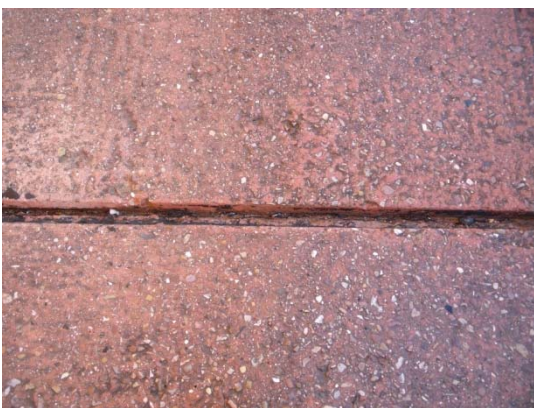
Figure A11: Promenade joints without sealant

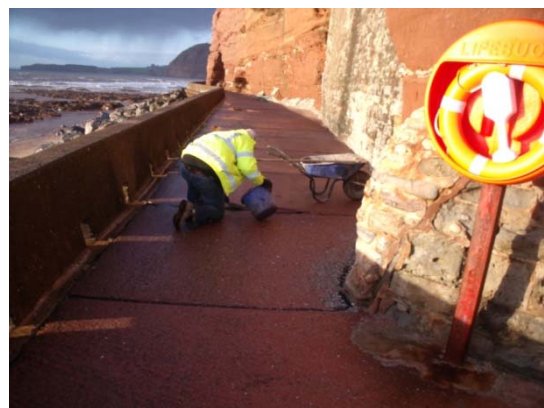
- Outfalls were seen to be blocked by beach material as they are not flapped. This is compromising their drainage function and they should be cleaned.
- A maintenance operative was observed applying mortar to holes in surfacing and expansion joints without any initial surface preparation. Where expansion joints exist, mortar should not be placed as this prevents the structure from being allowed to thermally expand. Mortar as a material is also unlikely to be particularly durable as it lacks larger aggregate and has a high water-cement ratio. It is recommended that specialist concrete and sealant repairs are undertaken to protect the asset instead.

Figure A12: Mortar filling to expansion joints

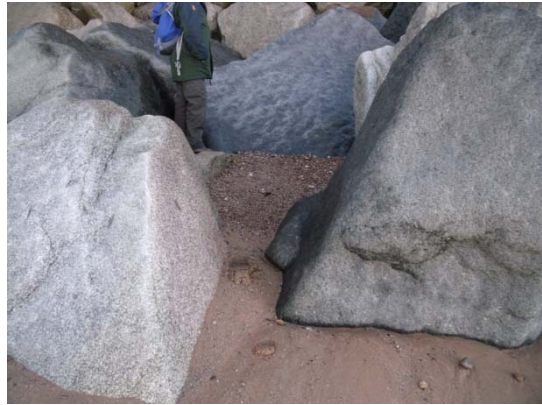
Figure A14: Large voids between rock armour

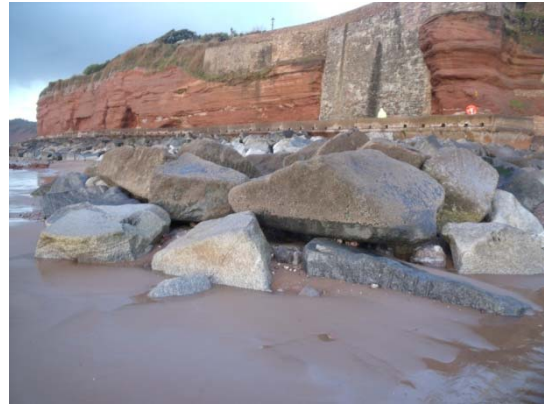
Figure A16: Rock groyne packing and profile

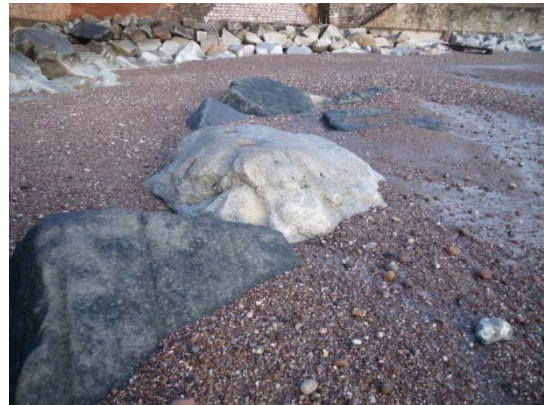
Figure A18: Large displaced rocks

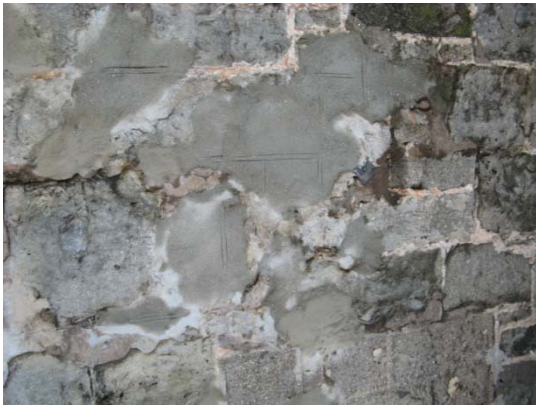
Figure B3: Masonry mortar repairs

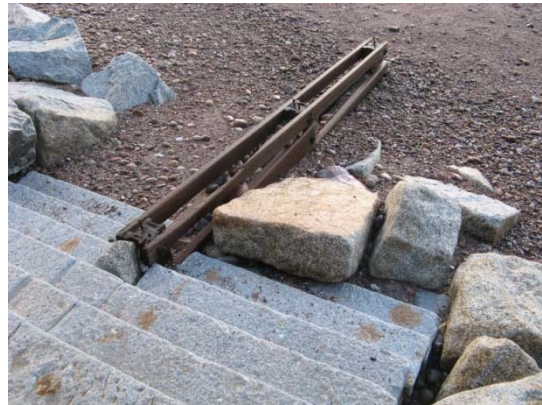
Figure B14: Displaced rocks

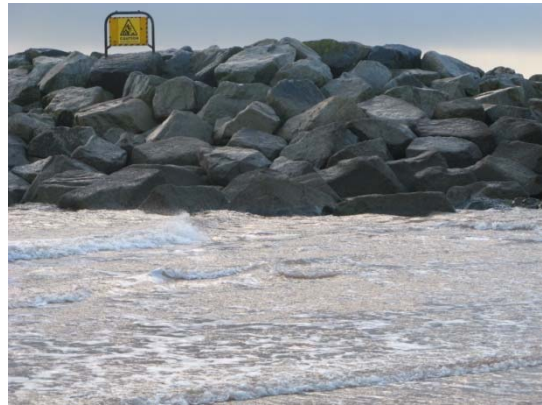
Figure B18: Rock packing on western breakwater

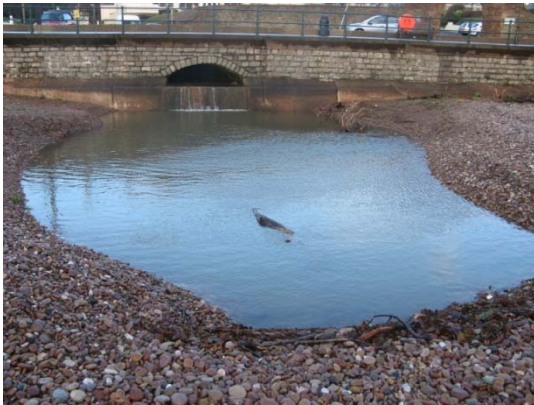
Figure C3: Large outfall and water ponding

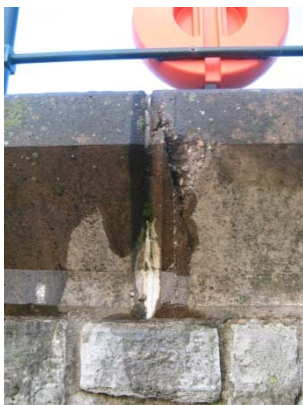
Figure C5: Cracking and missing sealant on coping

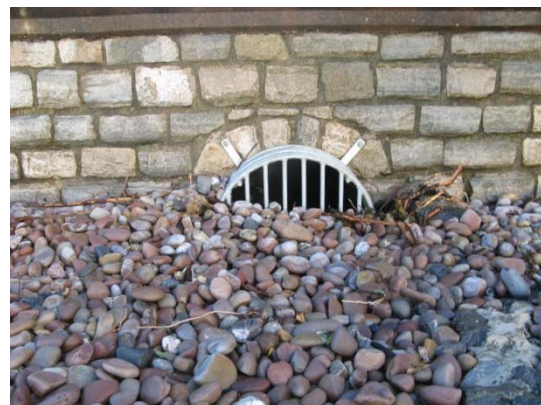
Figure C6: Blocked outfalls

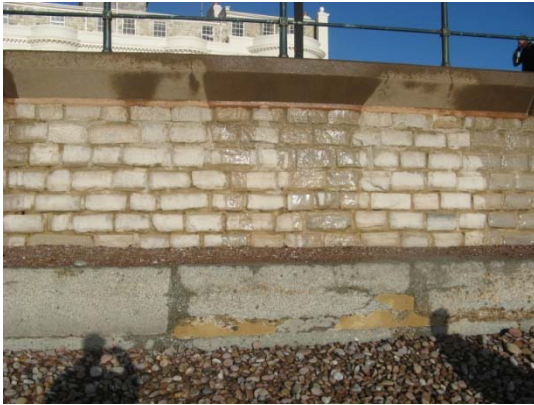
Figure D1: Mortar repairs to apron

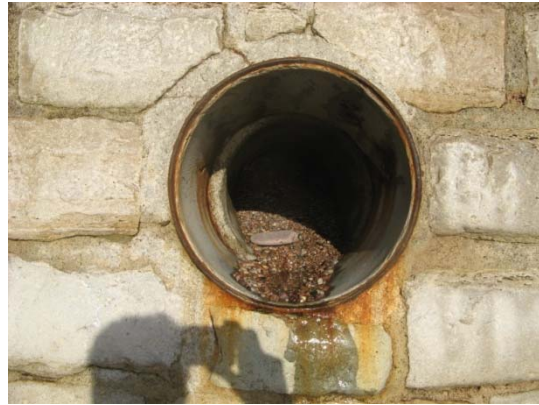
Figure D2: Blocked outfall

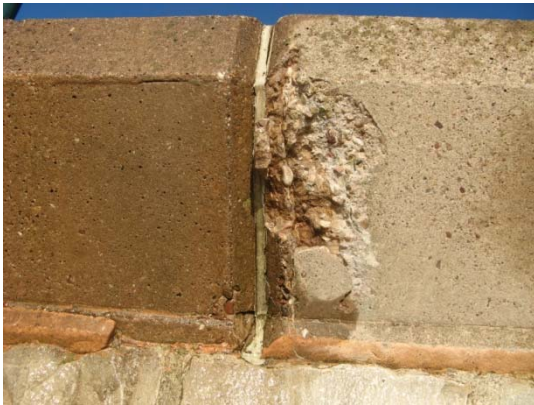
Figure D3: Spalling at expansion joints

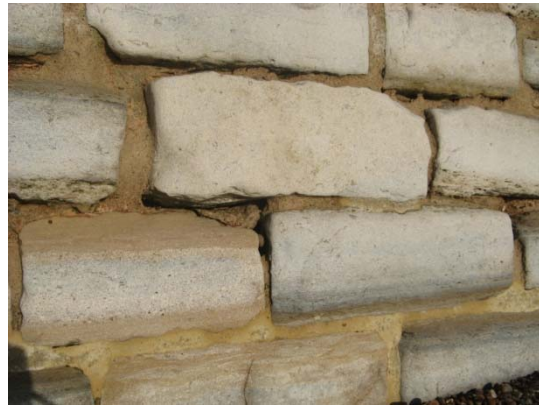
Figure D4: Masonry joints filled with mortar

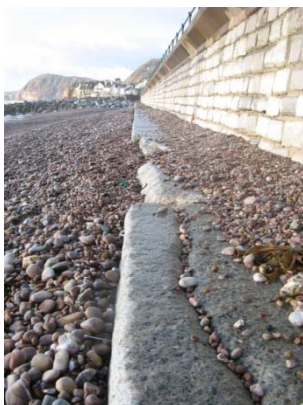
Figure D5: Cracking and abrasion to apron

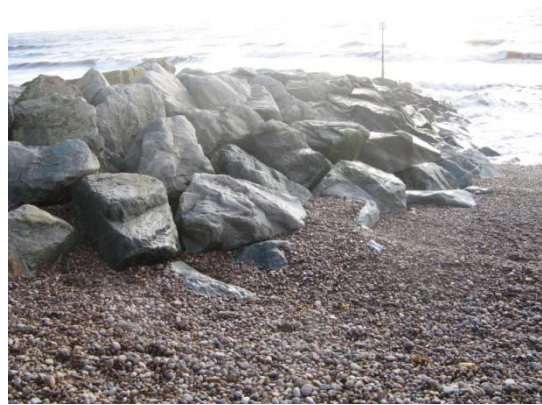
Figure D8: Rock groyne West flank

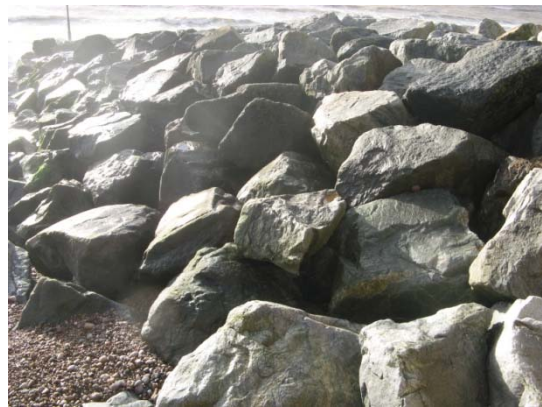
Figure D10: Rock packing and angularity

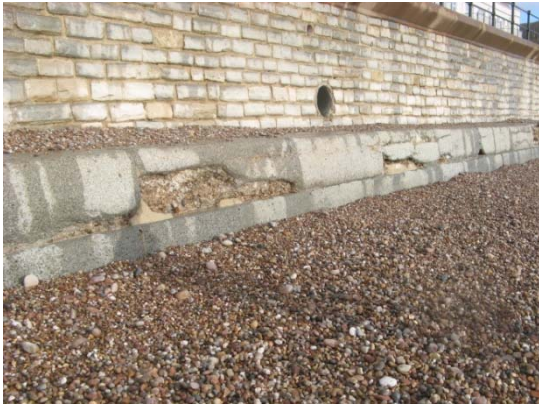
Figure E1: Badly damaged apron

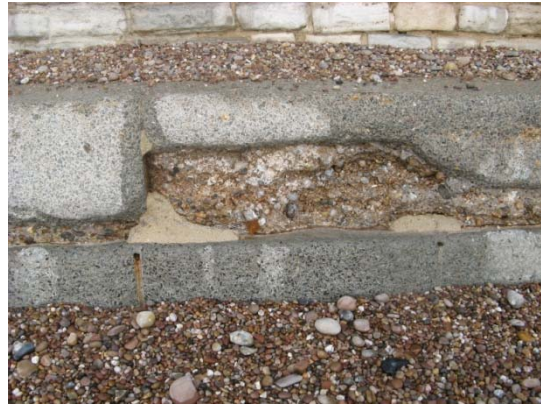
Figure E2: Badly damaged apron

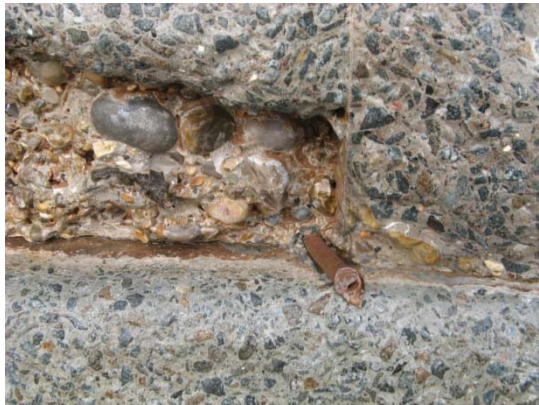
Figure E3: Exposed protruding reinforcement

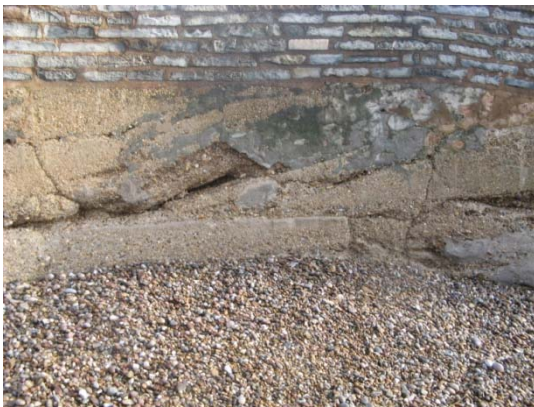
Figure F7: Holes and cracking

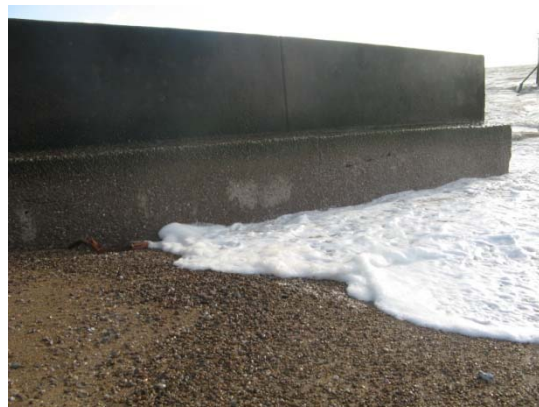
Figure F8: Extensive, later construction

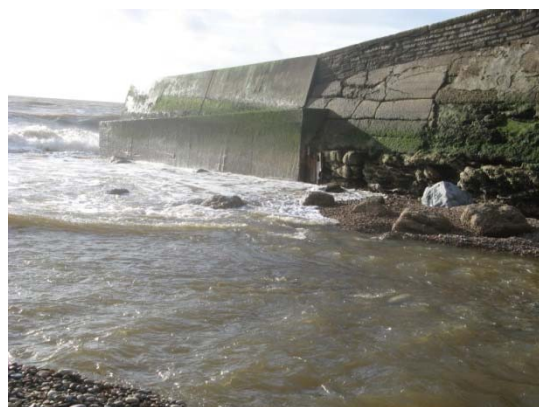
Figure F10: East groyne flank

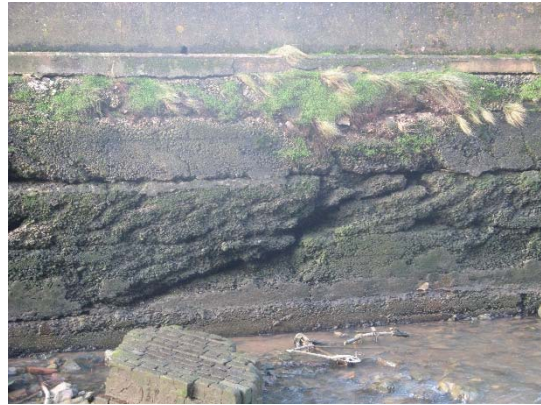
Figure G6: River wall spalling/erosion

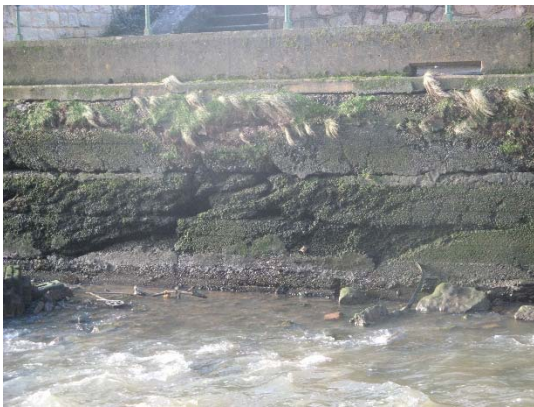
Figure G7: River wall spalling/erosion

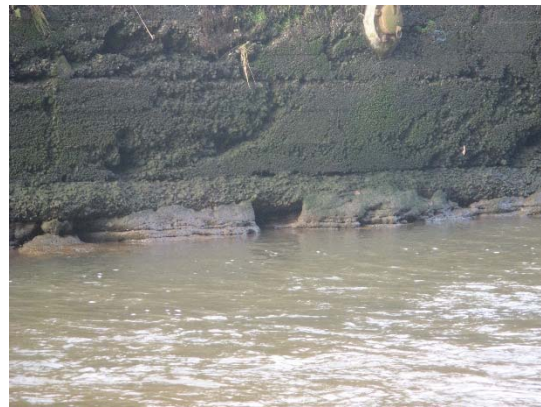
Figure G8: River wall undermining
