Sidmouth & East Beach Management Plan

Prepared for
East Devon District Council

January 2016

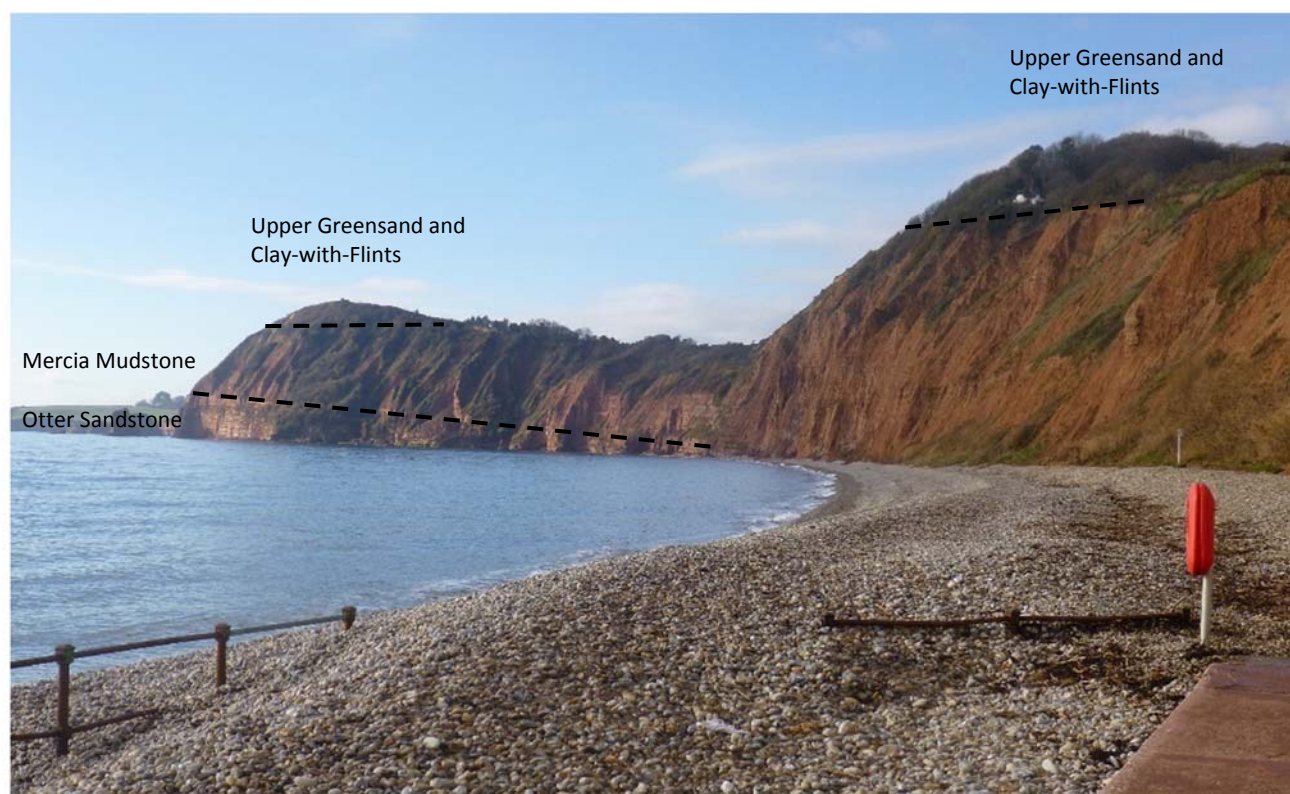
Figure 2-2 Photograph showing view to High Peak Hill/Big Picket Rock, looking west. Photograph taken during site visit 9th December 2013. Note near-vertical basal cliff formed in Otter Sandstone (left of image) and shallower angled, heavily incised upper cliff formed in Mercia Mudstone. The hills are capped with Upper Greensand and Clay-with-Flints. The cliffs are fronted by a substantial gravel beach

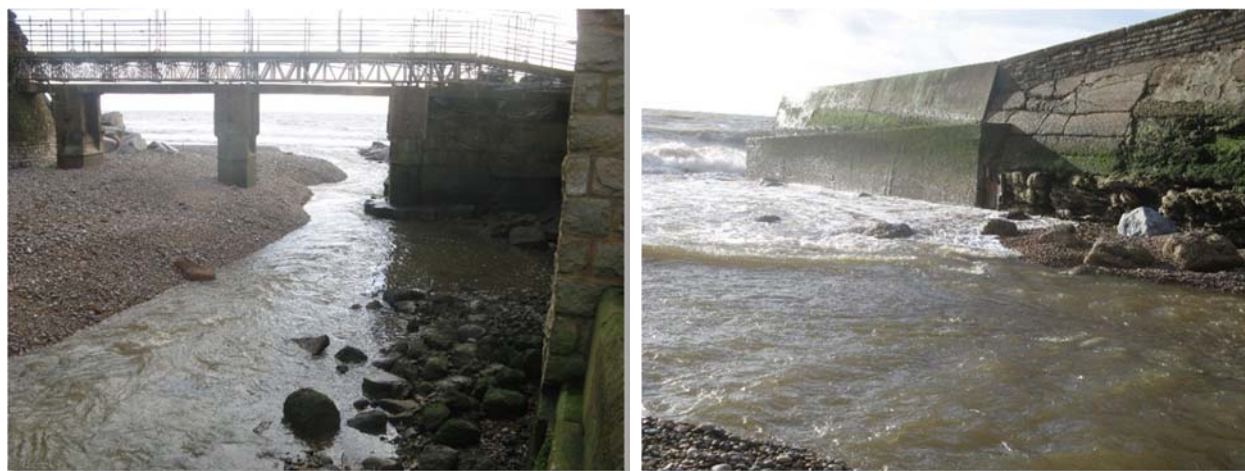
At the mouth of the River Sid, a bank of shingle material extends from East Beach in an upstream direction. During a site visit in January 2014, the shingle bank was observed to deflect the main channel flow to the west against the training wall (refer to Figure 2-8); this is beach material that has been driven into the channel and is not sediment derived from the river catchment.

Figure 2-8 The mouth of the River Sid: left, looking downstream with the shingle bank on the left, and right; the main channel discharging to the sea along the flanks of the river flood defence and training wall. Photographs taken during site visit 12th January 2014.

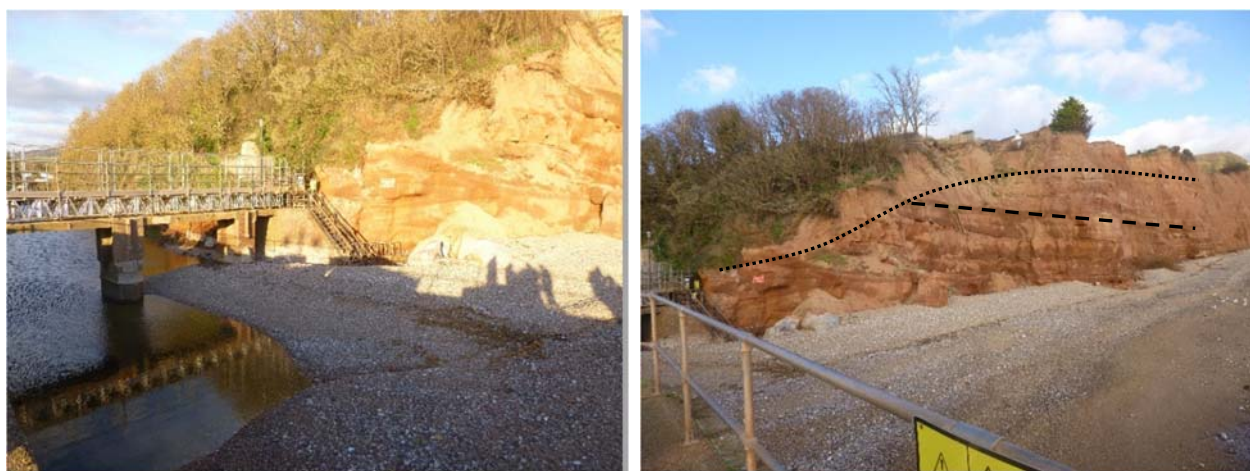
At the mouth of the River Sid, a bank of shingle material extends around Pennington Point from East Beach in an upstream direction. Superficially, the composition of the beach has been observed to change in an eastwards direction, from one primarily of shingle, to an upper beach of coarse sand overlain by a veneer of poorly sorted shingle and a lower beach of coarse sand. With the exception of a collection of imported boulders at the toe of the cliffs at Pennington Point, this coastline is undefended.

Figure 2-9 Photographs showing the coastline to the east of the River Sid, looking north east: left, the shingle bank at Alma Bridge and Pennington Point, and right; Pennington Point and Salcombe Hill Cliffs. Here the boundary between the Otter Sandstone and overlying Mercia Mudstone is shown by the dashed line and the base of the weathered mudstone and valley fill sediments of the River Sid is shown by the dotted line. Photographs taken during site visit 9th December 2013.

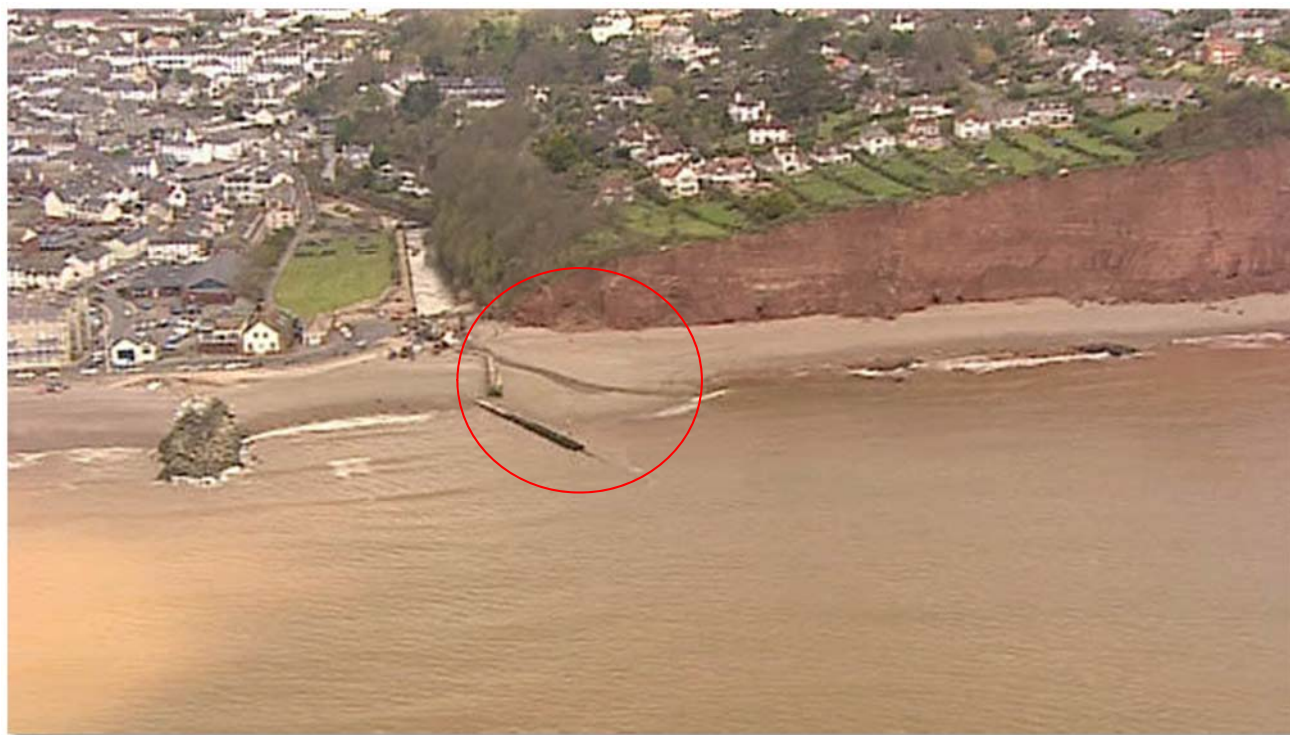
Figure 4-11 Aerial photograph showing the mouth of the River Sid and the accumulation of beach gravel against the training wall and outfall resulting from a south-easterly storm (circled in red) (Halcrow, 2002).

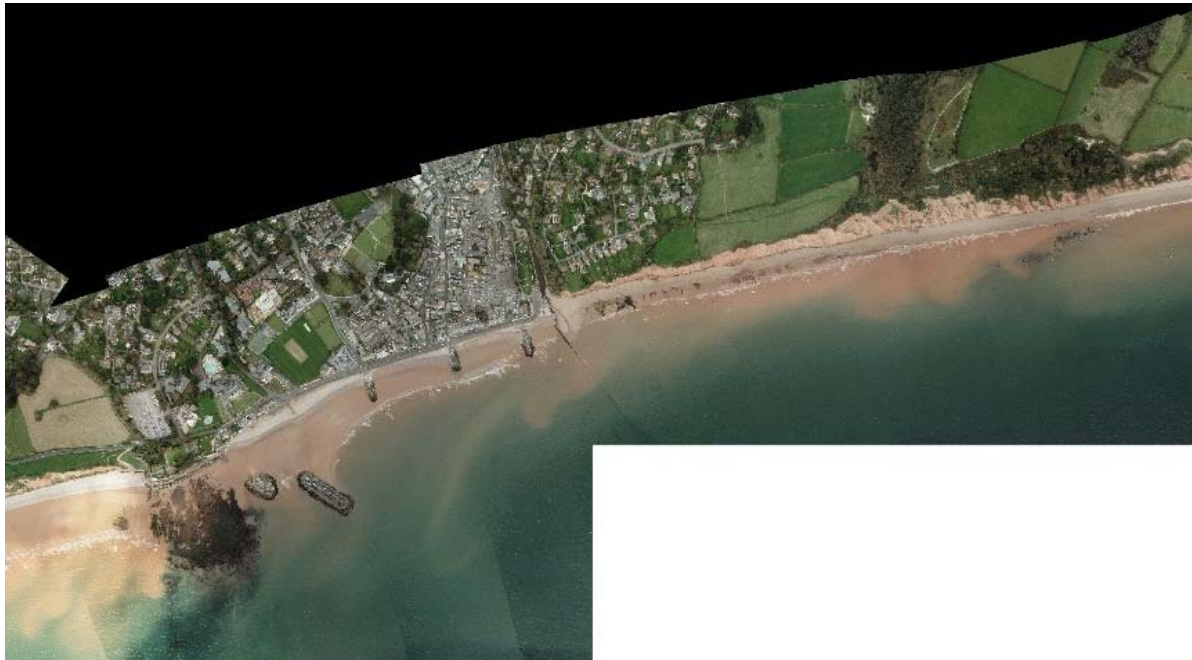
Date	Photo	Interpretation
17 th Sept 2012

<ul style="list-style-type: none"> • Jacob's Ladder east beach appears healthy. • The upper shingle beach in the lee of the breakwaters is narrow, as is the beach between the groyne bays. • The beach in the groyne bays is widest at the eastern end. The beach is particularly narrow to the west, with what appears to be little shingle at the toe of the seawall. • River Sid training wall extension and SWW outfall very clear in the photographs. • Shingle bank extends across the mouth of the River Sid, with accumulation of material in the lee of the extended River Sid training wall. • River Sid has carved a channel through the shingle banks and a small delta exists where the River Sid meets the sea. • East Beach set-back within cliff embayment and continuous to east

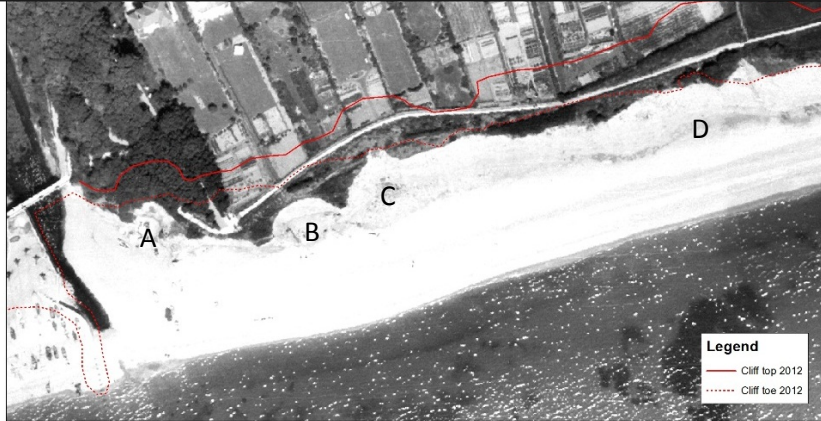
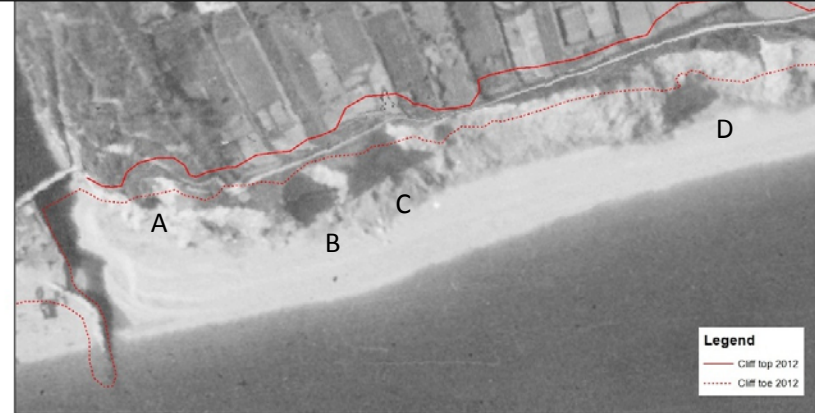
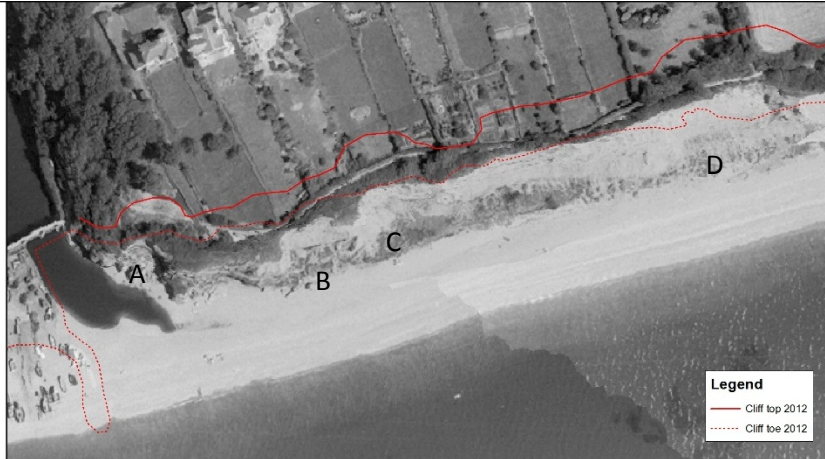
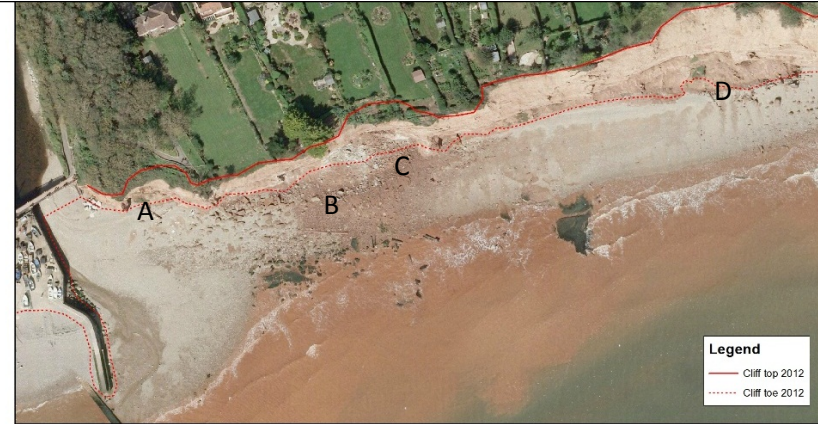
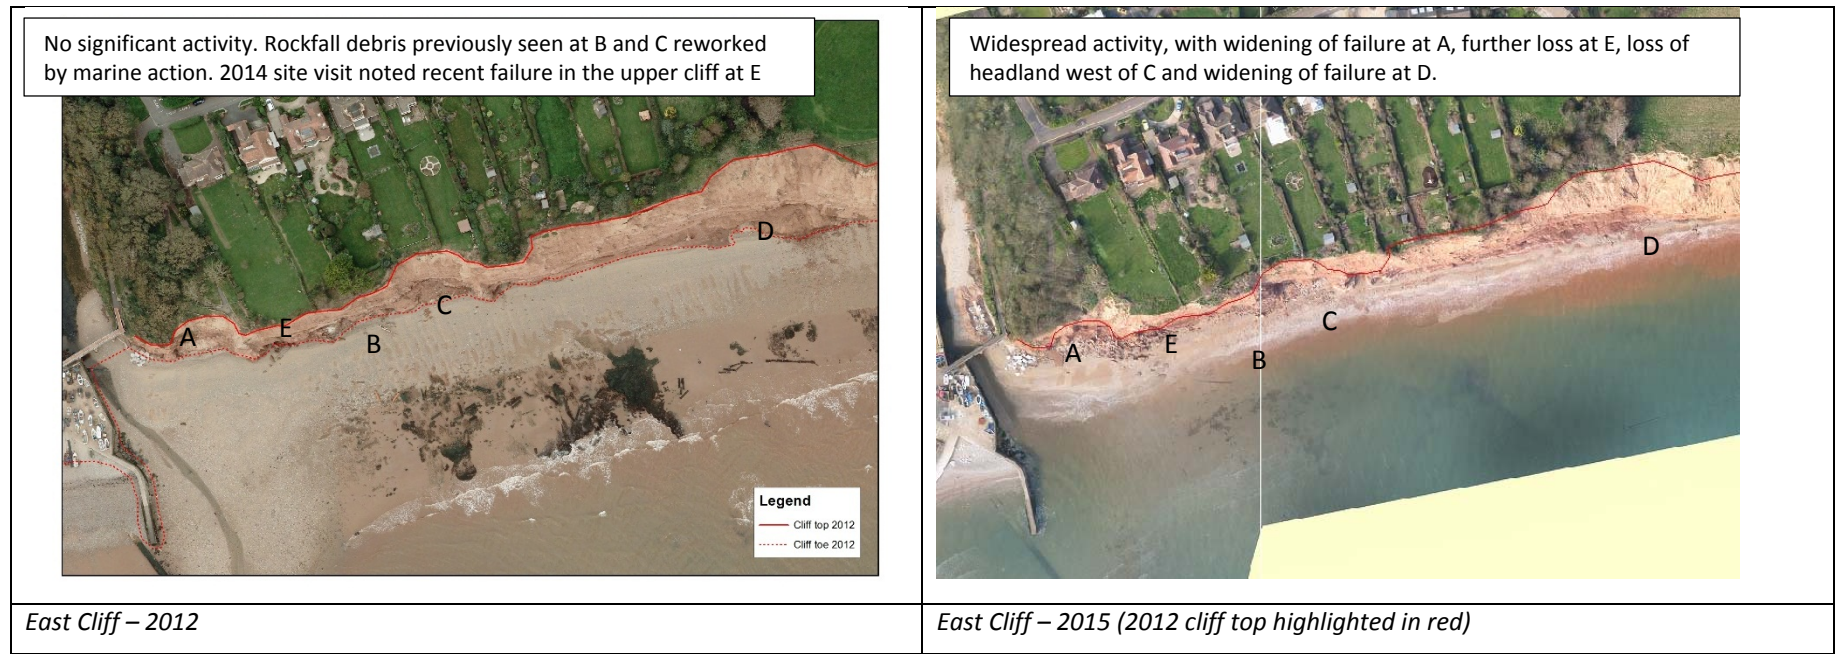
Figure 5-2 Aerial photography indicating the evolution of the western part of East Cliff and Pennington Point.

Failures in upper cliff (Clay-with-Flints and weathered mudstone) at A, B and C associated with faults and weathered material at Pennington Point. This section was also coincident with the route of a tunnel, lost by 1995 (Frederick Sherrell Ltd, 1995). Pennington Point cliff top well-vegetated.

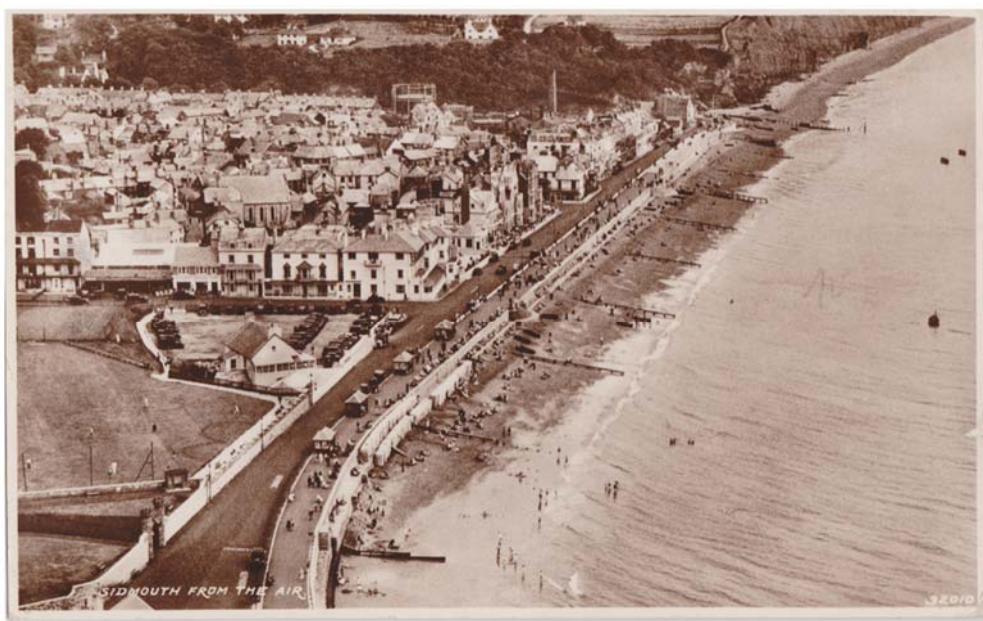
Figure 5-23 Aerial image of Sidmouth Beach, looking east, image postmarked 1937. Low and narrow beach levels are evident by the exposed groynes. Cliff failure at Pennington Point/East Cliff can be seen in the distance. Source: Mary Walden.

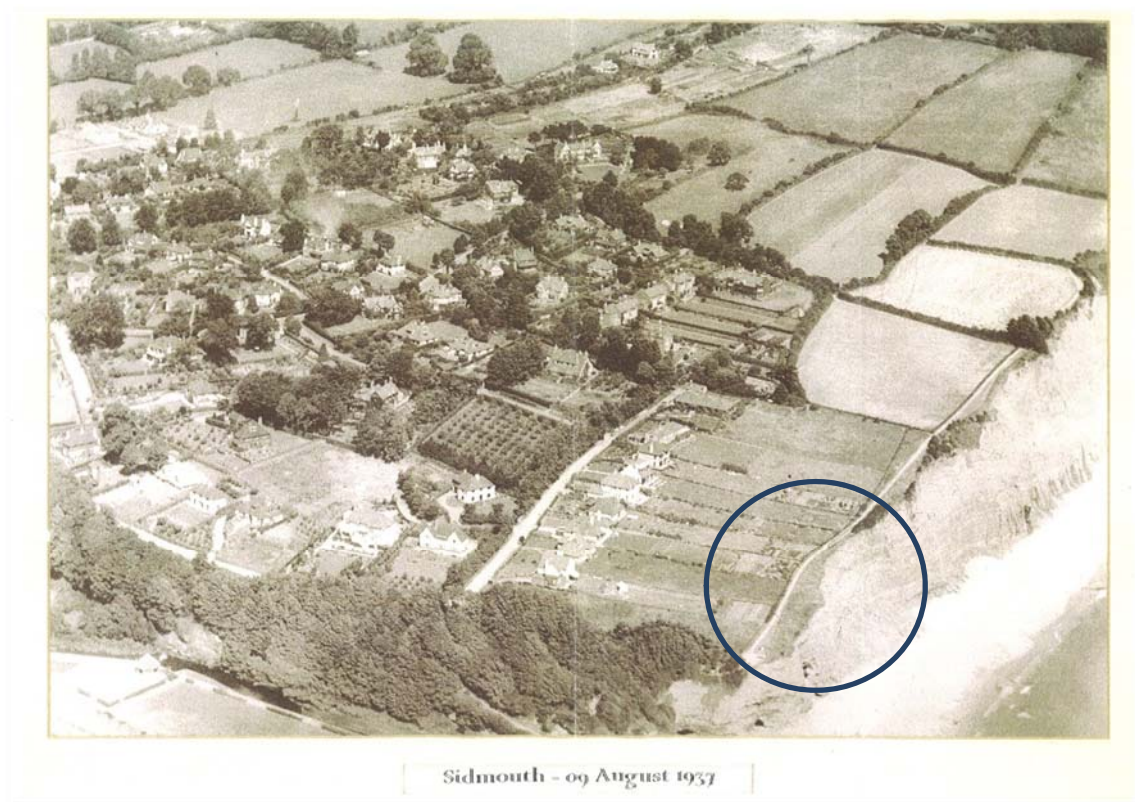
Figure 5-24 East Cliff 1937. Healthy beaches and large recent cliff failure that threatens the coast path (shown in circle). Source: Cliff Road Action Group (CRAG).

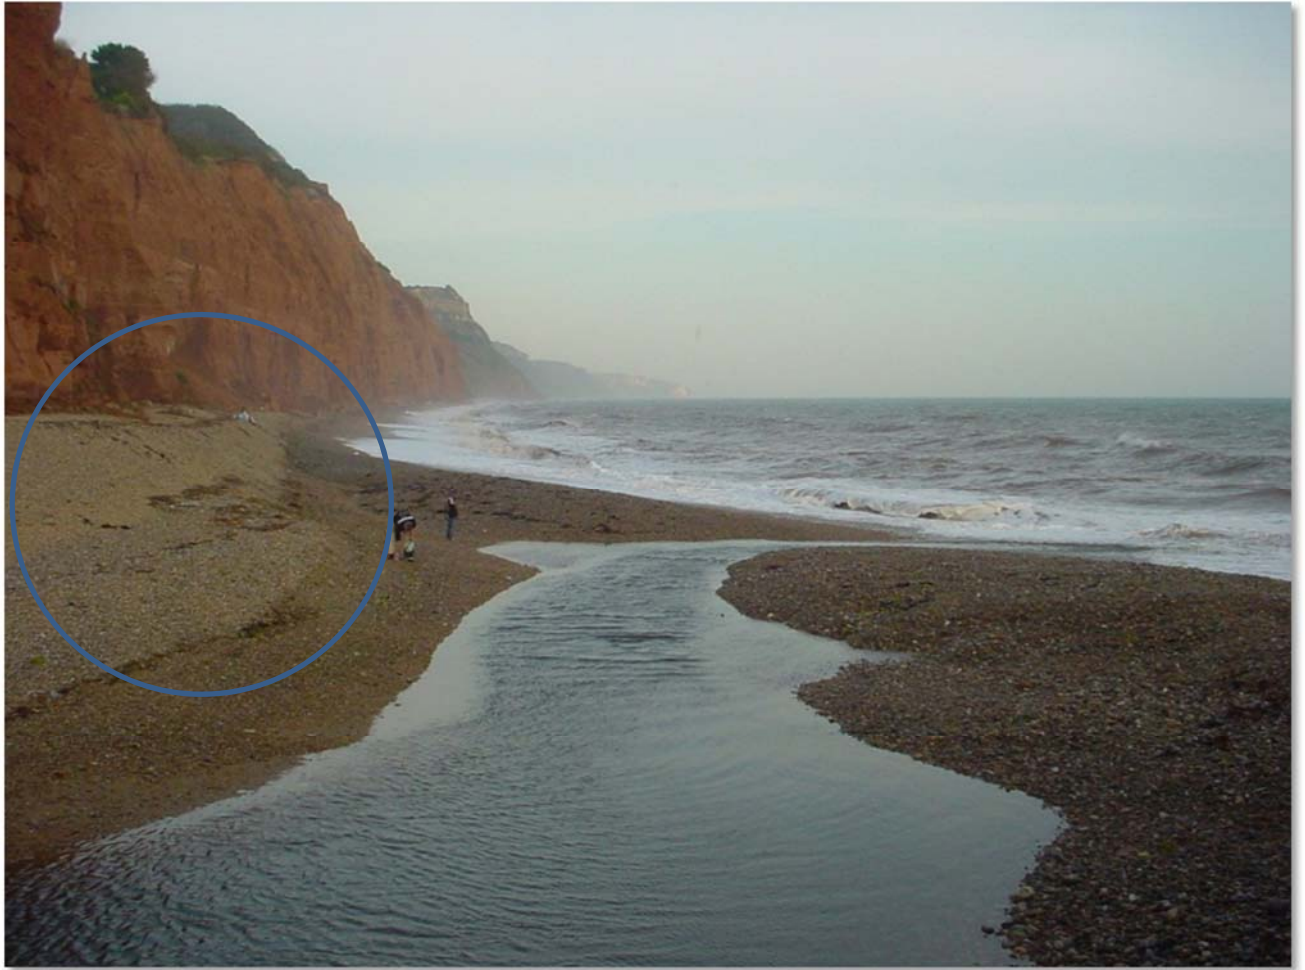
Figure 5-34 East Cliff beach in 2005 showing localised high gravel bank accumulated at the toe of the cliff immediately east of the Sid and very narrow upper beach further east. Source: Professor B Golding.
