### OTTERTON

Prepared for East Devon District Council by John Fisher BA, MA, MRTPI with contributions from Town and Parish Councils and Amenity Societies in East Devon

### **Otterton Interim Conservation Area Review**

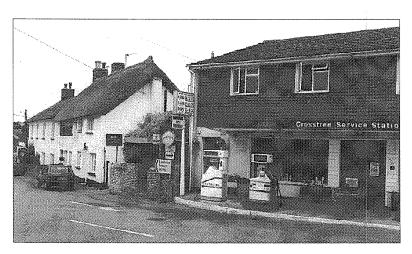
The Service Station (left) is intrusive, but new housing off Ottery Street (below) is well-proportioned. Ottery Street has several good 16th-17th century cottages and farmhouses with typical projecting lateral stacks (opposite). At the north end are a further pair of Rolle cottages in flint and brick.

The Crosstree Service Station is no longer in operation although the 1970's building remains and is considered incoherent with the character of the street scene.

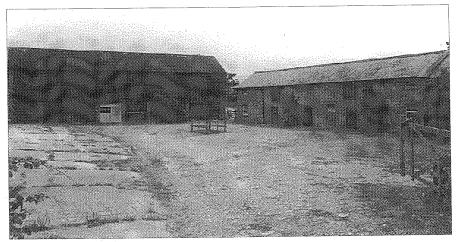
Farm buildings south of Barton House, partially empty.

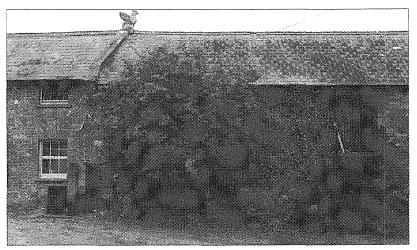
Farm buildings south of Barton House, partially empty

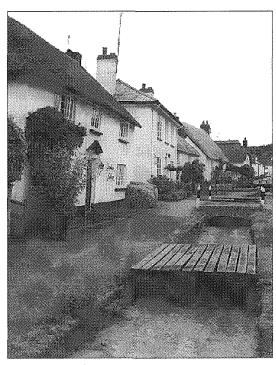
The stream is an attractive feature when flowing but has lost its natural bed which is starkly apparent in times of drought. The mix of cob and rendered brick or stonework with thatch and slate fronted by small gardens in a long main street gives the village much of its character.

- intrusion from tall TV aerials, especially prominent when viewed from Fore Street looking west.
- poor condition and treatment of surfaces in places; (e.g the concrete base of the stream; and failing tarmacadam close to the War Memorial

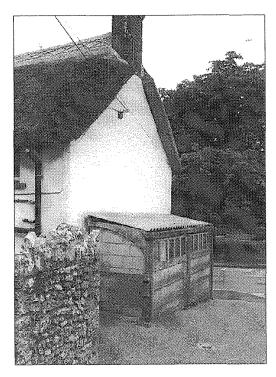
- the concrete and blockwork bus shelter attached to the gable wall of No 1 The Green
- visual intrusion from street parked cars, partly resulting from the lack of few obvious sites for off-street parking within curtilages. Nos 1-9 The Green suffer particularly from this problem.

A useful but unattractive bus shelter at the junction of Maunder's Hill and Fore Street

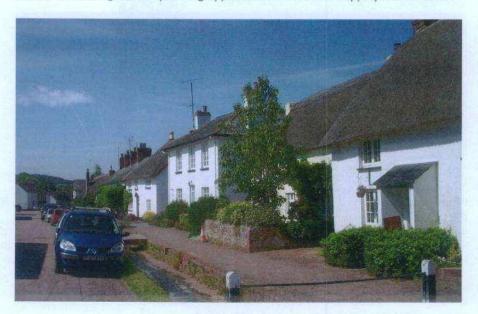
- The most noticeable aspect of the main thoroughfare is the increasing amount of parked cars. There have been several approvals for conversion of farm buildings within the village over recent years and where parking provision is often required for new dwellings this rarely accounts for multiple car ownership and visitor parking; therefore an increase in on-road parking is inevitable. It is clear that parking in such an attractive and dense historic settlement needs to managed in a more positive way with the encouragement of parking to the rear of buildings where planning applications can offer the appropriate controls.

Cars are parked virtually the entire length of Fore Street. The impact appears to be worsening.
