Sidford Interim Conservation Area Review

SIDFORD

Prepared for East Devon District Council by John Fisher BA, MA, MRTPI
with contributions from Town and Parish Councils and Amenity Societies in East Devon

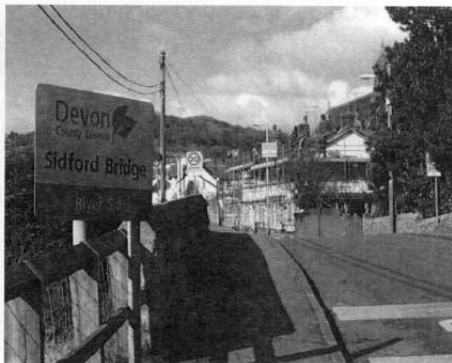
- The new County council bridge signs seem unnecessary and out of keeping with the ancient bridge. They appear to be advertisements for Devon CC which add nothing to the appearance and little to any understanding of the bridge.

Large new sign at Sidford Bridge which does really achieve anything.

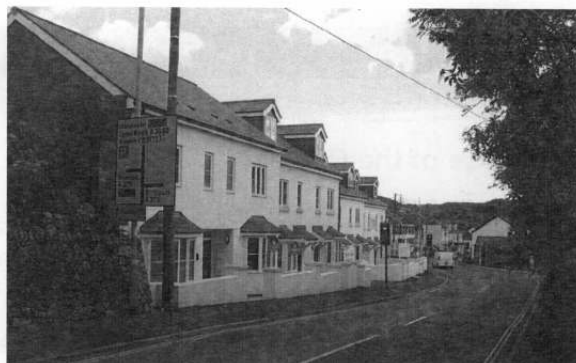
New housing at Sidford Cross is prominent within the centre of the conservation area.

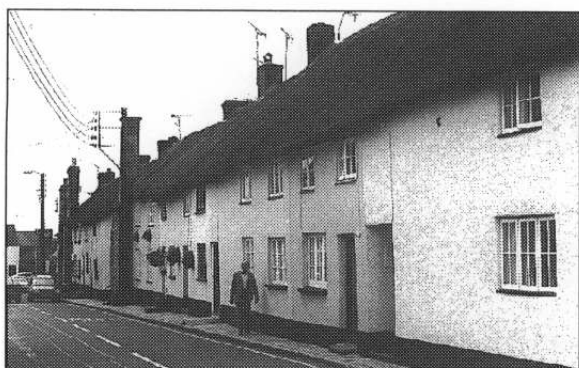
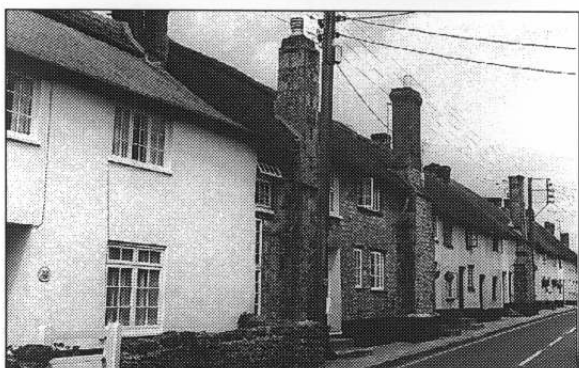
School Street; a long range of 17th century or earlier cottages is an outstanding survival, unrivalled elsewhere in east Devon. It is unfortunate that narrow pavements, heavy traffic flows, prominent overhead power lines and TV aerials make their special character harder to appreciate.

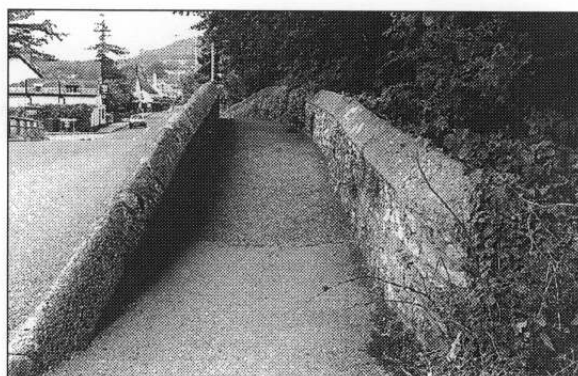
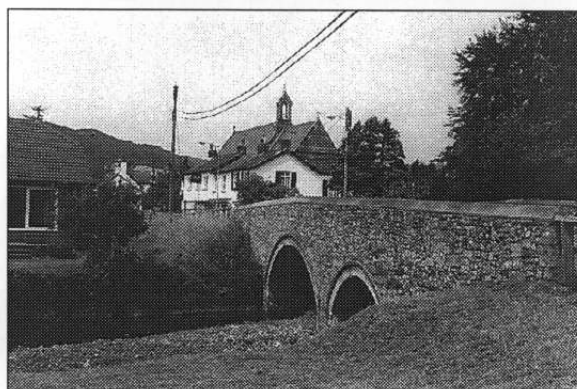
Sidford Bridge is a dual structure of former packhorse bridge which is said to date from the 12th century; the later bridge adjoining is mid 20th century. Recent housing adjoining the river is prominent.

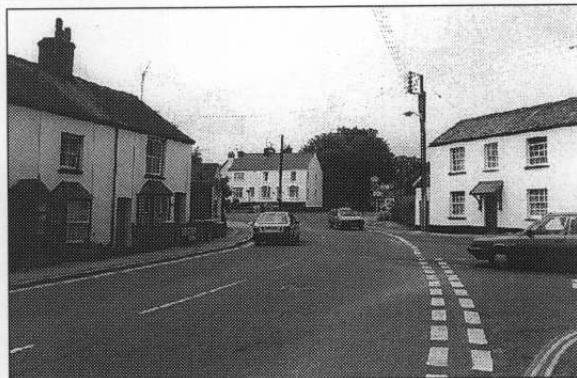
View west from Church Street at the junction with School Street. Traffic flows are especially heavy here and are considerable on all through routes within the conservation area.

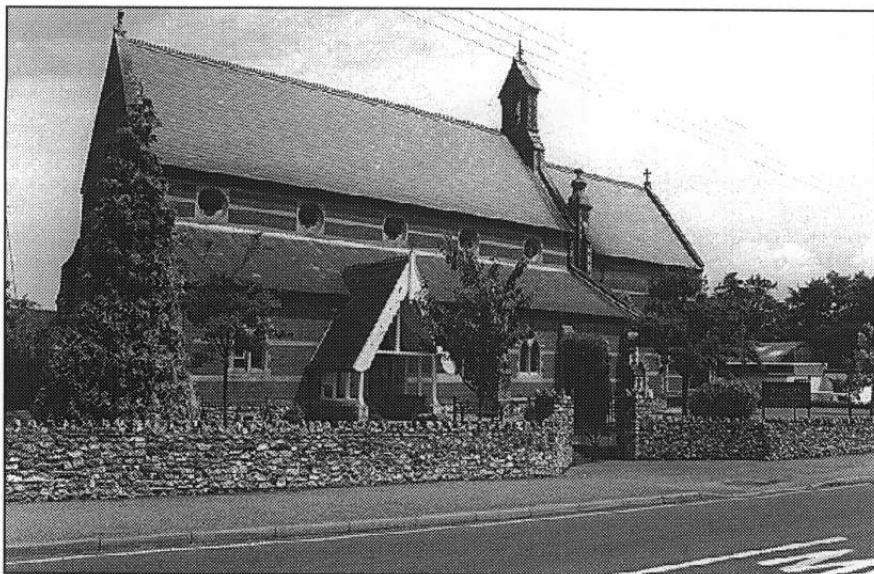
(Above and right) Church Street; the austere Victorian church c.1870 is somewhat incongruous and dominates the eastern part of the conservation area. The churchyard enclosed by chert stone walls and the entrance through wrought iron gates to the striking porch lessen the impact of extensive brickwork.

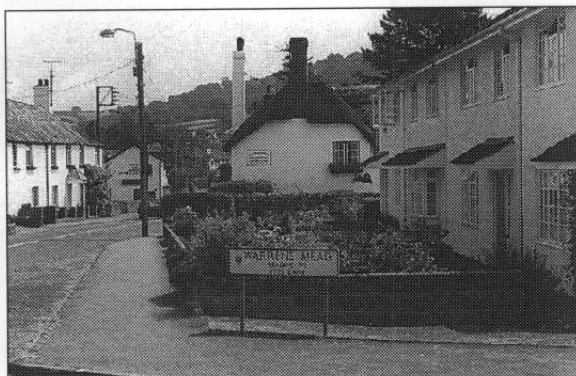
Church Street/Warrens Mead. 1970's infill destroyed several cottages and reduced the former rural quality. Loss of traditional stone walls and replacement with modern blockwork is particularly unfortunate

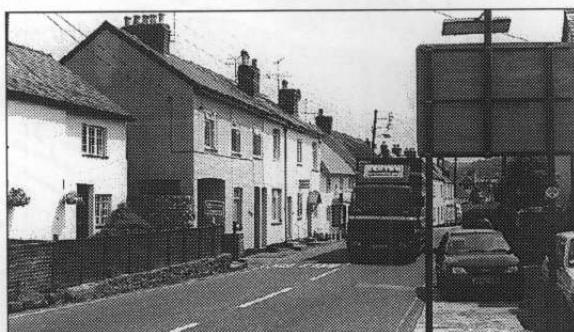
Church Street; removal of heavy vehicles and prominent road signs would greatly improve the quality of townscape

11.2 Removal of through traffic, on-street servicing, and of other clutter; for example prominent road signs, overhead electricity lines and television aerials would do much to restore character in what is one of the most complete early 17th century streets in this part of Devon, if not beyond.

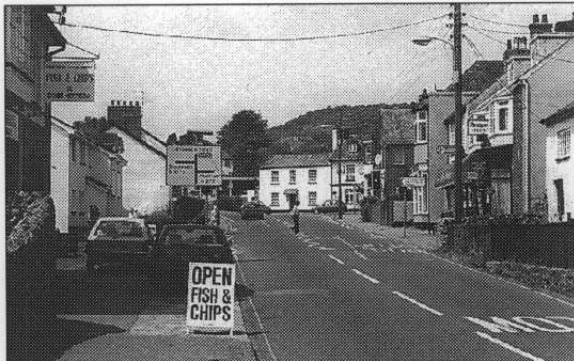
Church Street looking west. Heavy traffic, commercial activity and associated signage together with frontages infilled with recent development have led to loss of character.

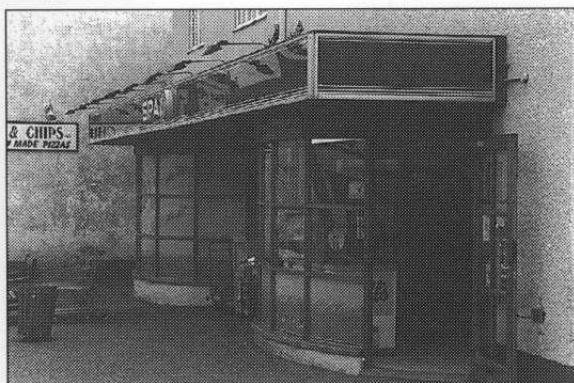
This particularly bad example of standardised modern toplit shopfront is entirely inappropriate within a conservation area
