Ottery St Mary Interim Conservation Area Review

OTTERY ST. MARY

Prepared for East Devon District Council by John Fisher BA, MA, MRTPI
with contributions from Town and Parish Councils and Amenity Societies in East Devon

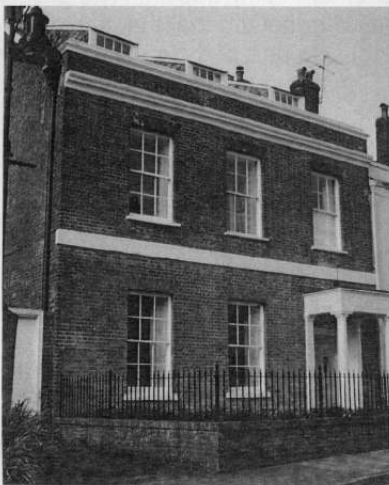
- The listed buildings in Paternoster Row have now been refurbished, particularly number 3 which was recently classified as at risk. Their forecourts now have smart new wrought iron railings that seem to be a fairly exact replica of Victorian railings. Paternoster House has been paved with granite setts that are successful as a formal front area treatment.

A successful restoration of 3 Paternoster Row.

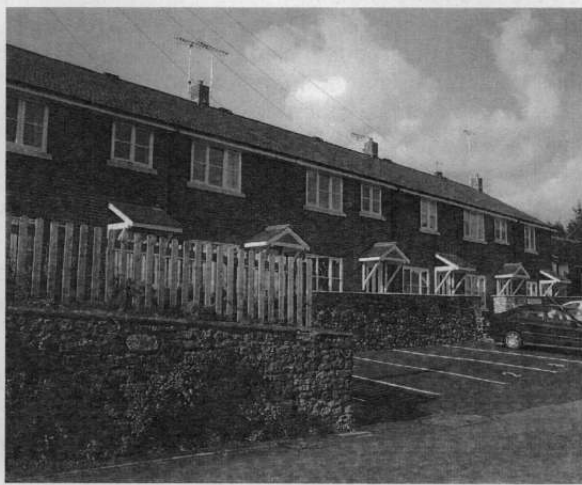
- Several new houses have been built in the conservation area, three in Sandhill Street, and one is being built in Chapel Lane. Those in Sandhill Street are unfortunately set back from the street frontage to allow for car parking and have introduced an uncomfortable suburban look to this tightly packed town centre. There are a few derelict or under-used sites that will be under development pressure, notably another site in Sandhill Street.

The provision of parking and unfortunately set this new development back from the road.

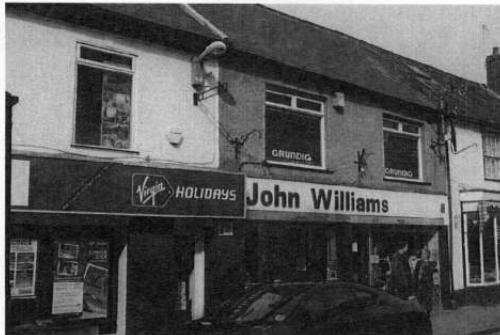
- Shop fronts are increasingly modern and enlarged with brash over-sized signage and lighting. Some examples of these have been fitted without the benefit of the necessary consents.

Overly deep plastic fascia signs with advertising even in the first floor windows,

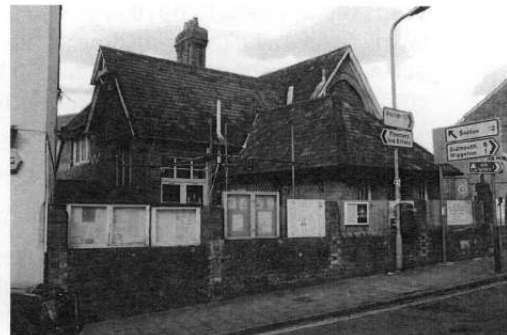
- Signage and notices are proliferating in the central area, with the area around the Coleridge Pre- School most afflicted, but other important key sites such as the library in The Flexton also very poor. A large front garden sign has been installed at Ridgeway House. The Canaan Way car park has too many overlarge signs and even the graveyard has well advertised CCTV with a large notice on the fence.

Excessive signage in front a key building identified in the conservation area appraisal.

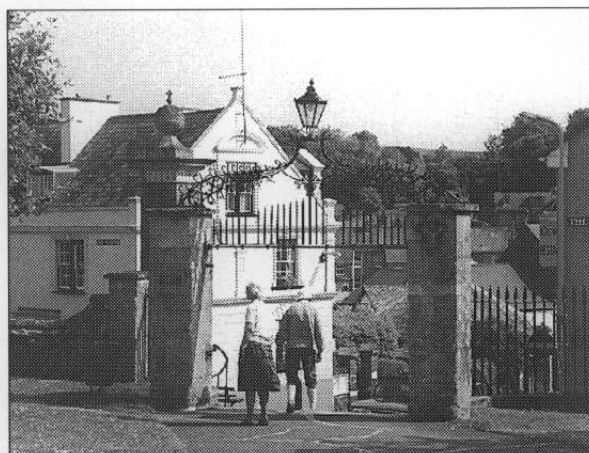
View across the town from the Churchyard with wrought iron overthrow. The gates have been removed.

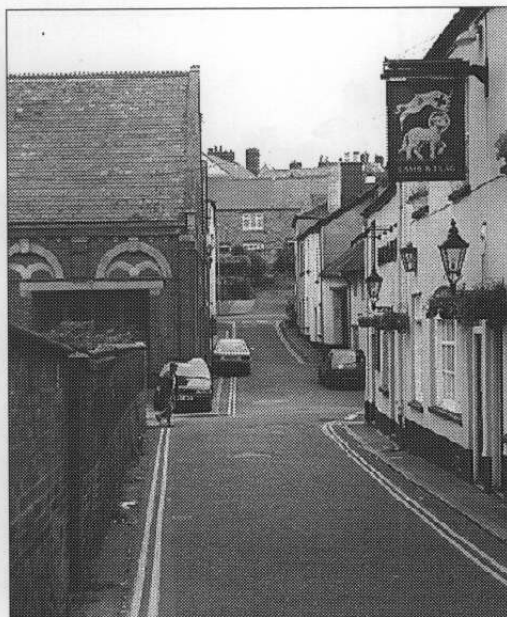
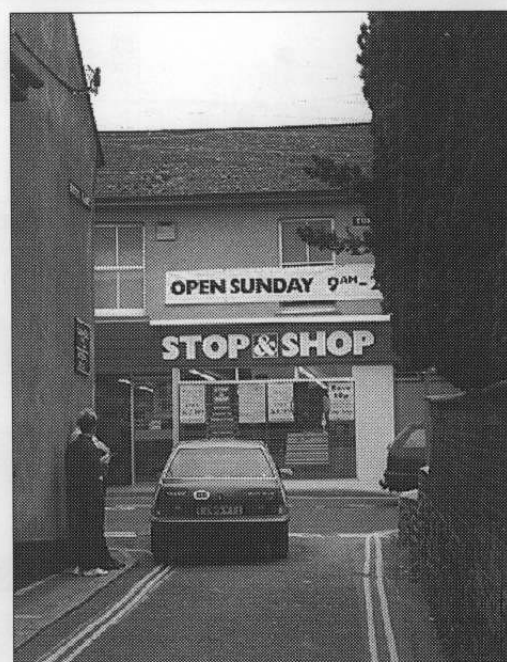
Batts Lane forms a link across the eastern edge of the town. The view at the south end is spoilt by the assertive modern shopfront. The former fire station (left) is a major public building standing empty

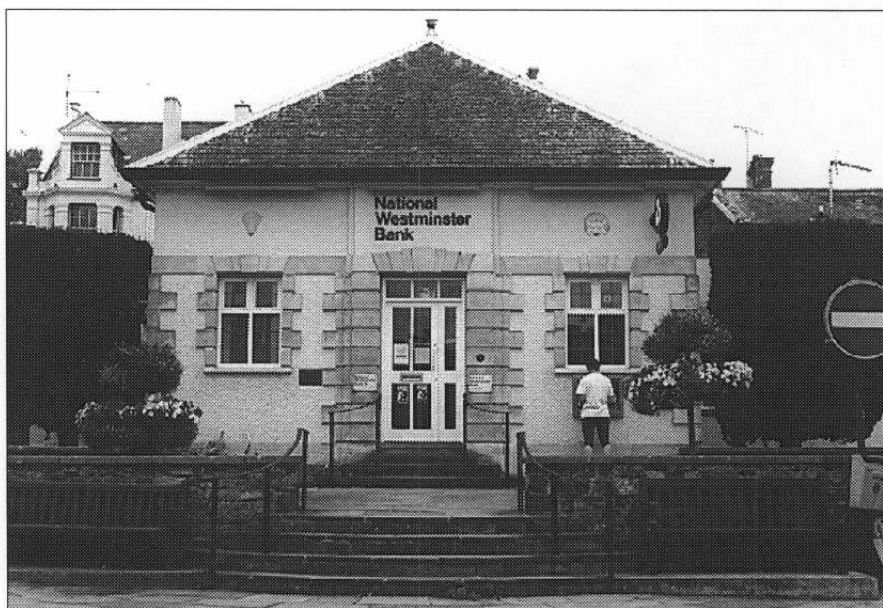
Silver Street, less than 100 metres from Hind Street, presents an attractive townscape although street furniture still tends to dominate

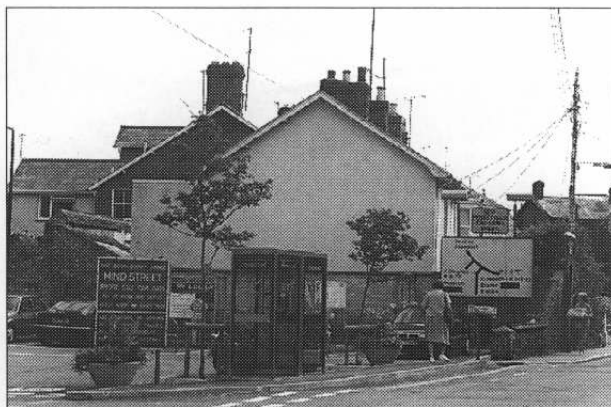
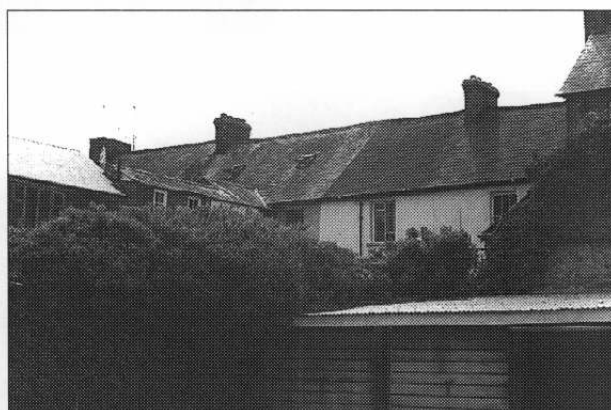
(Above) These views close to the entry of Hind Street to Broad Street contain disruptive elements that typify the edge of many town centres with prominent car parking, a clutter of signs and unsightly rear service yards

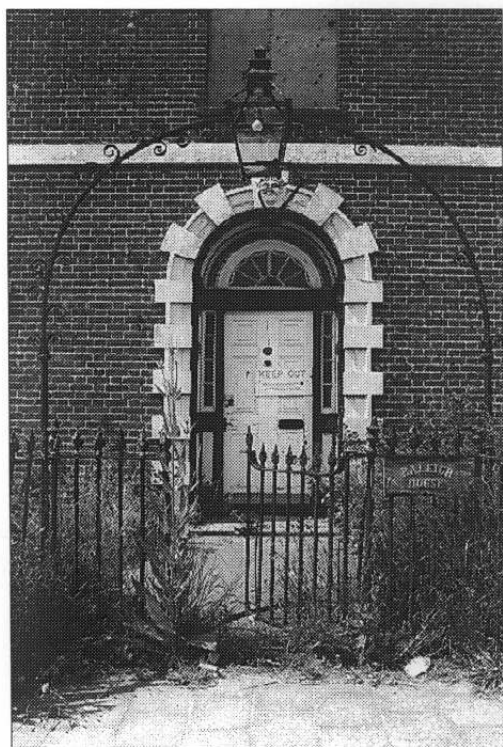
(Left) Mill Street, Raleigh House; one of the finest 18th century houses in the town with original iron railings was in a neglected state at the time of this survey (but is now restored)

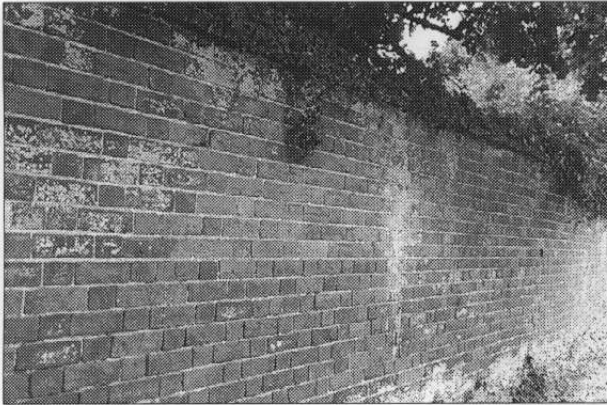
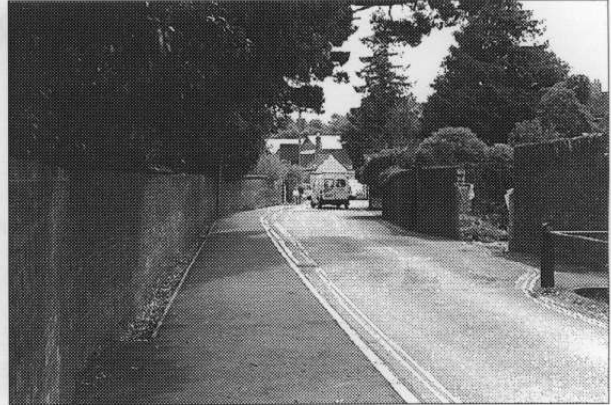
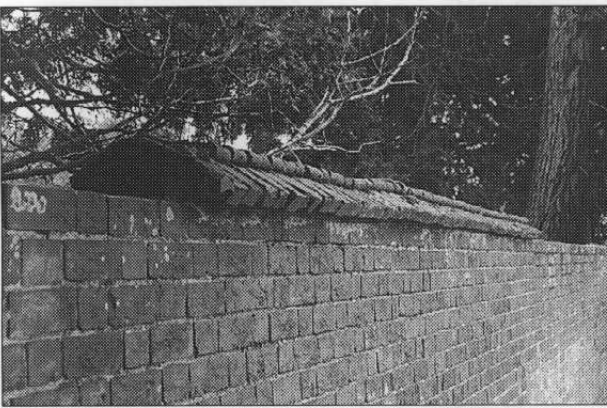
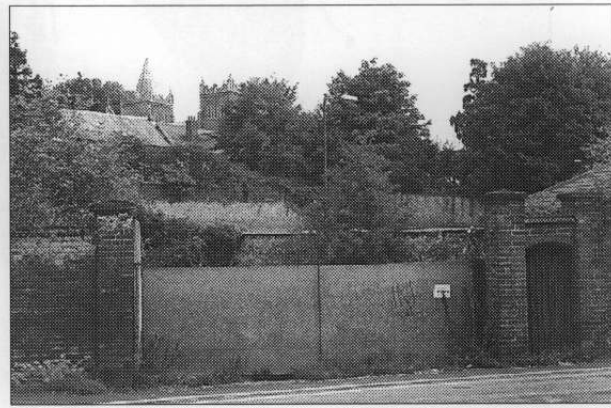
- traffic and pedestrian conflict at Broad Street and adjoining junctions
- poor linkage between public car parks and main historic attractions
- deteriorating boundary walls, particularly the extensive brick walls in Hind Street which provide an important entrance to the town centre

Hind Street is largely enclosed by brick walls at its eastern end. The condition is variable with loss of capping stone (above left), breaches to allow development (top right) and unsightly gaps (above right). There are important views towards the Parish Church from this part of the town
