Coastal Processes Baseline

Prepared for

East Devon District
Council

August 2017

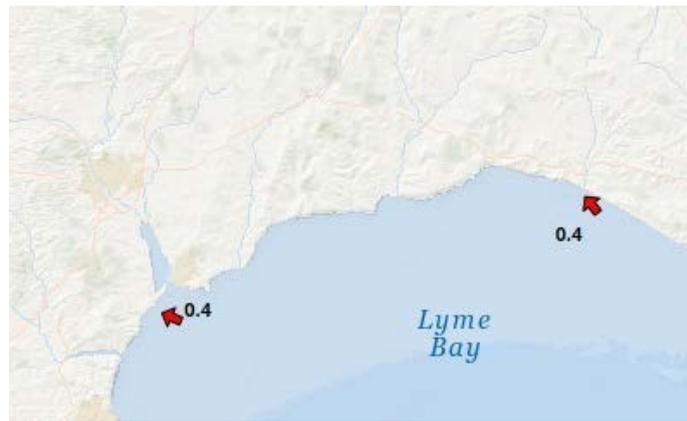
Figure 3.5 Locations of Cefas 'Wavenet' Datawell Directional Waveride buoys, including Dawlish and West Bay
Source: <http://wavenet.cefas.co.uk/Map>

- Measured wave data is collected via two Datawell Directional Waverider MkIII buoys, both of which are operated by the Channel Coast Observatory (CCO). The first is located to the west at Dawlish and the second located to the east at West Bay (see Figure 3.5). The buoys form part of the strategic wave monitoring network, 'Wavenet', run by the Centre for Environment, Fisheries and Aquaculture Science (Cefas), and which provide a single source of real-time wave data for areas at risk of flooding around the UK.

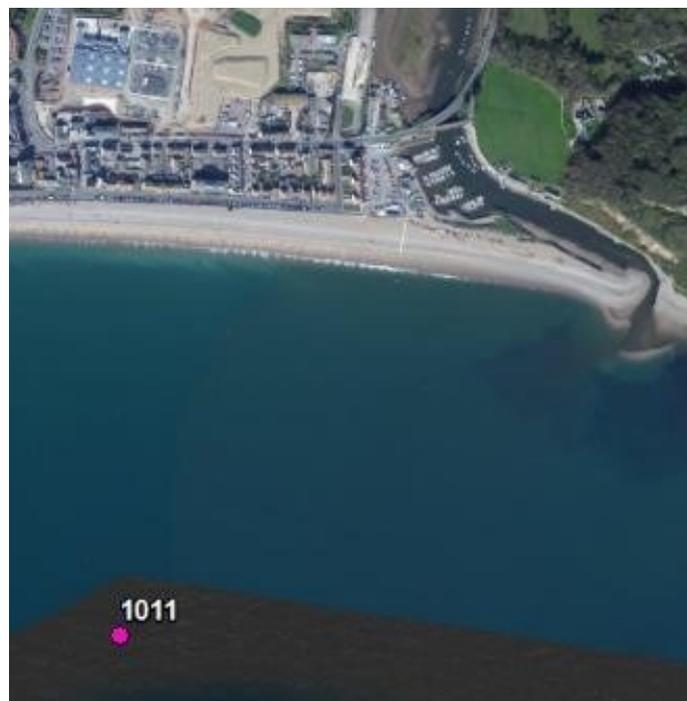
Figure 3.7 Map showing location of SoN data point, 1011', which is located closest to Seaton

- As part of the Environment Agency's SON project to improve knowledge of coastal boundary conditions (i.e. water levels and waves), the Met Office wave hindcast model outputs were used to run a wave model (SWAN) to provide data on the inshore wave climate around the UK coastline. Similarly, to the Met Office model, there are a series of data points, the closest to Seaton being '1011', as shown in Figure 3.7.

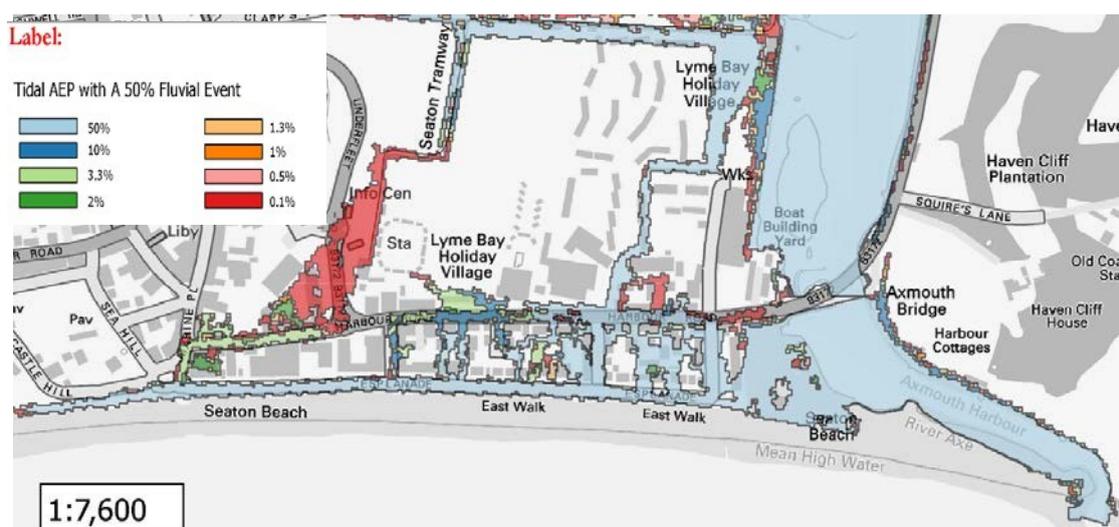
Figure 3.12 Present Day Flood Risk from Wave Overtopping of Coastal Defences Under a range of Return Periods

It should be noted that the flood zones are a projection of still water level, and do not include wave run-up or wave overtopping. However, recent work completed for the Lyme Bay Coastal Flood Forecasting Phase 2 shows the present-day flood risk from wave overtopping of coastal defences under a range of extreme return period events (refer to Figure 3.12).

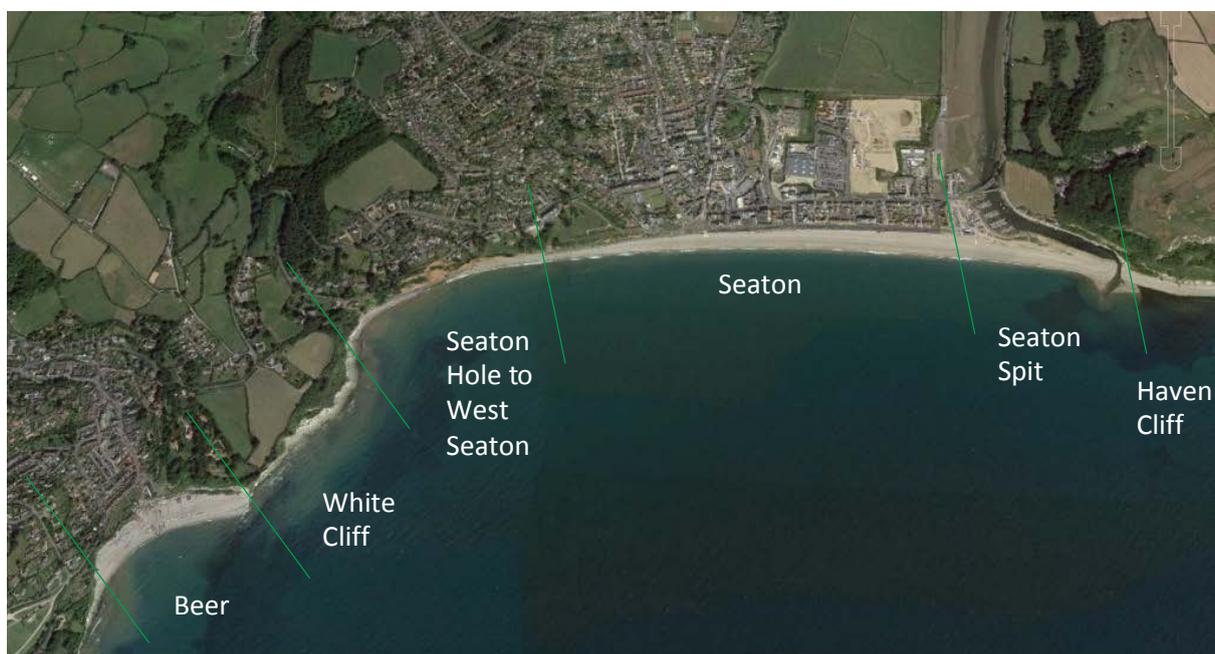
Figure 4.1 Map showing coastal units defined for the BMP

Considering the geomorphology of the shoreline and the defence history, the coastline has been divided into a series of units, and appraised accordingly. The units are listed below and shown in Figure 4.1. It is important to consider the linkages with the coastline downdrift and updrift of the study area as changes at these locations can have a direct influence on the coastline at Seaton. Therefore, for this section of the report only, consideration is given to the coastline downdrift, at Beer, and updrift, at Haven Cliff.

1. Beer
2. White Cliff
3. Seaton Hole to Seaton Spit, including sub-units Seaton Hole to West Seaton and Seaton and Seaton Spit
4. Axe Estuary
5. Haven Cliff

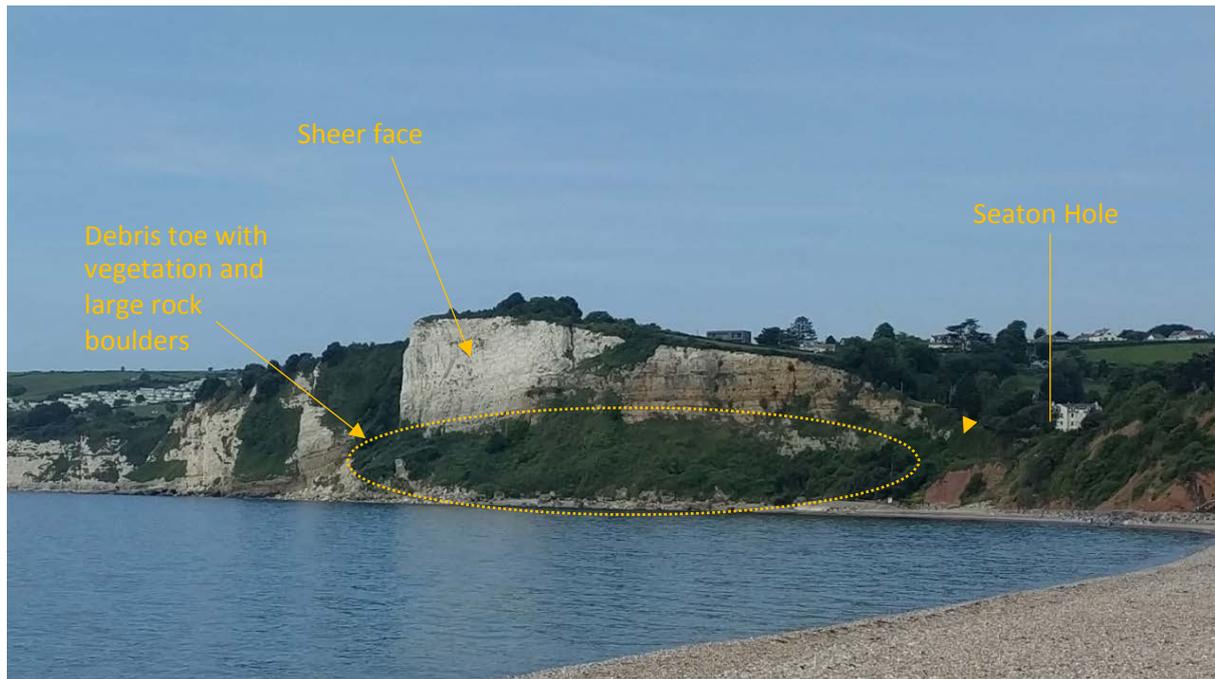
Figure 4.4 White Cliff geomorphology and defences
Photographs taken during Defence Condition Assessment 14th June 2017, facing west

The cliffs between Beer Head and Seaton Hole are comprised of sandstone, limestone and chalk and have been largely unchanged over the past century, with only infrequent, localised failures occurring (SCOPAC, 2012). Erosion generally occurs via cliff failure, such as rockfalls and landslips. The cliff face is sheer with a debris toe at the bottom that is covered by vegetation and consists of large rock boulders and is fronted by a shingle beach and rock platform (comprised of mudstone) (refer to Figure 4.4).

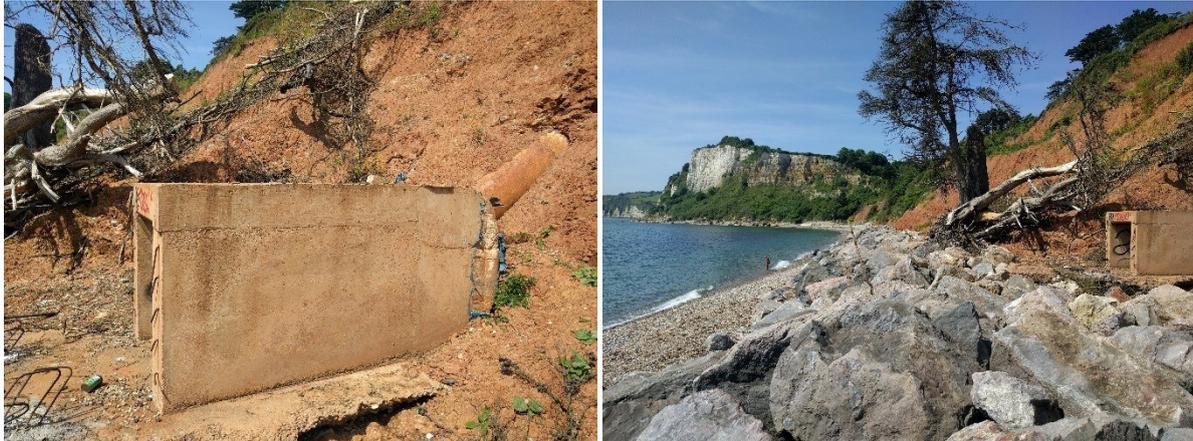
Figure 4.5 Photographs of the cliffs at Seaton Hole
Photograph taken during defence condition assessment 28th June 2017, looking south-west

Today debris, as well as man-made structures are observed to be falling out from the cliffs as they erode, which is a health and safety issue. For example, see Figure 4.5, which shows the old emergency overflow from Seaton Hole sewerage pumping station at the cliff toe.

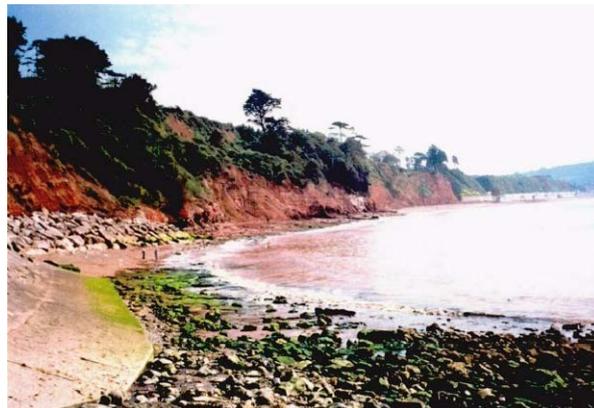
Figure 4.7 Photograph of beach between Seaton Hole and West Seaton, assumed to date 1993/1994
Source: Posford Duvivier, 1994

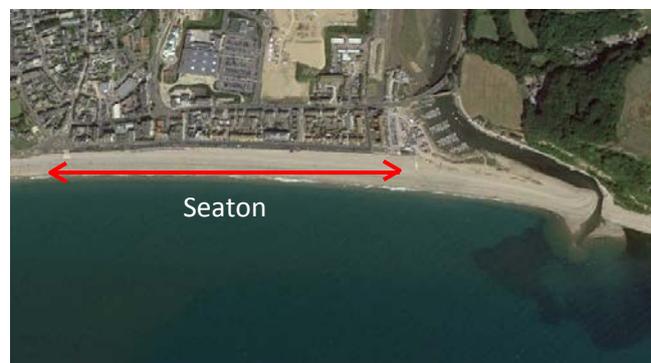
Figure 4.9 Seaton
Aerial image © 2015 Google Earth

Seaton Town has developed on the western bank of the Axe Valley, but in more recent times in its south-eastern quarter, development has encroached onto former saltmarsh and mudflat. A shingle beach exists along the length, which extends eastward to form Seaton Spit at the mouth of Axe Estuary (refer to Figure 4.9 and Figure 4.10). The beach and spit are comprised of shingle (gravel chert), flints and pebbles from the Budleigh Salterton Beds), formed by the long term longshore transport of material from west to east. The shingle beach is underlain by a sandy substrate and in places a rock platform.

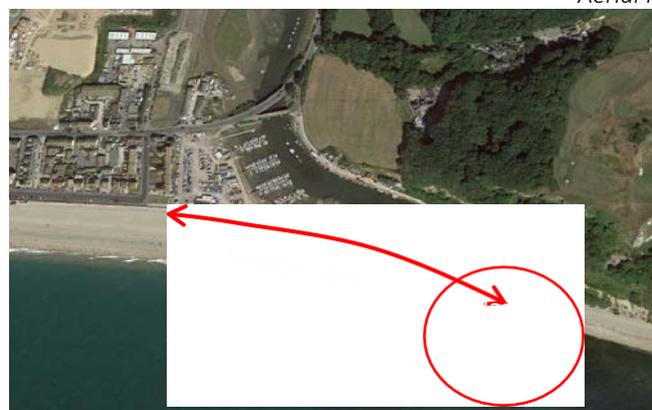
Figure 4.10 Seaton Spit, the 'bar' and delta (below)
Aerial image © 2015 Google Earth

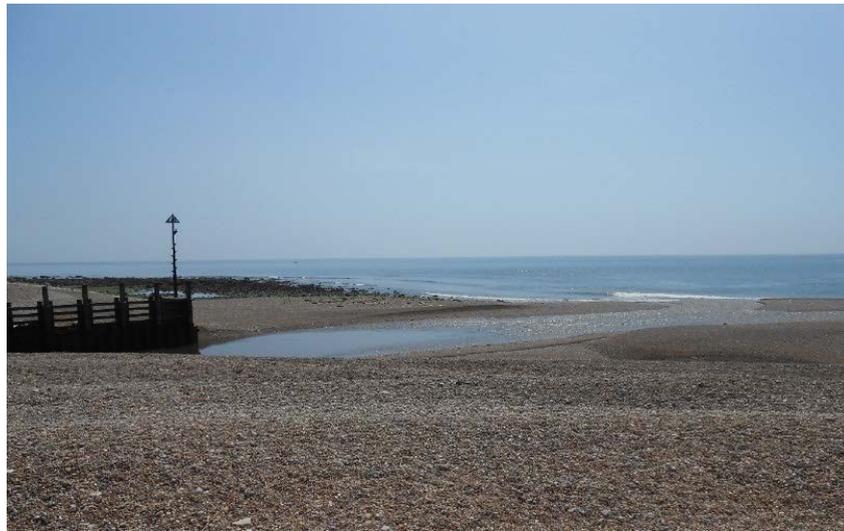
Figure 4.12 Photograph showing the estuary bar
 Photograph taken during site visit 24th May 2017, looking south-east

At the mouth of the estuary, exists a bar of material, although it is rarely a linear feature that runs parallel to the coast, rather a dynamic feature that is continuously changing shape in response to tides and waves. The bar is comprised of shingle and gravel, as observed during a site visit on the 24th May 2017 (see Figure 4.12). The Axe Estuary is understood to be ebb-dominant (Halcrow, 2002; SCOPAC, 2012). The presence of an estuary delta has been questioned (SCOPAC, 2012), however, it is evident from aerial photos and observations of the spit that a delta does exist at the mouth of the estuary. Pritchard (2006) suggests that the delta (referred to as a 'Fan Shaped Shingle Plateau') is a 'new phenomenon' and its formation could be linked to an increase in the number of days of south-easterly conditions compared to the prevailing south-westerly conditions, over the past two years.

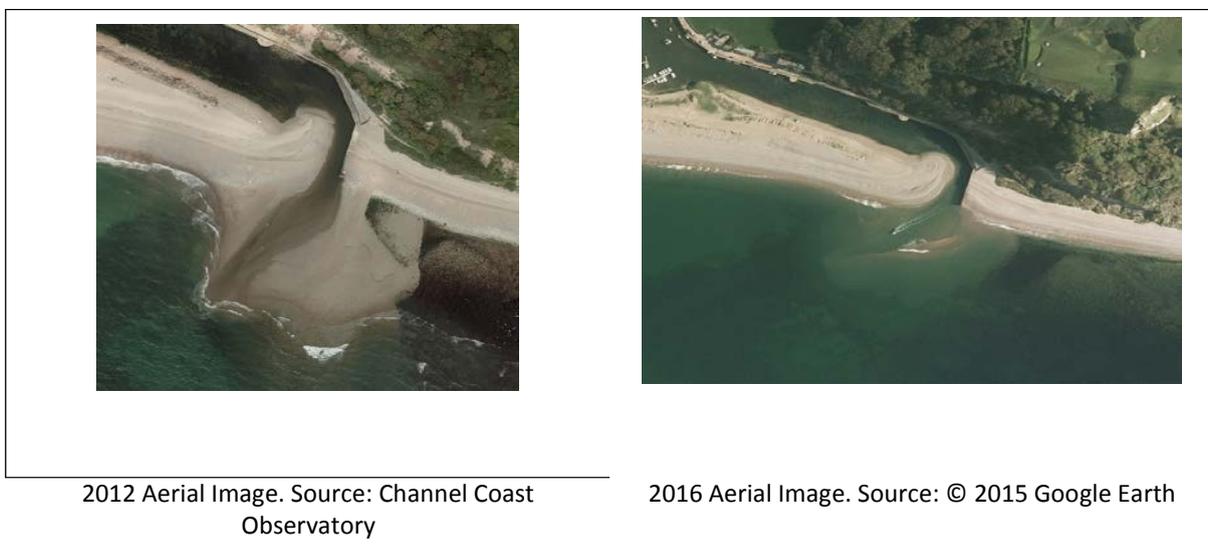
2012 Aerial Image. Source: Channel Coast Observatory

2016 Aerial Image. Source: © 2015 Google Earth

In the past, the bar is reported to have extended across the mouth of the Axe Estuary during conditions of south-westerly waves and sustained strong west to east drift (Parkinson, 1985). However, it has been proposed that intensification of ebb tidal current velocities due to river channel training walls, and the construction of a short breakwater on the east side of the mouth, has kept the exit open in recent decades (SCOPAC, 2012). The bar is dynamic and takes many forms; these have been typified into four scenarios (see Figure 4.13) and supported by observations made from aerial photography, refer to Figure 4.14.

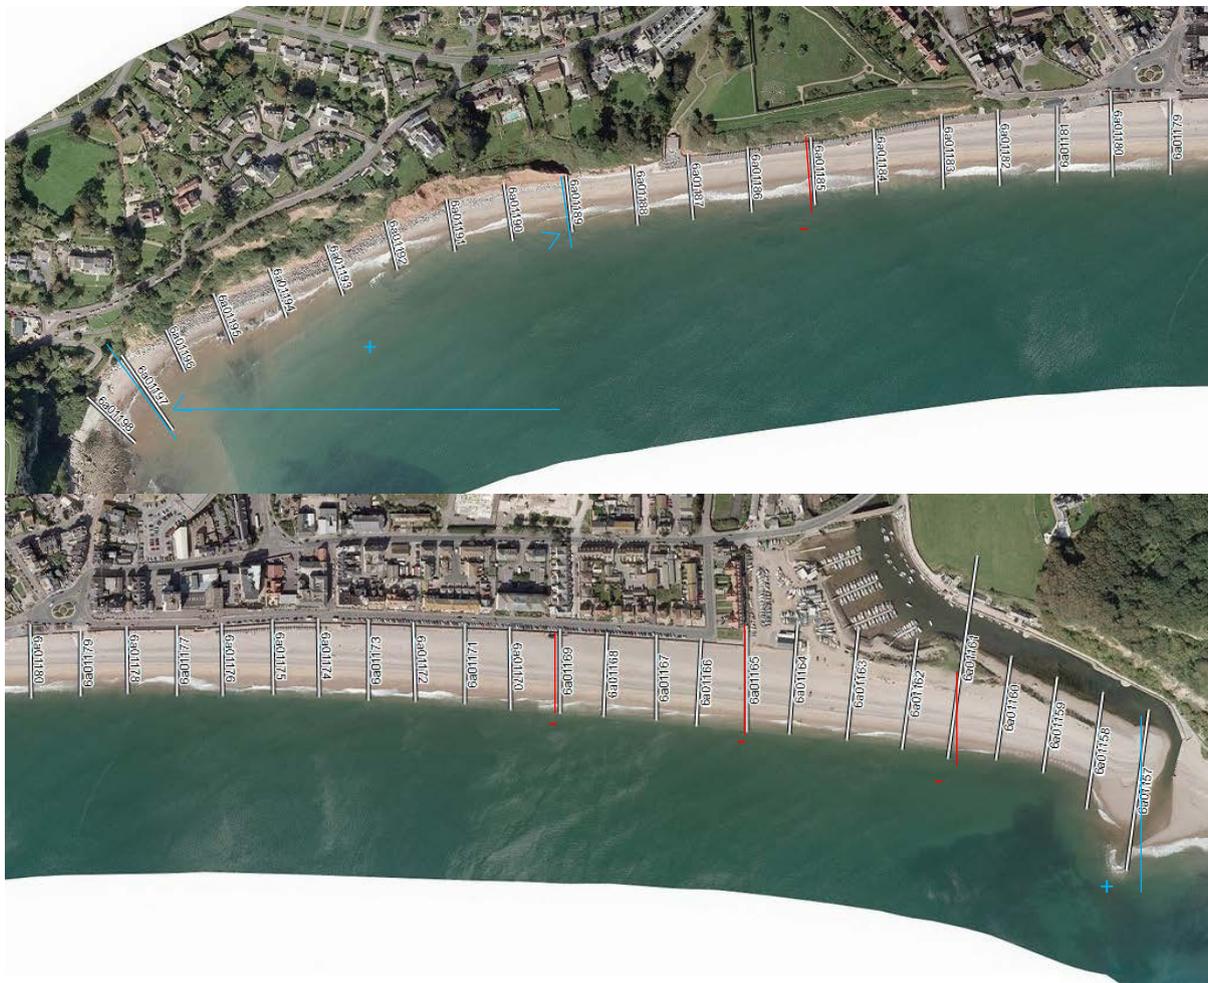
Figure 4.15 Map showing location of beach profiles with positive cross-sectional change shown in blue and negative cross-sectional change in red

A review of Plymouth Coastal Observatory's (PCO) Annual reporting on beach profile change has been undertaken for the coastline between Seaton Hole and Seaton Spit. The reporting is based on data collected between 2007 and 2017 for the Southwest Regional Coastal Monitoring Programme (SWRCMP). The review compares the reported cross-sectional area change from one year to the next for the profiles between Seaton Hole and the Axe Estuary (profiles 6a01197 to 6a01157, see Figure 4.15); unfortunately, beach profile data for the coastline at Beer and to the east at Haven Cliff is not collected and included in the annual reporting. The results of the analysis are presented in Table 4.1 and the key findings summarised in Figure 4.15 and below.

- At a few profile locations, the cross-sectional area change between 2007 and 2017 is positive, indicating accretion; these locations include:
 - Profiles 6a001197 to 6a01189 (Seaton Hole to Check House Seawall) – **these findings should be treated with caution; the latest PCO report (PCO, 2016) suggests that the large changes at profile 6a01193, reflect the profiles short length and not the material loss or gain and as observed from reviewing the beach profile data in SANDS (see Section 4.3.2.4 below); this can arise due to restricted access at the time of survey due to cliff hazards;** and

- Profile 6a001157 (distal end of the spit).
- At a few profile locations, the cross-sectional area change between 2007 and 2017 is negative, indicating erosion, however, it should be noted that PCO consider cross-sectional area change of less than 5m² to represent no change, and therefore these locations could in fact be considered to be stable. These locations include:

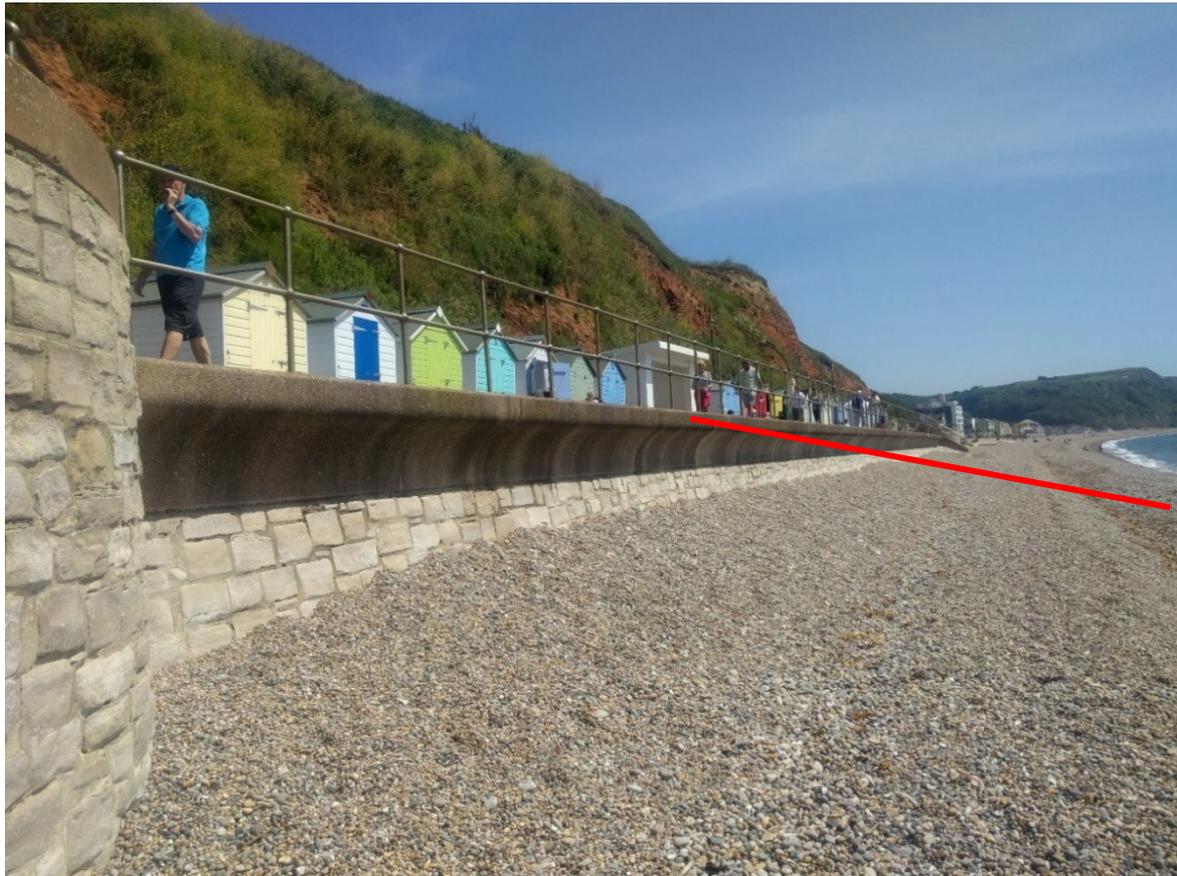
Figure 4.16 Photograph of beach at the location of eroding beach at profile 6a01185 (approximate position shown by red line)
Photograph taken during defence condition assessment 28th June 2017, looking east

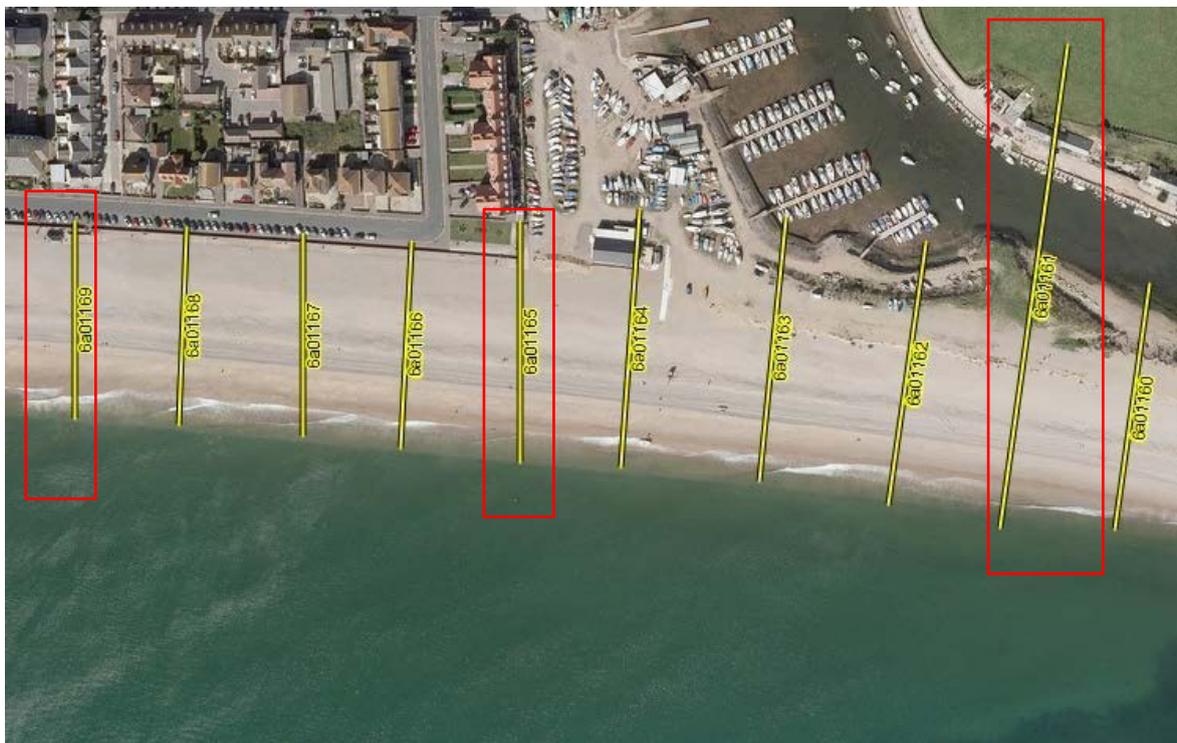
Figure 4.17 Map showing locations of eroding profiles at eastern the end of Seaton, including 6a01169, 6a01165 and 6a01161
Source: Photo Channel Coast Observatory, 2009

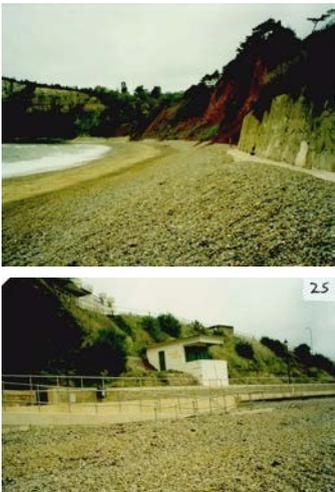
Date	Storm Description	Impact on Beach	Data Source
January / February 2014	South-westerly	Wave overtopping of the seawall	PCO (2014c)
November 2005	Not reported	Overtopping of the spit and significant of the spit.	Pritchard (2006)
2000/2001	Severe gales	Erosion of the end of the spit, over-widening of the mouth and significant erosion along the seaward face of the spit.	Axe Harbour Management Company Ltd (2001)
November 1998	Not reported	Steepening and exposure of sand and ramping-up against the seawall

Historic photograph supplied by EDDC for the BMP
Winter 1995/1996	Not reported	The spit was 'dangerously narrowed'.	Author unknown 1 (2000)

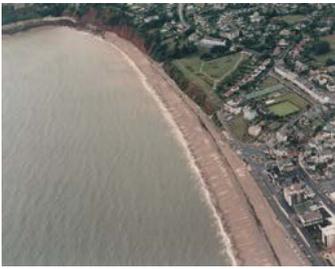
Date	Storm Description	Impact on Beach	Data Source
November 1995	Not reported	Erosion of the shingle spit, on both seaward and landward sides. Disposal trench exposed and previously buried dredged material exposed.	Historic photographs supplied by EDDC for the BMP
September 1995	Easterly	Low beach levels

Posford Duvivier (1997) Historic photograph supplied by EDDC for the BMP
December 1989 to July 1993 / 1994	Not reported	Low beach levels. Comparison of a pre-storm beach profile and survey data suggests a loss of 110,000m ³ of sediment between Seaton Hole and the western end of the seawall. Losses at Sidmouth during the same storm are reported to have been of the same magnitude.	SCOPAC (2012) Posford Duvivier (1994) Posford Duvivier (1997)
1993	Not reported	Overtopping of the spit and flooding of the estuary, requiring removal of shingle from the harbour and entrance.	Author unknown 2, 2015

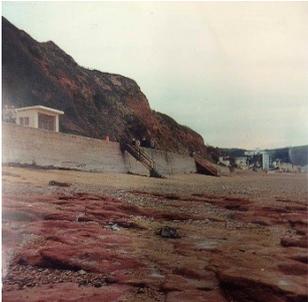
September 1993	Not reported	Significant loss and depletion of the beach, with exposure of bedrock in front of the West Walk Esplanade over its whole length.	Posford Duvivier (1994)
29 th January 1993	Not reported	Beach erosion and depletion of sediment resulting in exposure of sand substrate and rock platform.

Observed from notes/photos held by Seaton Museum
30 th August 1992	South south westerly storm, estimated to be less than a 1: 50 year event.	Significant loss and depletion of the beach, with exposure of bedrock in front of the West Walk Esplanade for approximately 100m.	Posford Duvivier (1994)
Winter 1989/1990	South-westerly winter storms, estimated to be less than a 1: 50 year event.	Substantial loss and depletion of the beach between Seaton Hole and the eastern end of the West Walk Promenade. It is estimated using numerical modelling that longshore movement of material (grainsize not specified but assumed to be shingle) during this storm could have been in the order of 8,000 to 9,000m ³ . Exposure of bedrock at Seaton Hole. Increasing beach quantity east towards Seaton.	Posford Duvivier (1994)

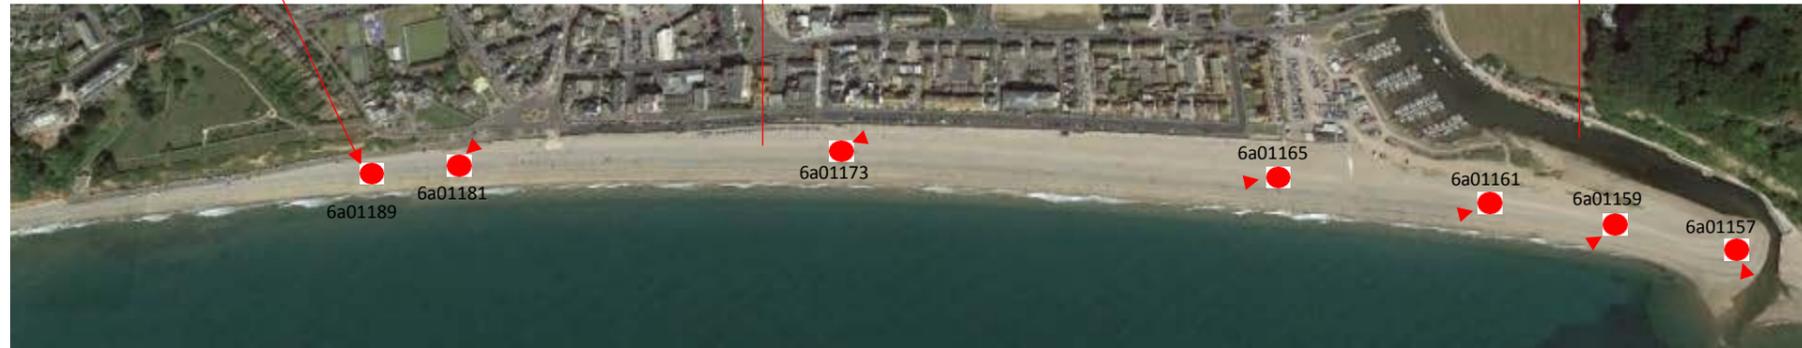
Figure 4.19 Beach profiles for post-storm surveys, where a notable change outside of the general profile change is marked by a profile in bold (2016 storm in grey and 2017 in blue)
 *Note that the 2017 post-storm profile for profile 6a01165 was surveyed at the same time the trench was dug for the disposal of dredge material

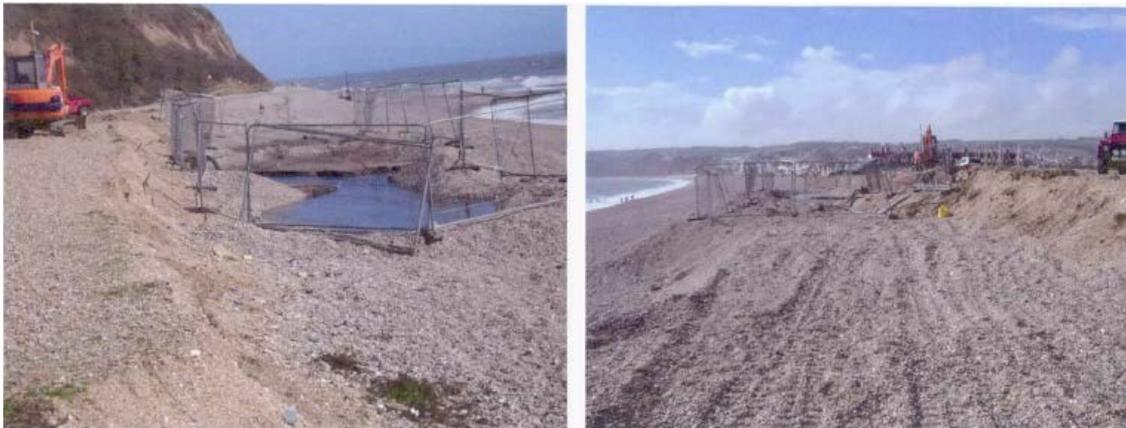
Figure 4.22 Trench for disposal of dredge material 2009/2010
Source: Author unknown 0, no date specified

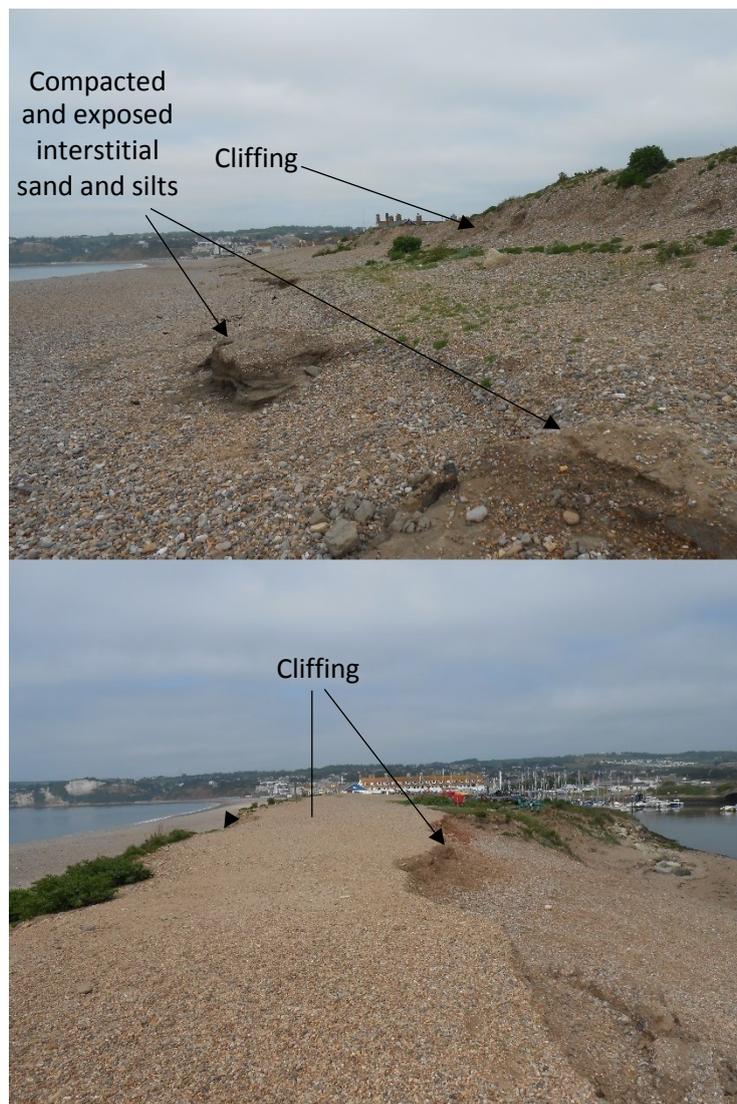
Figure 4.24 Photographs of the Seaton Spit, showing cliffing and exposed compacted interstitial sand and silts
 Photographs taken during site visit 24th May 2017, top looking west, and bottom, looking north-west

In turn, cliffing can also increase wave reflection on beaches and thereby further reduce beach levels in front due to scour action by waves.

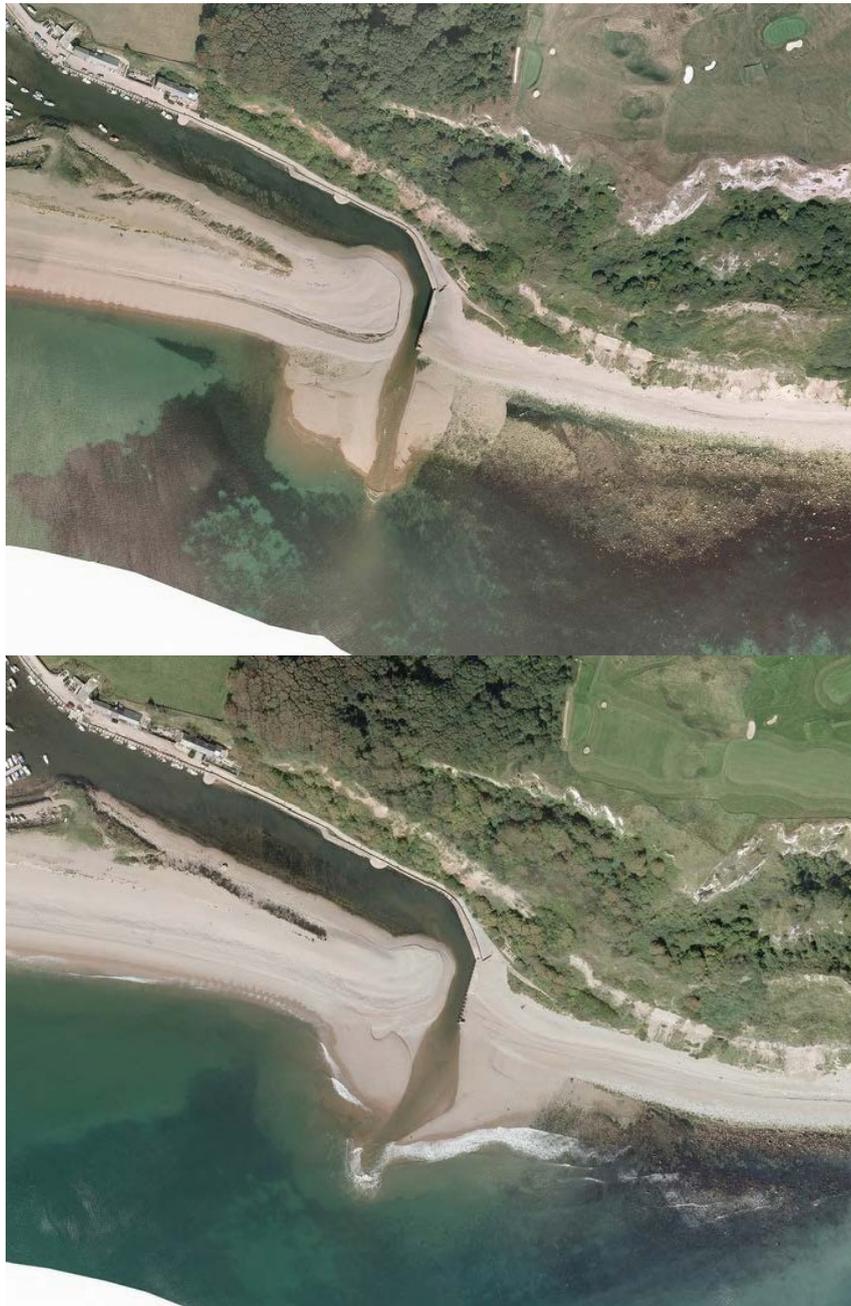
Figure 4.26 Aerial photographs of the Axe Estuary mouth and Haven Cliff beach in 2006 (left) and 2009 (right)
Source: Channel Coast Observatory, 2006 and 2009

A rock platform is shown to protrude from the cliffs and foreshore on the eastern bank side of the estuary mouth. Aerial photographs from 2006 and 2009 (refer to Figure 4.26) clearly show the shingle beach, boulder beach rock platform and the build-up of the bar material and estuary delta. It is inferred from the photographs that the rock platform has the potential to affect movement of material around the mouth of the estuary. It is possible that material held within the delta may supply the beach at Seaton under certain incident wave conditions, i.e. when prevailing conditions drive east to west sediment transport.
