BEER

Prepared for East Devon District Council by John Fisher BA, MA, MRTPI
with contributions from Town and Parish Councils and Amenity Societies in East Devon

Published by East Devon District Council 1999
© Copyright East Devon District Council

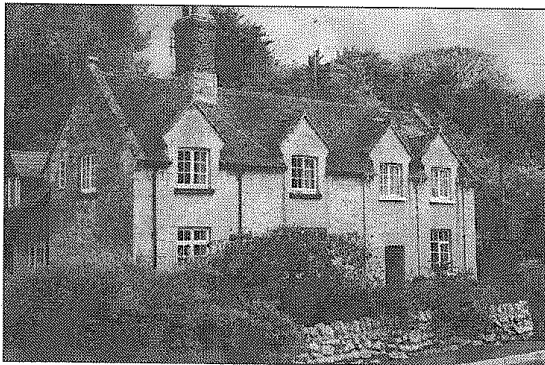
Examples of cottages in Causeway and Clapps Lane showing a typical range of materials with a fair proportion of original detail retained, but also some loss of traditional timber windows and doors

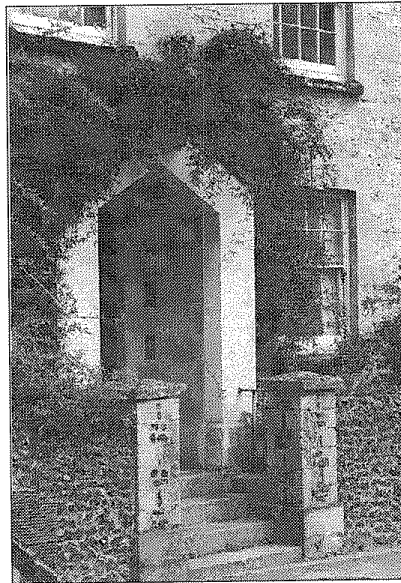
Causeway: Farmhouse entrance with attractive contrast between flint and dressed Beer stone

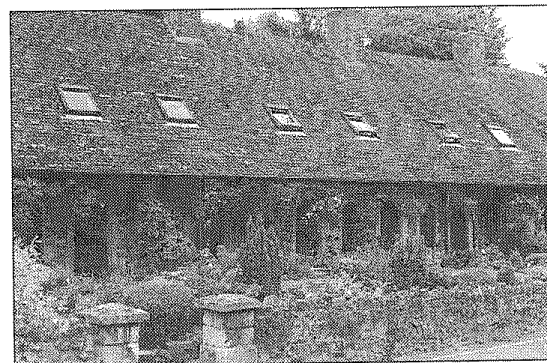
Rolle almshouses, Causeway: a most attractive combination of decorative tiles and dressed Beer stone with some random flint and rubblestone

The **Almshouses and Charity School** was a gift of Lady Rolle in 1820, and is a Gothic design with deep eaves forming a continuous porch, and a dominant roof of patterned tiles. The **Cemetery Chapel** 1866 was another Rolle gift in Decorated style with steep pitched roof, bellcote and dripstone detail depicting Youth and Age.

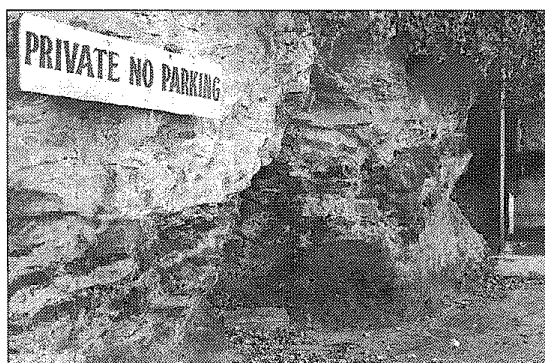
Causeway; natural rock outcrops and a fast-flowing stream provide a striking contrast to an otherwise largely urban setting

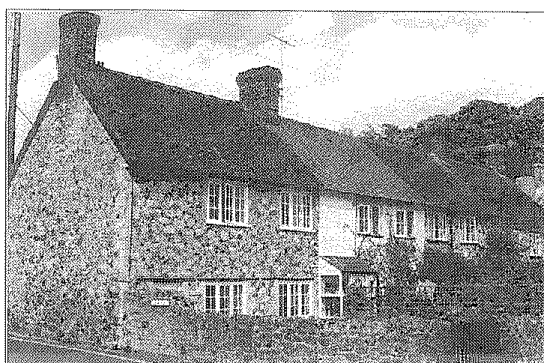
Immediately adjoining the previous photograph is this terrace where much original detail has managed to survive, including the stone boundary walls which contribute greatly to the overall character

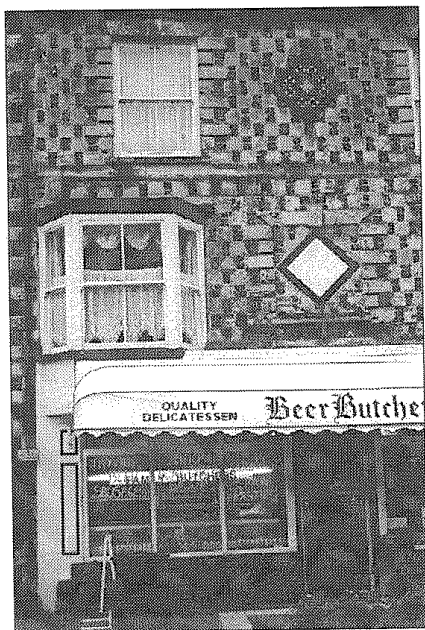
19th century modifications to earlier (probably 17th century) original Beer stone and flint chequerwork. Note first floor bays and encaustic tile motif

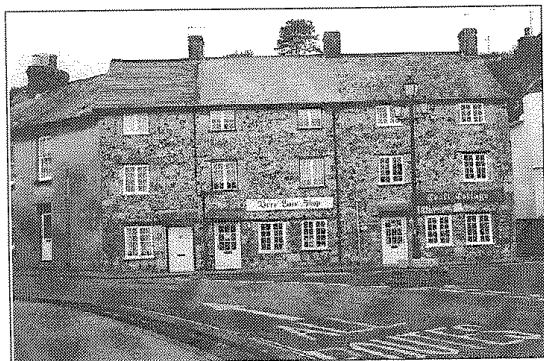
The Cross; unusual three-storey houses built of flint and random rubblestone with Beerstone dressings and footings

8.4 Facing down the street at **The Square or Cross** are three-storey flint and rubblestone houses dated 1664. Near the first conduit is an attractive thatched house with projecting wings. Close to the Congregational Church is a once grand house with four gables and seven bays, the centre three advanced; the windows have projecting keystones. **Diamond House** is 17th century in origin, of three-storeys with flint and Beer stone in a chequer pattern and two decorative lozenges in the centre. The **Dolphin Hotel**, also of flint and stone, has four tall upper windows.

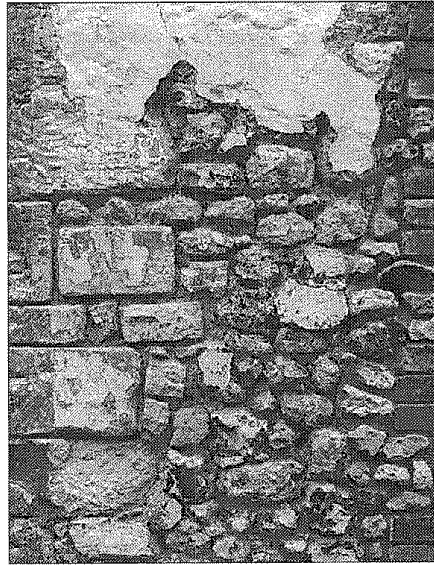
Consolidation of a section of wall in New Cut has been well handled with minimal use of mortar

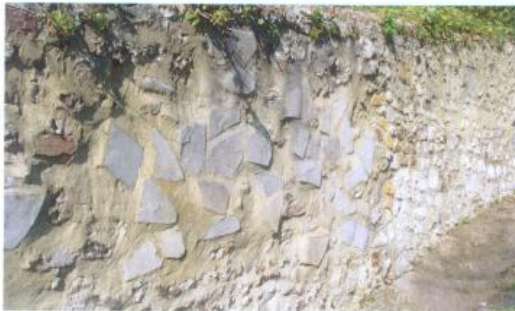
- A trend is developing in the village of important stone walls being poorly repaired. Some walls are being completely inappropriately treated, e.g. cement rendered, and many have been so plastered with render at various times that the individual stones are almost obscured. This seems to be an increasing problem in Beer, e.g. at the Corner of Berry Lane and in New Road, also the church wall in Church Hill. There are also a small number of unrepaired stone walls in very poor condition, e.g. Berry Lane, which may have been hit by vehicle and Common Lane where the allotment wall has been damaged.

Poor wall repairs in Church Hill using excessive cement mortar.

- Minor incremental changes can have a significant impact upon the conservation area where the character is very distinctive. Lack of maintenance of chert walls and indeed inappropriate repairs with excessive cement mortar can have a damaging impact. The retention of prominent sections of front garden walls is important and where this cannot be controlled an Article 4 Direction could provide means to protect this aspect of the conservation area.
