## **Honiton Interim Conservation Area Review**

## **HONITON**

Prepared for East Devon District Council by John Fisher BA, MA, MRTPI with contributions from Town and Parish Councils and Amenity Societies in East Devon

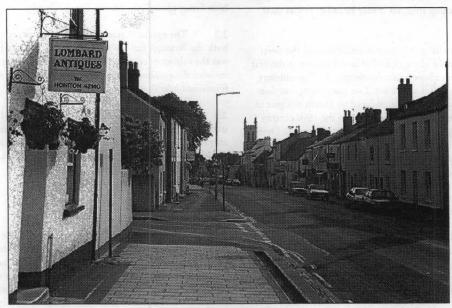
Approach to the conservation area from the east. Attractive and varied townscape, on a largely domestic scale.

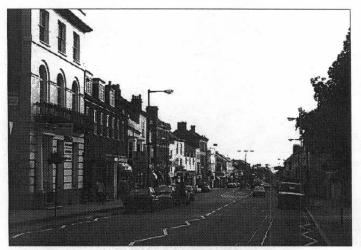
High Street, town centre; note iron balcony (No 68) on the left, churchyard trees on the right, and distant views beyond the town.

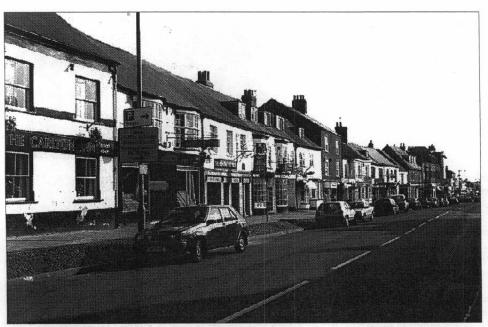
High Street (east) south side. Frontages in this part of the town are pleasing and generally little compromised by modern replacements.

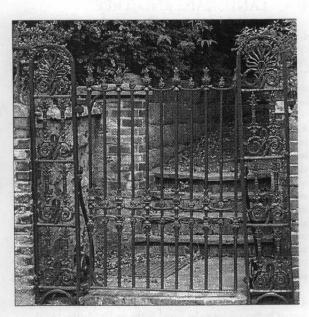
A fine cast iron gate entrance off New Street to No.8 Summerland.

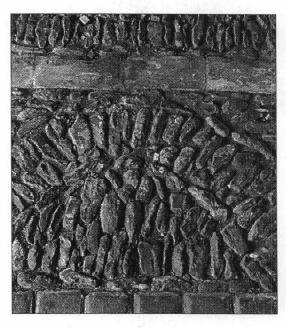
Decoratively patterned chert cobbles and stable tiles in a courtyard off King Street.

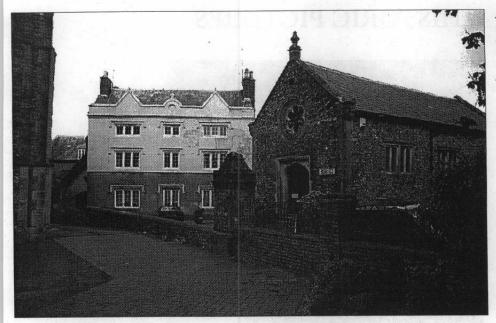
Allhallows Museum (right) also mainly built in chert. Beyond are the former Allhallows School buildings. Hard surfaces, mainly pedestrian, predominate in this part of the town.
