Seaton Beach Management Plan (BMP)

Non-Technical Summary – Defences Baseline

Purpose of the Defences Baseline Report

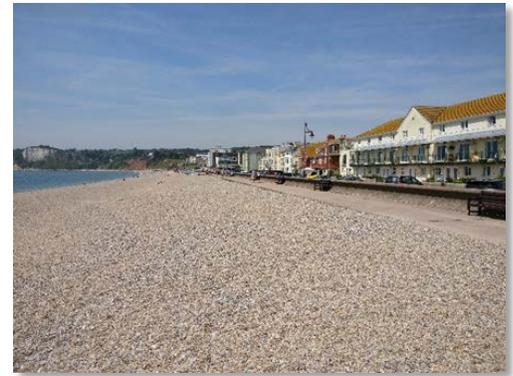
Most of the defences were graded at Grade 2 (Good) or Grade 3 (Fair) with only three defences graded Grade 4 (Poor). At Grade 4 the defences have defects that significantly reduce the performance of the asset. The defences identified as being Grade 4 included the Seaton Hole concrete structure, the rock armour between Seaton Hole and West Seaton and the composite gabion defence to the west of the Check House Wall.

The BMP frontage was split into 13 sections to assess the variation of defence elements present. Each section was given a condition grade between 1(Very Good) and 5 (Very Poor) using the Environment Agency's Condition Assessment Manual.
