Original Report Number 09103
New Report Number 09103/17341

EAST DEVON DISTRICT COUNCIL

**HSG 264 Management
Asbestos Survey of
Exmouth Town Hall
St Andrews Road
Exmouth EX8 1AW**

**Re-Inspection 4 & 12 October 2017
(next inspection due by 4 October 2018)**

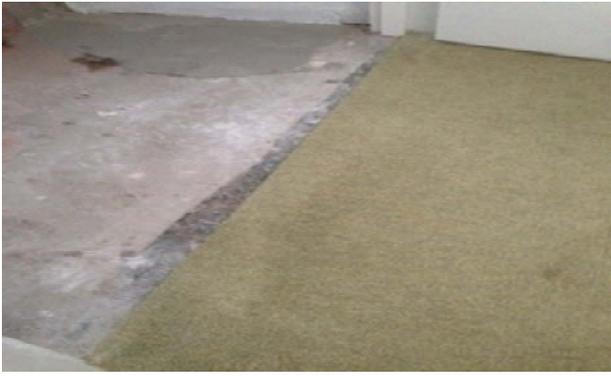
Asbestos Register and Management Plan						
Client: East Devon District Council, Knowle, Sidmouth EX10 8HL						
Site: Exmouth Town Hall, St Andrews Road, Exmouth EX8 1AW						
Project Number: 17341		Re-inspection Dates: 4 & 12 October 2017		HSG264 management survey		
Sample Ref	Location/Client Ref	Item/Quantity	Material Assessment Score		Priority Assessment Score	
BS21384 (taken 01.06.09)	GF reception	Bituminous floor adhesive concealed below carpet (full extent on GF unknown) / N/Q	Product Type	1	Normal Occupant Activity	
			Condition	0	Likelihood of Disturbance	
Plan Ref	Product Type	Fibre Type(s)	Treatment	0	Human Exposure Potential	
1	Asbestos reinforced composite	Chrysotile fibre	Asbestos Type	0	Maintenance Activity	
			Material Assessment Total	2	Priority Assessment Total

Total Risk Score			
			Recommended Management Action			
			As the full extent of an asbestos containing bituminous adhesive below existing floor coverings on the GF has not been investigated, it is strongly presumed to be present throughout the GF. Manage this material until removed in accordance with The Control of Asbestos Regulations 2012

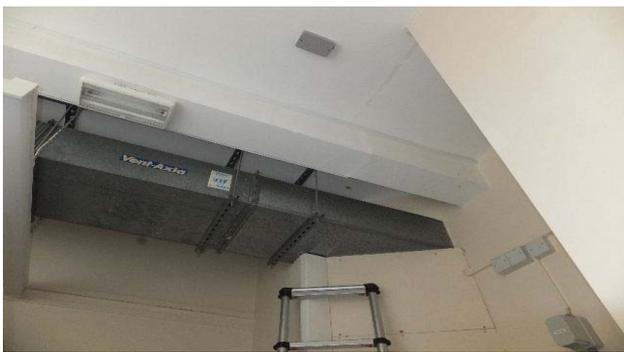
Sample Ref	Location/Client Ref	Item/Quantity	Material Assessment Score		Priority Assessment Score	
Presumption (due to inaccessibility)	GF male toilets	Flange gaskets/seals to ventilation duckwork in ceiling void / N/Q	Product Type	1	Normal Occupant Activity	
			Condition	0	Likelihood of Disturbance	
Plan Ref	Product Type	Fibre Type(s)	Treatment	0	Human Exposure Potential	
2	Asbestos reinforced composite	Chrysotile fibre	Asbestos Type	2	Maintenance Activity	
			Material Assessment Total	3	Priority Assessment Total

Total Risk Score			
			Recommended Management Action			
			Treat as ACM and manage until confirmed otherwise

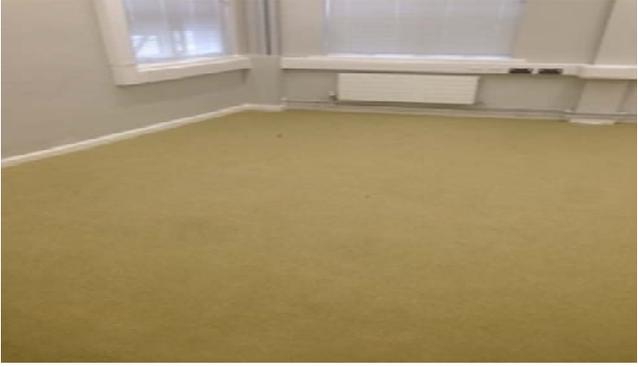
Asbestos Register and Management Plan					
Client: East Devon District Council, Knowle, Sidmouth EX10 8HL					
Site: Exmouth Town Hall, St Andrews Road, Exmouth EX8 1AW					
Project Number: 17341		Re-inspection Dates: 4 & 12 October 2017		HSG264 management survey	
Sample Ref	Location/Client Ref	Item/Quantity	Material Assessment Score		Priority Assessment Score
BS17/838 (taken 23.03.17)	GF council of voluntary services, adj office & corridor	Bituminous floor adhesive (composite sample from below floor coverings, full extent on GF unknown) / N/Q	Product Type	1	Normal Occupant Activity
			Condition	0	Likelihood of Disturbance
Plan Ref	Product Type	Fibre Type(s)	Treatment	0	Human Exposure Potential
3	Asbestos reinforced composite	Chrysotile fibre	Asbestos Type	0	Maintenance Activity
			Material Assessment Total	2	Priority Assessment Total

Total Risk Score		
			Recommended Management Action		
			As the full extent of an asbestos containing bituminous adhesive below existing floor coverings on the GF has not been investigated, it is strongly presumed to be present throughout the GF. Manage this material until removed in accordance with The Control of Asbestos Regulations 2012

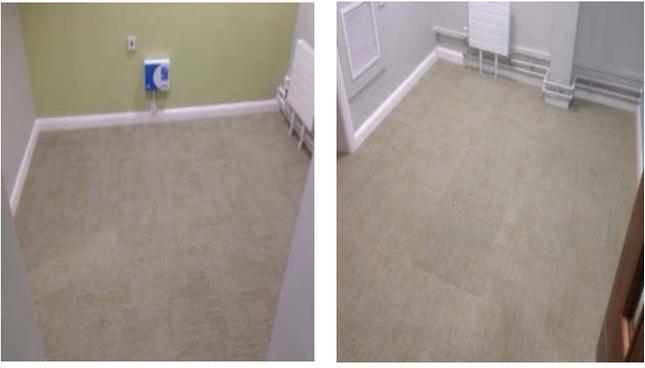
Sample Ref	Location/Client Ref	Item/Quantity	Material Assessment Score		Priority Assessment Score
BS17/840 (taken 23.03.17)	GF registrar & adjoining rear elevation office	Bituminous floor adhesive (composite sample from below floor coverings, full extent on GF unknown) / N/Q	Product Type	1	Normal Occupant Activity
			Condition	0	Likelihood of Disturbance
Plan Ref	Product Type	Fibre Type(s)	Treatment	0	Human Exposure Potential
4	Asbestos reinforced composite	Chrysotile fibre	Asbestos Type	0	Maintenance Activity
			Material Assessment Total	2	Priority Assessment Total

Total Risk Score		
			Recommended Management Action		
			As the full extent of an asbestos containing bituminous adhesive below existing floor coverings on the GF has not been investigated, it is strongly presumed to be present throughout the GF. Manage this material until removed in accordance with The Control of Asbestos Regulations 2012

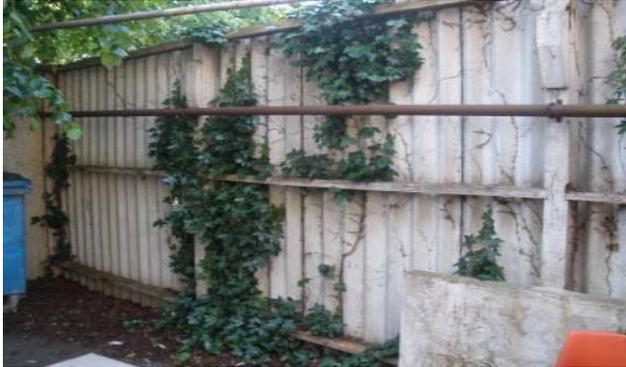
Asbestos Register and Management Plan					
Client: East Devon District Council, Knowle, Sidmouth EX10 8HL					
Site: Exmouth Town Hall, St Andrews Road, Exmouth EX8 1AW					
Project Number: 17341		Re-inspection Dates: 4 & 12 October 2017		HSG264 management survey	
Sample Ref	Location/Client Ref	Item/Quantity	Material Assessment Score		Priority Assessment Score
BS21386 (taken on 01.06.09)	GF external rear courtyard	Corrugated sheeting forming boundary wall / Approx. 25 sq mtrs	Product Type	1	Normal Occupant Activity
			Condition	1	Likelihood of Disturbance
Plan Ref	Product Type	Fibre Type(s)	Treatment	1	Human Exposure Potential
5	Asbestos cement	Chrysotile fibre	Asbestos Type	1	Maintenance Activity
			Material Assessment Total	4	Priority Assessment Total

Total Risk Score		
			Recommended Management Action		
			Manage until removed in accordance with The Control of Asbestos Regulations 2012		
Sample Ref	Location/Client Ref	Item/Quantity	Material Assessment Score		Priority Assessment Score

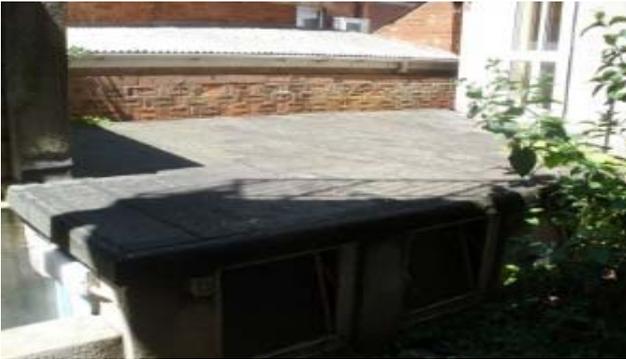
Presumption (as sampling may compromise roof integrity)	GF external boiler room	Felt to flat roof / Approx. 15 sq mtrs	Product Type	1	Normal Occupant Activity
			Condition	0	Likelihood of Disturbance
Plan Ref	Product Type	Fibre Type(s)	Treatment	0	Human Exposure Potential
6	Asbestos reinforced composite	Chrysotile fibre	Asbestos Type	1	Maintenance Activity
			Material Assessment Total	2	Priority Assessment Total

Total Risk Score		
			Recommended Management Action		
			Treat as ACM and manage until confirmed otherwise

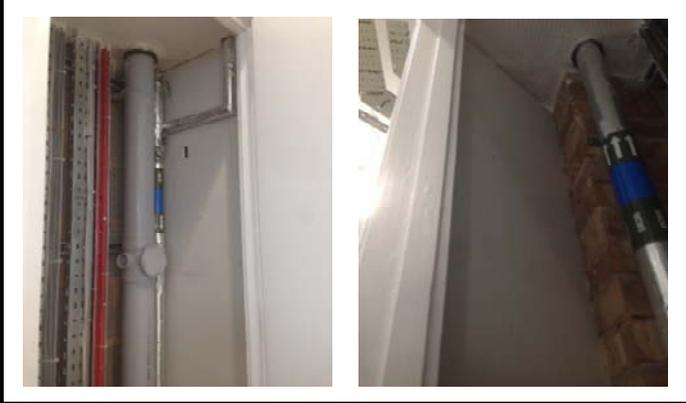
Asbestos Register and Management Plan						
Client: East Devon District Council, Knowle, Sidmouth EX10 8HL						
Site: Exmouth Town Hall, St Andrews Road, Exmouth EX8 1AW						
Project Number: 17341		Re-inspection Dates: 4 & 12 October 2017		HSG264 management survey		
Sample Ref	Location/Client Ref	Item/Quantity	Material Assessment Score		Priority Assessment Score	
BS14/2616 (taken 14.10.14)	1F service riser	Lining to rear face of partition walls & door / N/A	Product Type	N/A	Normal Occupant Activity	
			Condition	N/A	Likelihood of Disturbance	
Plan Ref	Product Type	Fibre Type(s)	Treatment	N/A	Human Exposure Potential	
7	Insulation board	Organic fibre. Asbestos fibres not detected	Asbestos Type	N/A	Maintenance Activity	
			Material Assessment Total	N/A	Priority Assessment Total

Total Risk Score			
			Recommended Management Action			
			No action required			
Sample Ref	Location/Client Ref	Item/Quantity	Material Assessment Score		Priority Assessment Score

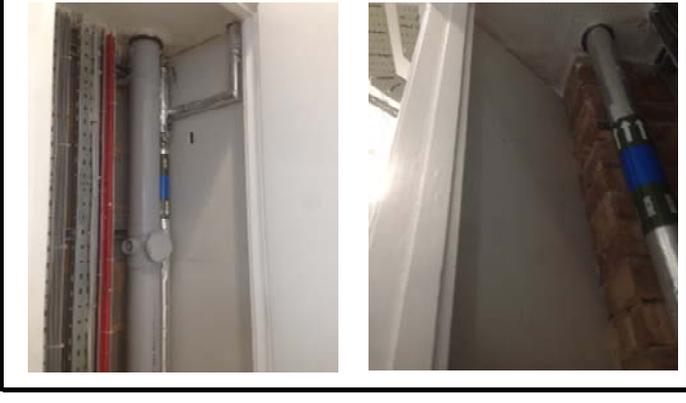
BS16/0385 (taken 01.02.16)	1F service riser	Wall boarding within electrical riser / N/A	Product Type	N/A	Normal Occupant Activity	
			Condition	N/A	Likelihood of Disturbance	
Plan Ref	Product Type	Fibre Type(s)	Treatment	N/A	Human Exposure Potential	
7	Insulation board	Organic fibre. Asbestos fibres not detected	Asbestos Type	N/A	Maintenance Activity	
			Material Assessment Total	N/A	Priority Assessment Total

Total Risk Score			
			Recommended Management Action			
			No action required

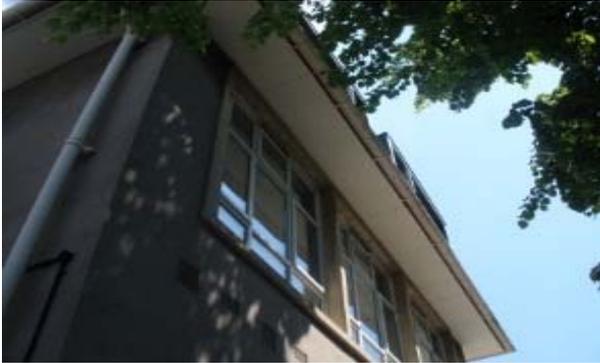
Asbestos Register and Management Plan						
Client: East Devon District Council, Knowle, Sidmouth EX10 8HL						
Site: Exmouth Town Hall, St Andrews Road, Exmouth EX8 1AW						
Project Number: 17341		Re-inspection Dates: 4 & 12 October 2017		HSG264 management survey		
Sample Ref	Location/Client Ref	Item/Quantity	Material Assessment Score		Priority Assessment Score	
BS21387 (taken 01.06.09)	1F external	Soffits to perimeter of building / N/Q	Product Type	1	Normal Occupant Activity	
			Condition	0	Likelihood of Disturbance	
Plan Ref	Product Type	Fibre Type(s)	Treatment	0	Human Exposure Potential	
8	Asbestos cement	Chrysotile fibre	Asbestos Type	0	Maintenance Activity	
			Material Assessment Total	2	Priority Assessment Total

Total Risk Score			
			Recommended Management Action			
			Manage until removed in accordance with The Control of Asbestos Regulations 2012			
Sample Ref	Location/Client Ref	Item/Quantity	Material Assessment Score		Priority Assessment Score

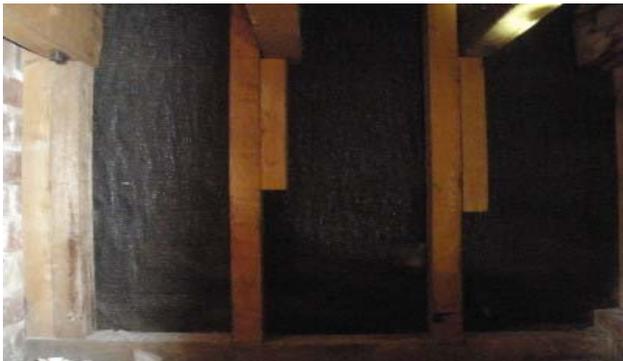
BS14/2619 (taken 14.10.14)	2F roof void	DPM to rear face of external walls / N/A	Product Type	N/A	Normal Occupant Activity	
			Condition	N/A	Likelihood of Disturbance	
Plan Ref	Product Type	Fibre Type(s)	Treatment	N/A	Human Exposure Potential	
9	Bituminous felt	Organic fibre. Asbestos fibres not detected	Asbestos Type	N/A	Maintenance Activity	
			Material Assessment Total	N/A	Priority Assessment Total

Total Risk Score			
			Recommended Management Action			
			No action required

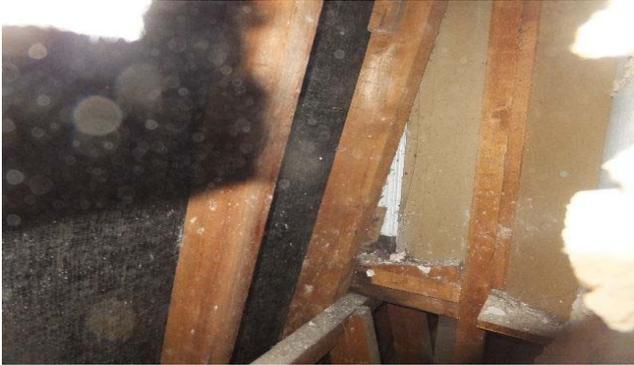
Asbestos Register and Management Plan							
Client: East Devon District Council, Knowle, Sidmouth EX10 8HL							
Site: Exmouth Town Hall, St Andrews Road, Exmouth EX8 1AW							
Project Number: 17341		Re-inspection Dates: 4 & 12 October 2017		HSG264 management survey			
Sample Ref	Location/Client Ref	Item/Quantity	Material Assessment Score		Priority Assessment Score		
BS16/0124 (taken 15.01.16)	2F roof void	Roofing felt / N/A	Product Type	N/A	Normal Occupant Activity		
			Condition	N/A	Likelihood of Disturbance		
Plan Ref	Product Type	Fibre Type(s)	Treatment	N/A	Human Exposure Potential		
10	Bituminous felt	Organic fibre. Asbestos fibres not detected	Asbestos Type	N/A	Maintenance Activity		
			Material Assessment Total	N/A	Priority Assessment Total

Total Risk Score				
			Recommended Management Action				
			No action required				
Sample Ref	Location/Client Ref	Item/Quantity	Material Assessment Score		Priority Assessment Score

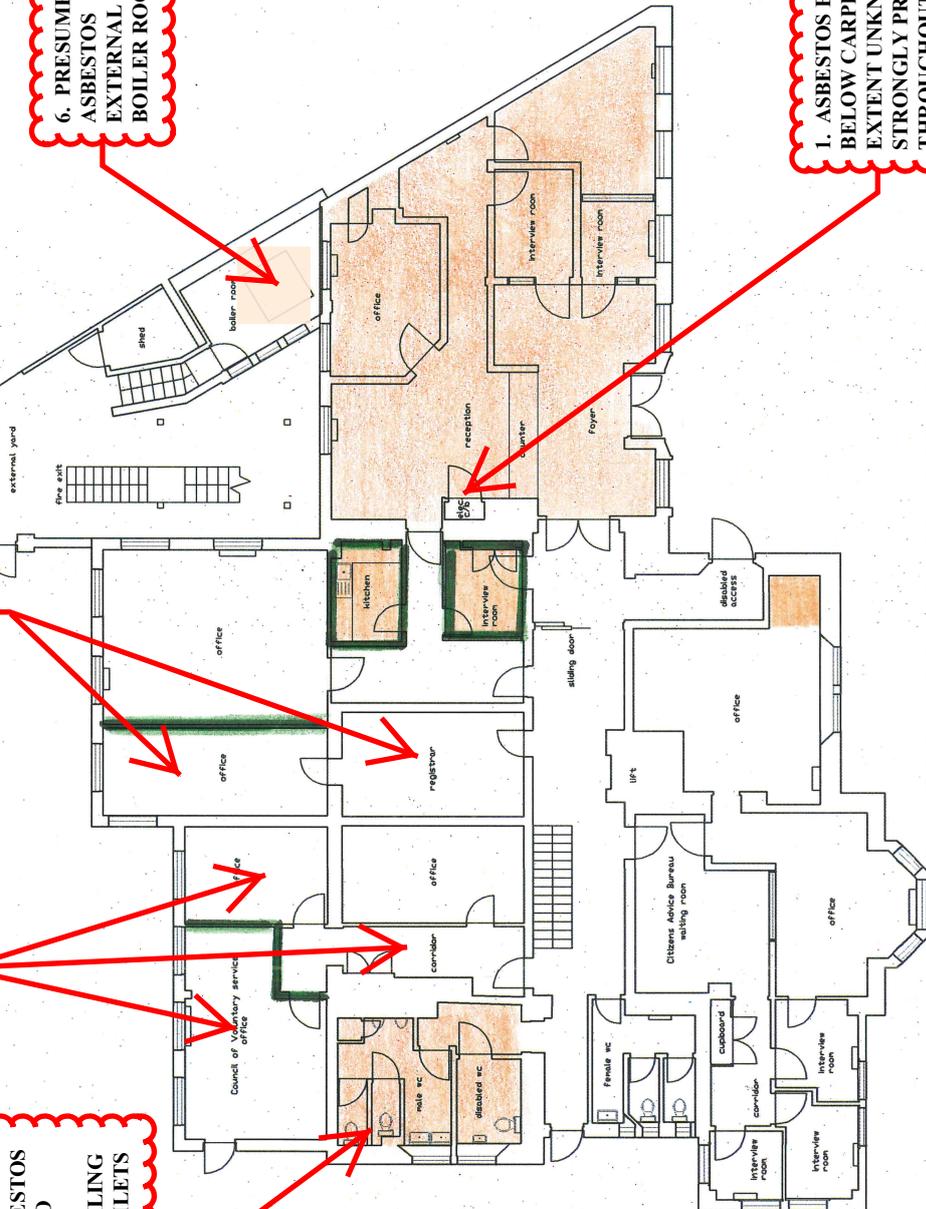
3. ASBESTOS BITUMEN BELOW CARPETS (FULL EXTENT UNKNOWN, STRONGLY PRESUMED THROUGHOUT GF)

2. PRESUMED ASBESTOS GASKETS/SEALS TO VENTILATION DUCTWORK IN CEILING VOID OF MALE TOILETS

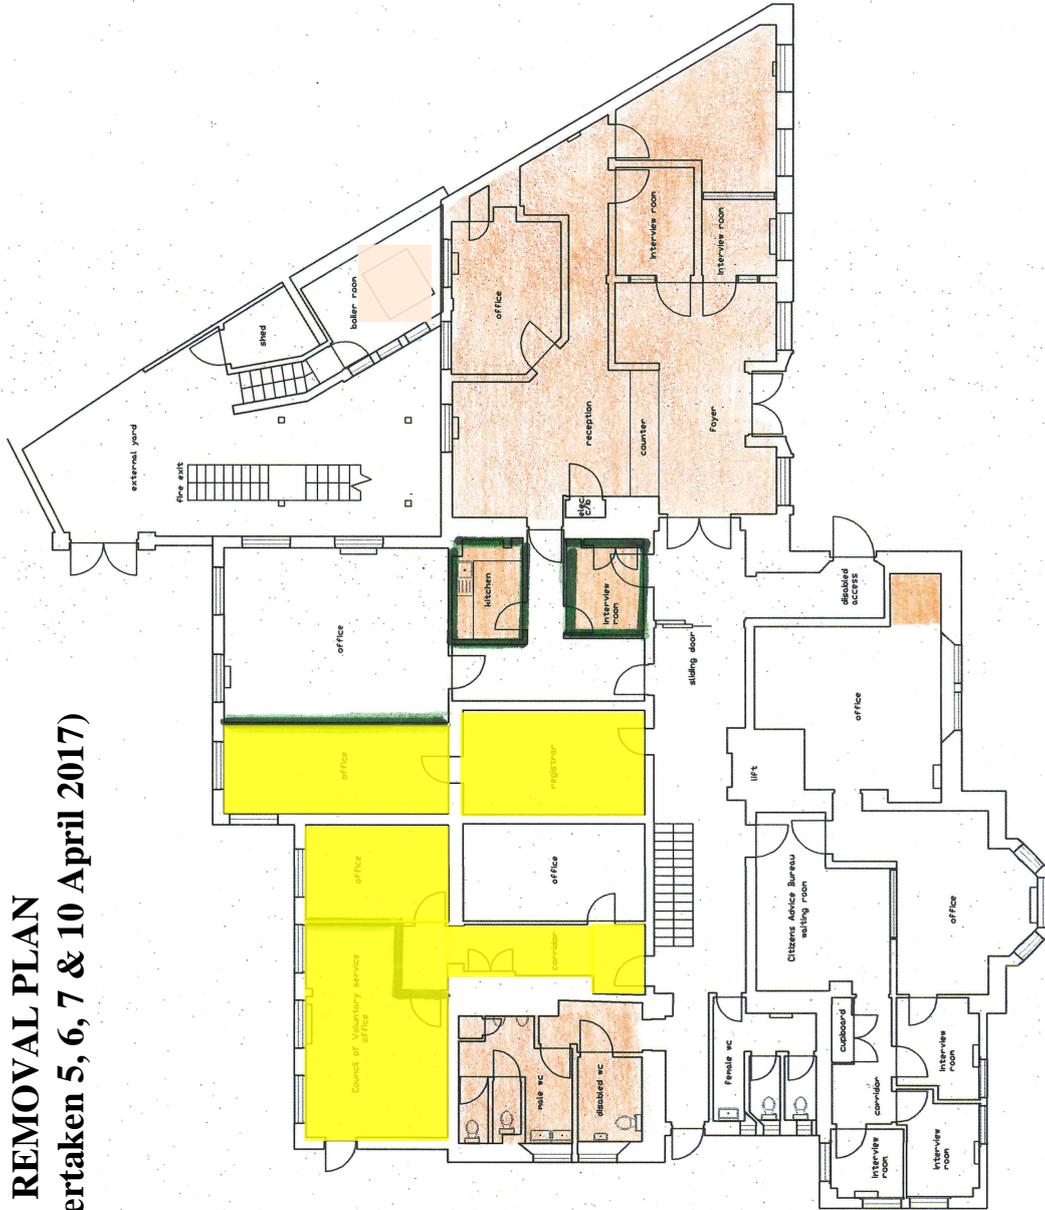
**ENVIRONMENTAL SERVICES, EXETER -
EXTENT OF ASBESTOS FLOOR TILE
REMOVAL PLAN
(work undertaken 5, 6, 7 & 10 April 2017)**

YELLOW SHADING INDICATES EXTENT OF ASBESTOS FLOOR TILES TO BE REMOVED FROM BELOW CARPETS, BEFORE THE EXPOSED ASBESTOS BITUMEN IS SEALED

Description of work: Removal and disposal of the asbestos reinforced composite floor tiles, concealed below carpet. Where the two could not be separated, the carpet was treated and disposed of as a hazardous waste. Upon completion, the now exposed asbestos containing bituminous adhesive was sealed with PVA and all surfaces cleaned with a type H vacuum and/or tack rags as necessary.

NOTE: The remaining bituminous floor adhesive has been identified as containing Chrysotile fibre (white asbestos). Timber skirtings were not removed, to avoid causing unnecessary damage, and therefore traces of tile remain trapped below them.
