St Swithun's Church from Greenway

1. HISTORIC AND TOPOGRAPHIC BACKGROUND

2. SETTING OF THE CONSERVATION AREA

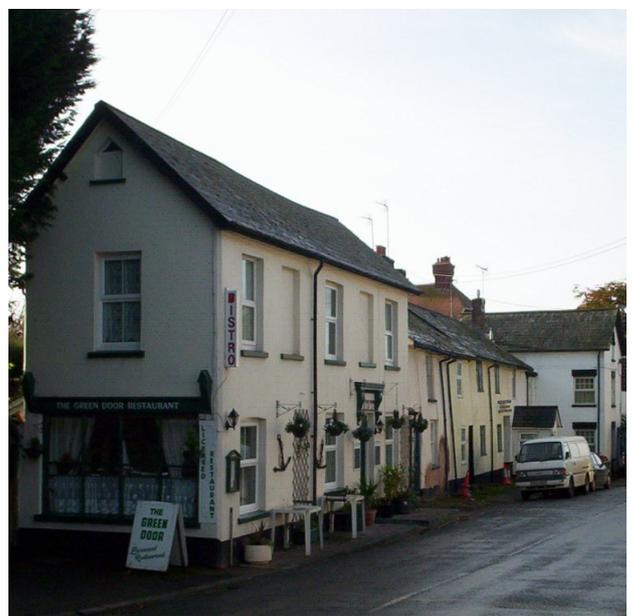
Cottage groups known as Cobblers and The Teeds have variable frontages with loss of original detail, although some improvements have been sensitively integrated.

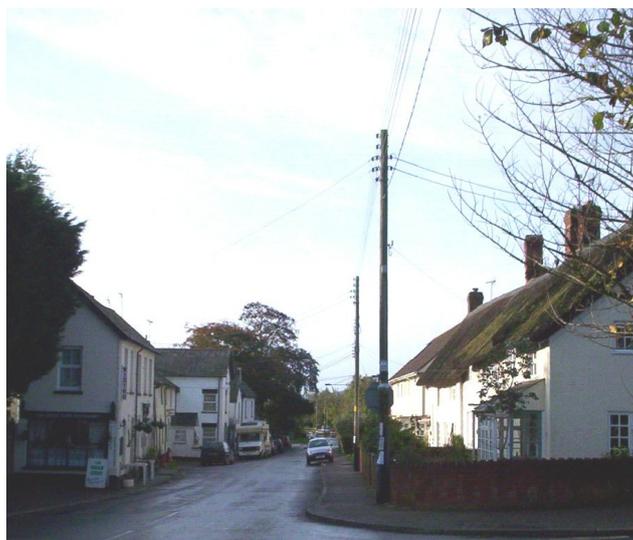
The view southwest from the village centre. Overhead power lines are prominent. The profile of buildings in this view would have changed little over the past century although some later porches have been added.

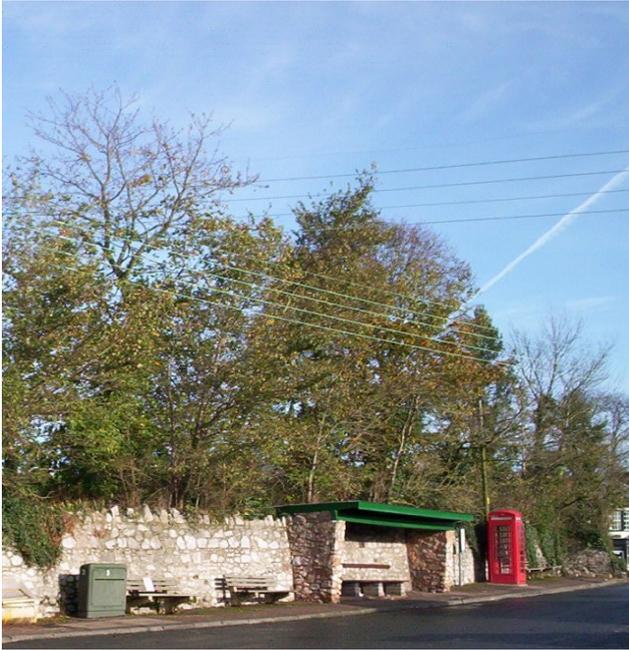
The north side of the village square has a fine group of trees behind grey limestone walls. Overhead power lines are very prominent. The red telephone box should be retained, but seating could be reorganised and other incidental clutter, including power lines, removed as part of a wider enhancement scheme.

-overhead power lines throughout the conservation area, but especially prominent at the Square

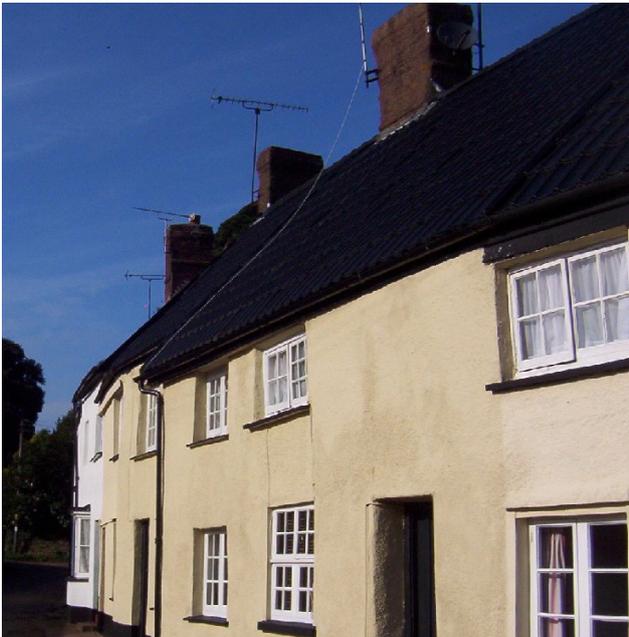
Church Step Cottages; the glazed black pantiles are of a type more commonly encountered in East Anglia.

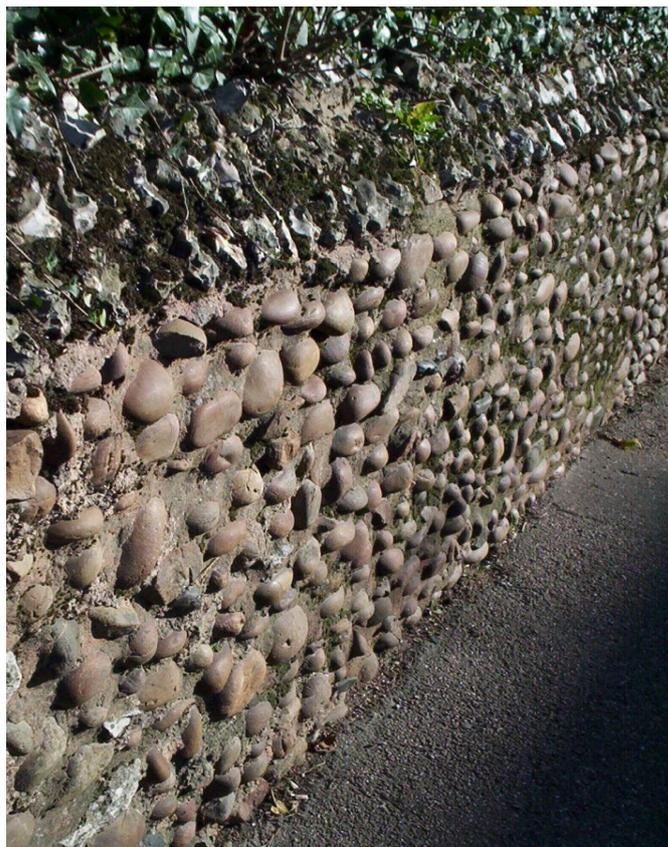
One of the many distinctive water-worn boulder (or 'Budleigh bun') walls which are a particular feature of the village often capped in flint.

6.2 Also more widely seen than elsewhere, in fact almost a curiosity peculiar to Woodbury are walls constructed of water-worn boulders, roughly coursed, mainly in boundary walls. There are even examples where quite small pebbles have been used to considerable decorative effect.

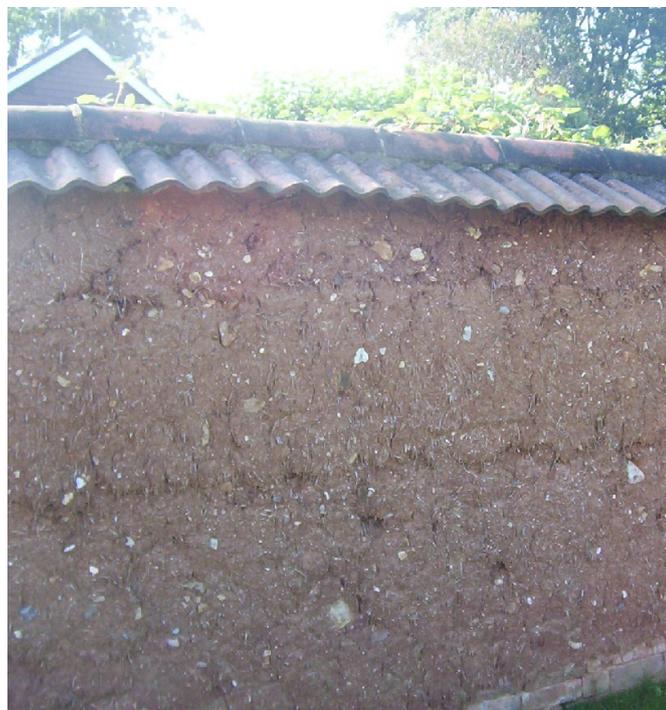
In addition to many water-worn boulder walls this un-rendered cob wall enclosing the church yard is a good survival of a vernacular tradition.

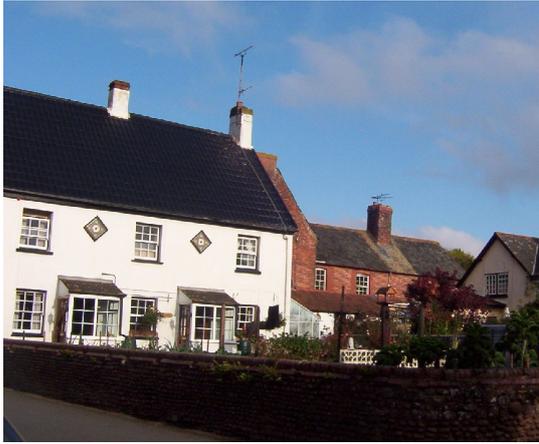
Thorn Cottages, formerly thatched, now with black glazed pantiles.

6.3 Roof materials are mainly slate, but with some good ranges of thatch. Decorative ridge tiles sometimes occur and Bridgwater pantiles are more commonly seen than in many East Devon villages. There are one or two examples of black glazed pantiles. These may also have originated from Bridgwater, but are more characteristic of East Anglia. There are also examples of plain tiles.

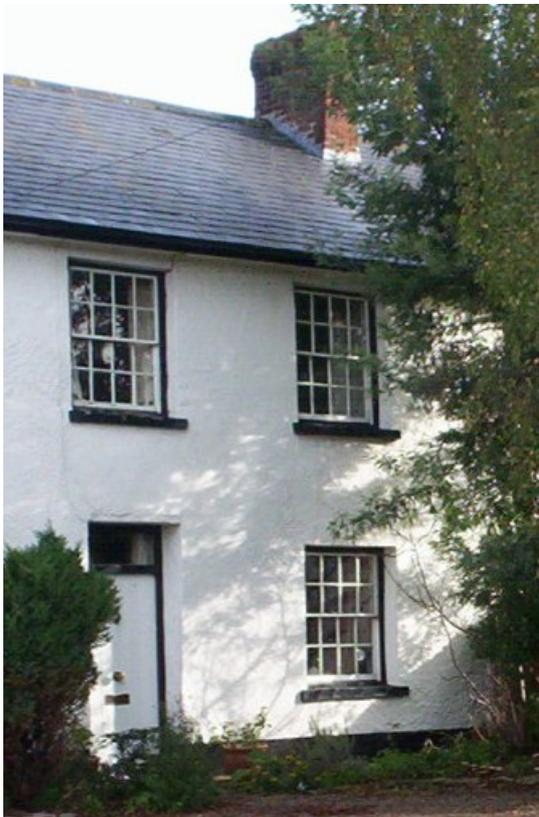
There are many good examples of double-hung sash windows with glazing bars.

6.4 A noteworthy feature of Woodbury is the generally good survival rate of traditional carpentry with both double-hung sash windows with glazing bars, usually in the larger

classical buildings, and of plain casement windows in many of the cottages. The doors also are either traditionally ledged and braced vertical planks in the plainer cottages or of considerable refinement - panelled with fixed square and oblong lights, or with fanlights over - in the larger houses. Sometimes there is a pleasing combination .

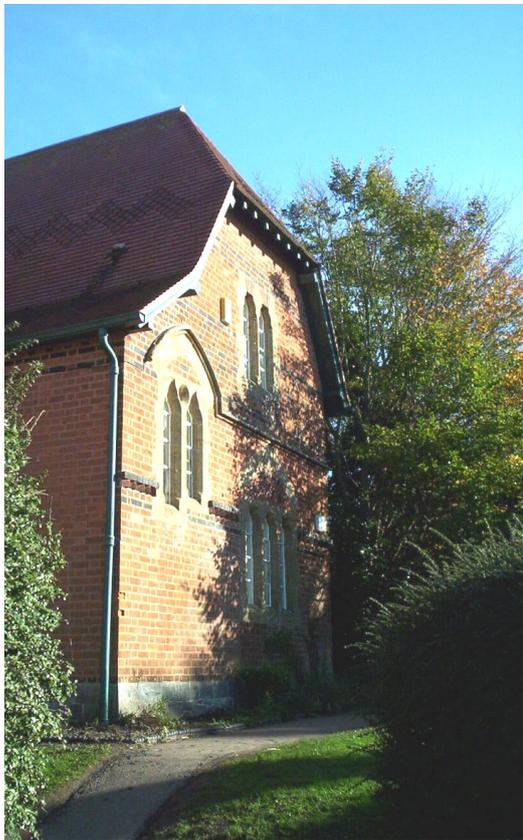
Woodbury Primary School: a good example of Victorian school architecture. The roof tiles have been replaced recently faithfully replicating decorative effects.

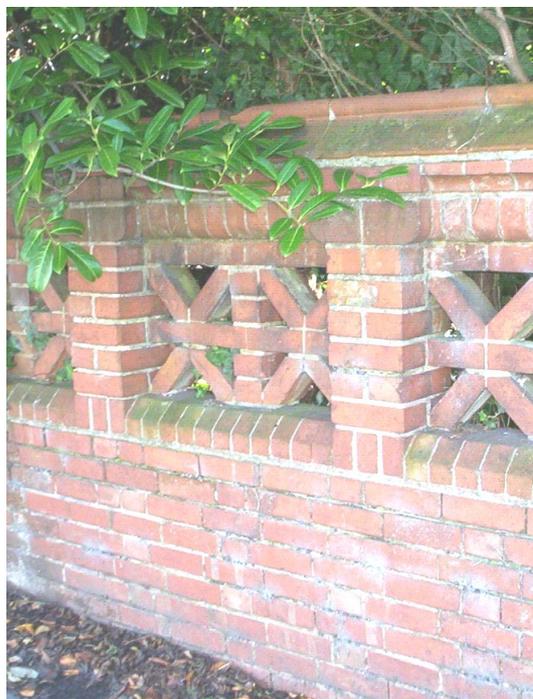
A nineteenth century brick boundary wall at the Priory, Greenway; an example of innovative detailing.

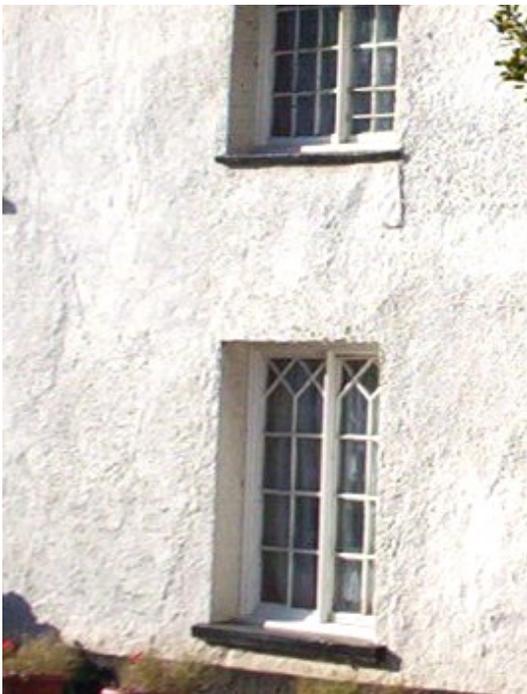
Good surviving early nineteenth century casements with decorative glazing bar details.

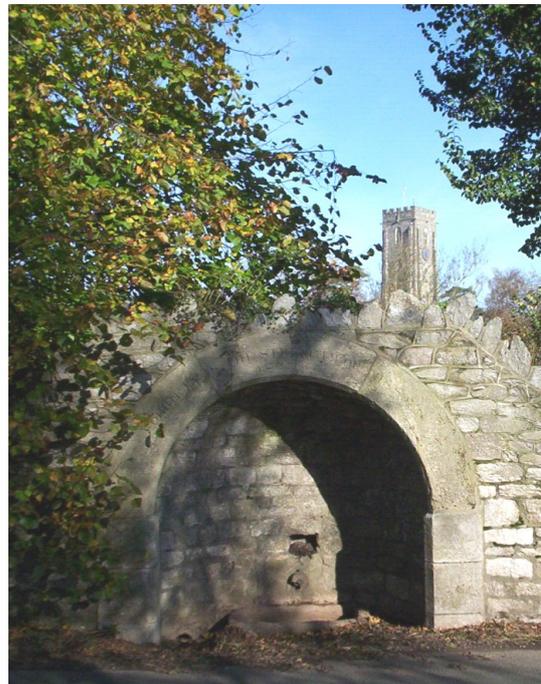
Drinking fountain dated 1867 and constructed from local grey limestone.

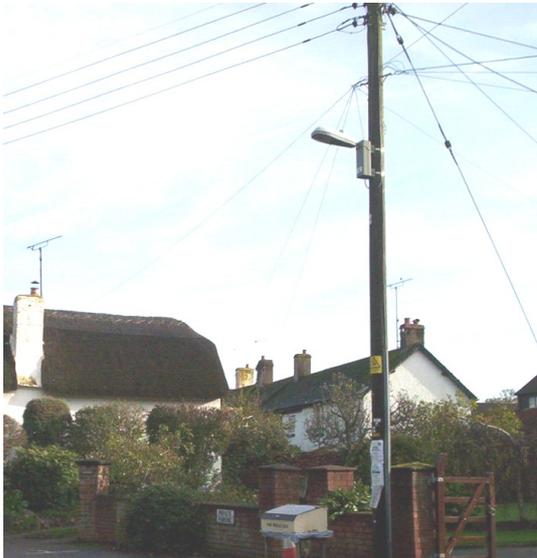
Overly prominent and incongruous overhead power cables.
