Sidmouth & East Beach Management Plan

Prepared for
East Devon District Council

January 2016

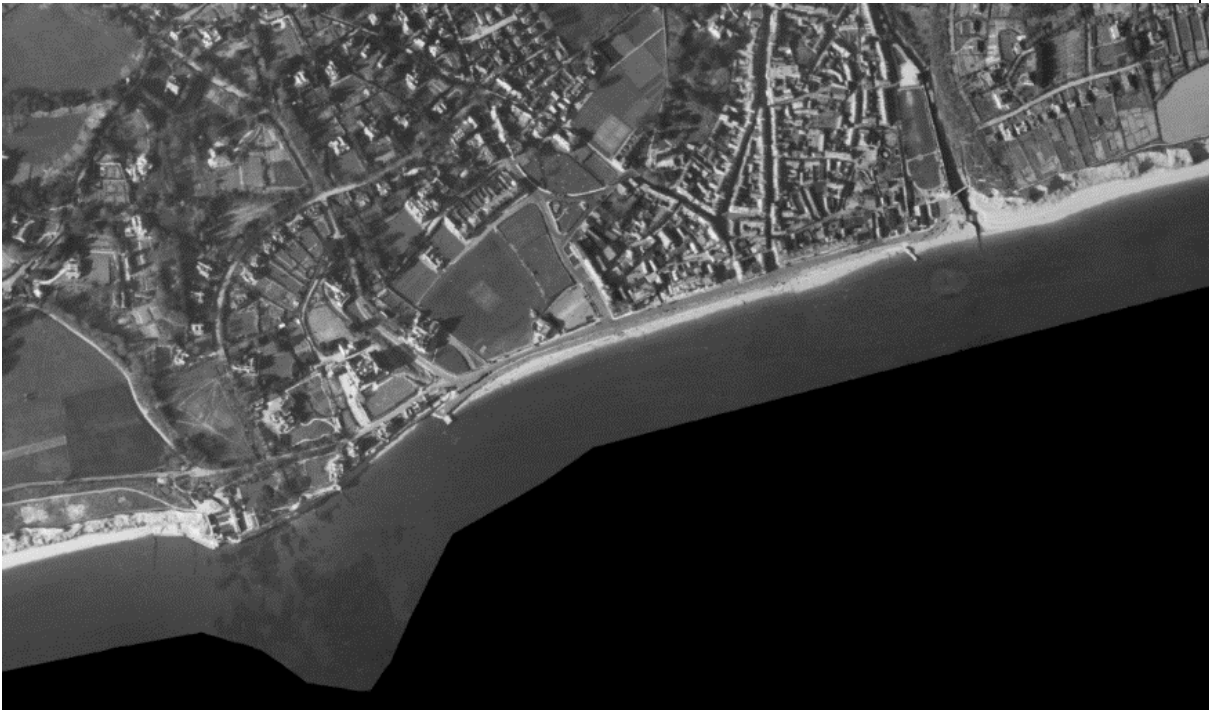
Date	Photo	Interpretation
1950

An aerial photograph showing a coastal town and its relationship to the sea. The town is built on a peninsula or headland, with a river (the River Sid) flowing through it. The beach is visible along the coast, and the sea is to the right. The photograph is in black and white, showing the layout of the town, the river, and the coastline.	<ul style="list-style-type: none">• Groynes constructed at Jacob's Ladder Beach east and around Chit Rocks headland.• Possibly more groynes constructed along frontage.• Beach between Chit Rocks and West Pier significantly narrowed since 1946.• Upper beach between West Pier and East Pier narrower than in 1946.• Upper beach east of East Pier narrower to the west.• The River Sid is flowing through the shingle bank.• Cliffs on Pennington Point have eroded further.• Wide continuous East Beach

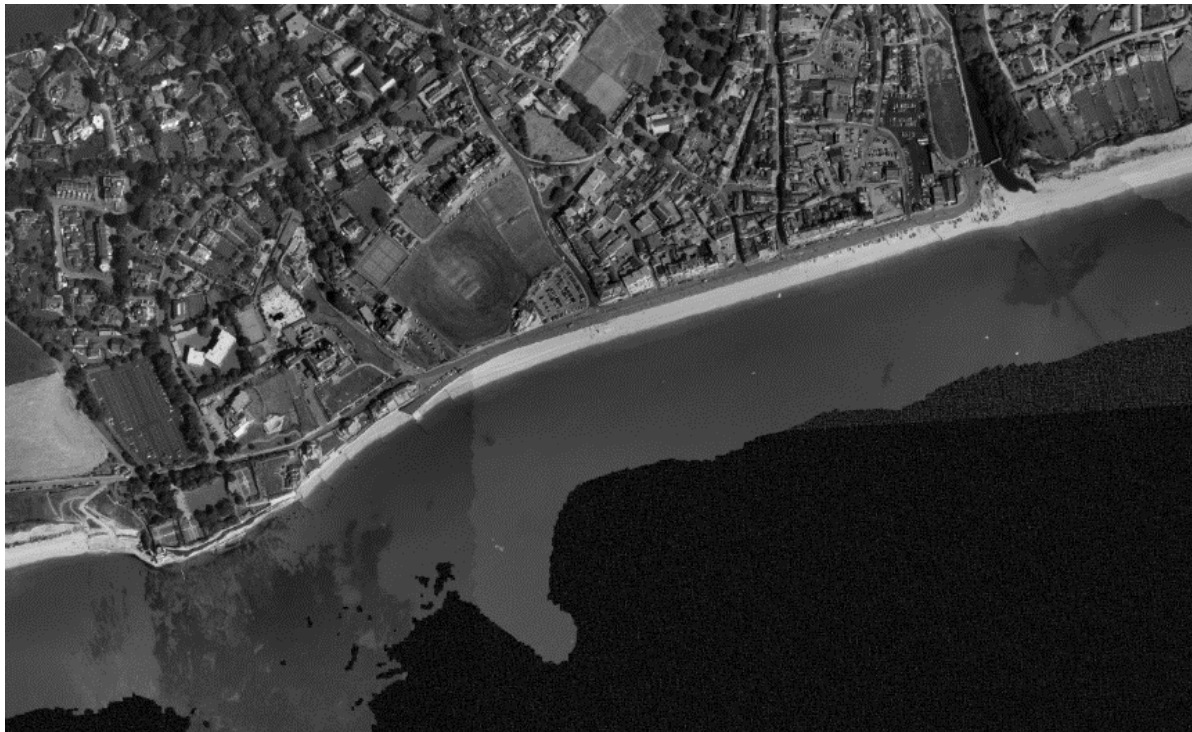
Date	Photo	Interpretation
1988

<ul style="list-style-type: none"> • Construction at Jacob's Ladder Beach east completed. • No notable change around Chit Rocks. • Beach appears to have widened between Chit Rocks and West Pier. • Beach between West Pier and East Pier wider, similar to 1946. • Beach width across the mouth of the River Sid has increased, similar to width in 1946. • The River Sid is pooling behind the shingle bank, possibly draining through the bank. It has moved eastwards away from the training wall up against the cliff at Pennington point. It could have pushed in this direction by westerly waves. • Wide continuous East Beach

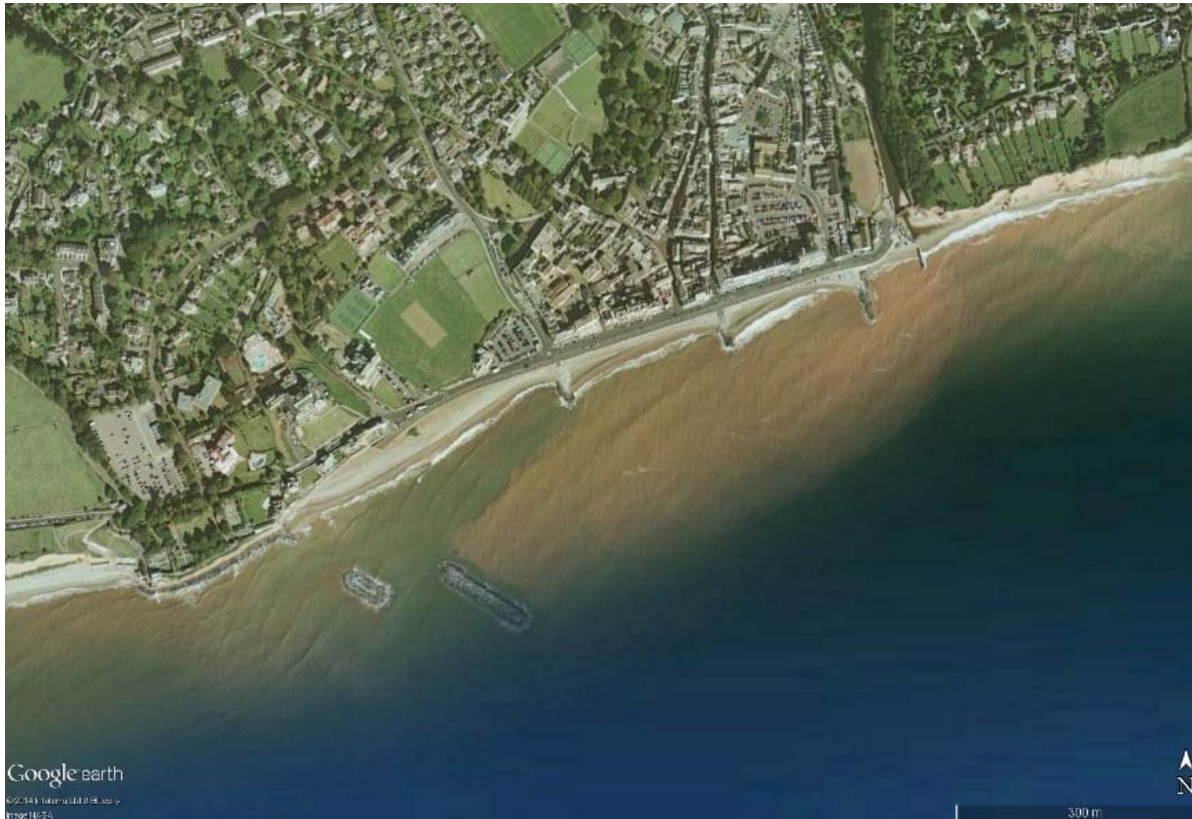
Date	Photo	Interpretation
2001 / 2002 (Google Earth)

- In the 2001/2002 and 2010 photographs, the beach within the groyne bays is wider at the western ends as is the beach in the lee of the breakwaters in the 2006 photographs. This indicates that at the time, the drift direction was to the west, which is the opposite to the predominant net drift direction which is to the east. It is noted that these photographs were taken in Spring and late Summer, when the beach is likely to be recovering from winter storms (i.e. easterly and south-easterly wave (storm) conditions).

<p>Google earth ©2014, Imagery ©2014, Imagery Image 10/50</p> <p>300 m</p>	<ul style="list-style-type: none"> • Evidence from the photograph including the colour of the trees, status of the cricket pitch and number of people on the beach suggest that the photo was taken during spring time. • Beach appears to be wide at the eastern end of Jacob's Ladder Beach. • Beach in lee of the breakwaters is wide. • Upper and lower beach within groyne bays wide at western end, indicating drift from east to west, which is counter to the net drift direction. • River Sid training wall extension very clear in the photographs. • Shingle bank extends across the mouth of the River Sid, appears to be narrower than in previous aerals. • Narrow and fragmented East Beach

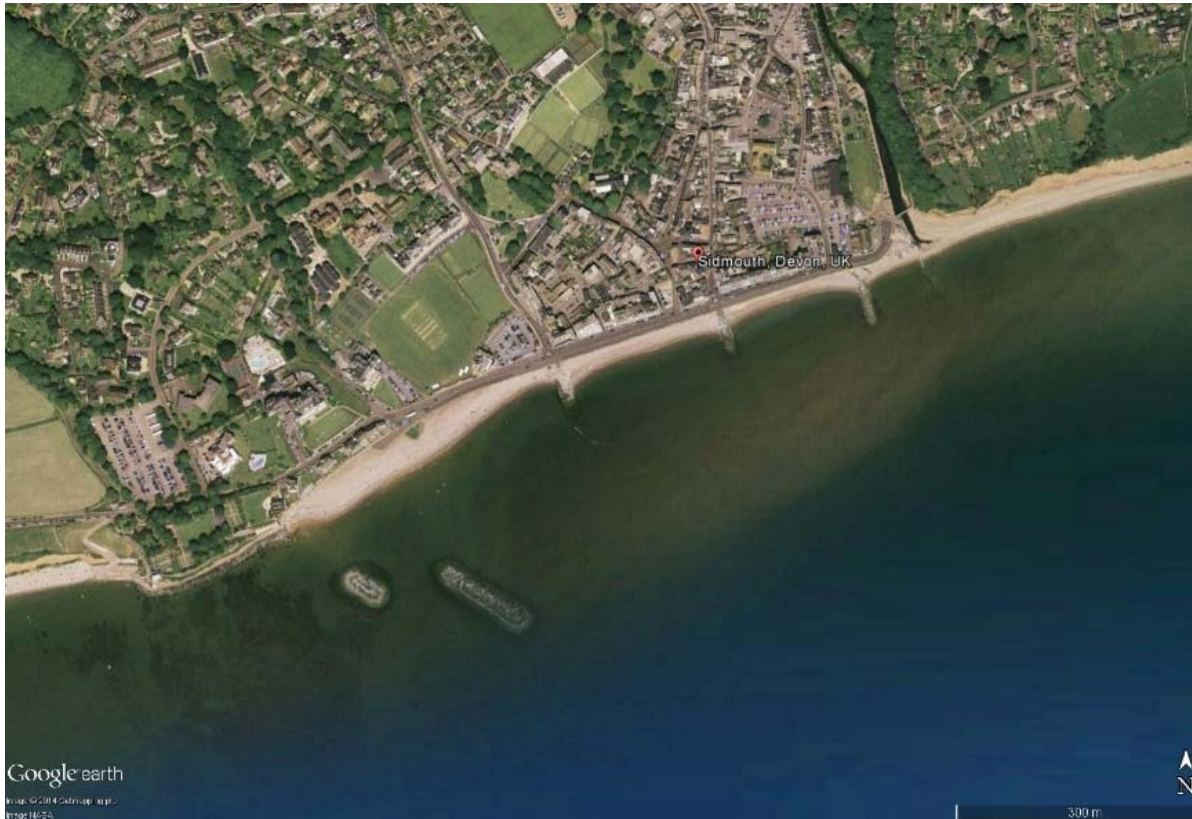
Date	Photo	Interpretation
<p>30th June 2006 (Google Earth)</p>

- The 2006 photograph was taken in June and reflects summer conditions, when the beach is evenly spread between the groyne bays and the beach around the mouth of the River Sid is wider, with no significant accumulation in the lee of the River Sid training wall and the outfall.
- The 2012 photograph shows the beach in the most depleted state, with very narrow beaches at the western end of the groyne bays, but simultaneously accumulation of shingle in the lee of the River Sid training wall and SWW outfall. This photograph was taken in September and could reflect post-storm conditions or overall low beach levels.
- The SWW outfall appears to be buried across a longer portion of its length in earlier photographs but in later photographs, it appears to be more exposed. The exception to this is in 2006, when it and the training wall are buried.

<p>Sidmouth, Devon, UK</p> <p>Google earth Image © 2014 Google, map data © 2014 Image 10/50</p> <p>300 m</p>	<ul style="list-style-type: none"> • The upper beach appears to be wide at the eastern end of Jacob's Ladder Beach. • Upper beach in lee of the breakwaters is wider than in 2002, and the beach itself here is wider at the western end. • Upper beach within groyne bays wider at both western and eastern ends and narrower between, indicating drift occurring in both directions. • Shingle bank extends across the mouth of the River Sid and the width of beach is wider than previous photograph. However, this may be due to the tidal state at the time of the photo. • Continuous East Beach re-established within recessed cliff frontage

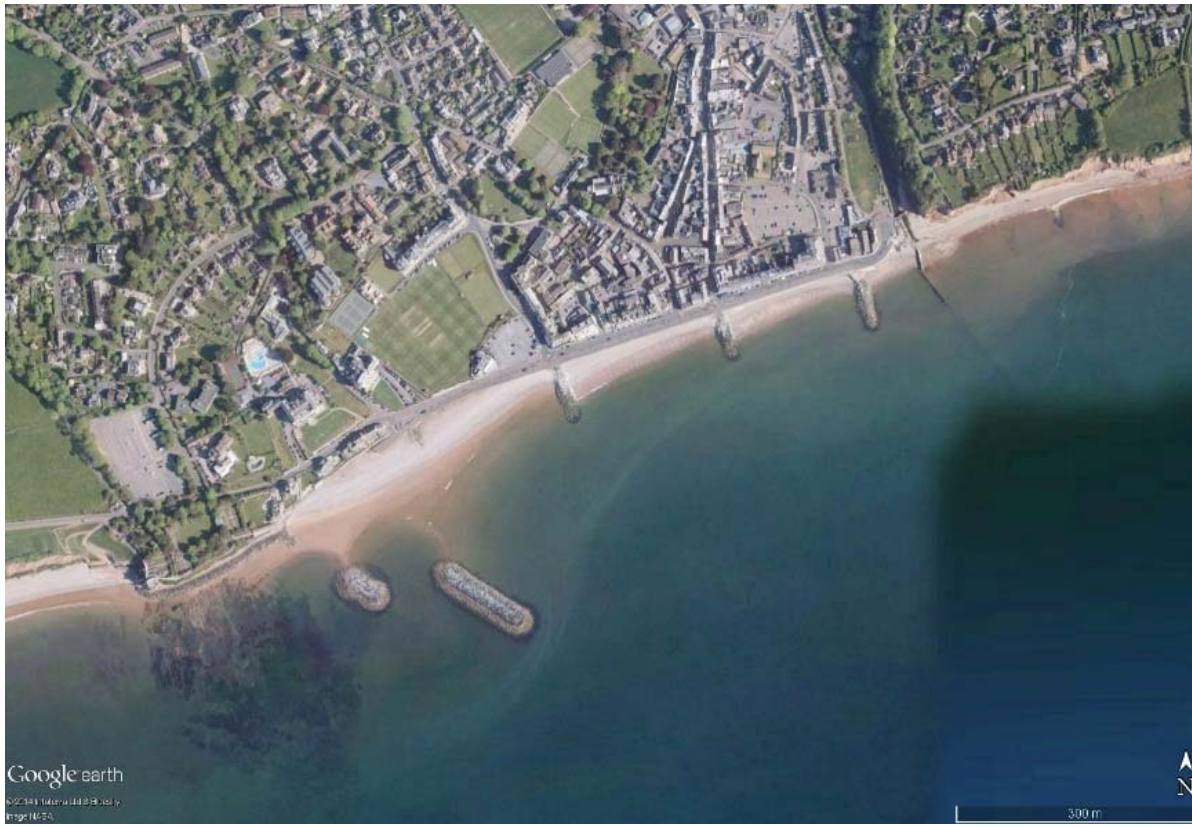
Date	Photo	Interpretation
Late summer 2010 (Google Earth)

<p>Google earth ©2014 International Business Image 10/50</p> <p>300 m</p>	<ul style="list-style-type: none"> • Evidence from the photograph including the colour of the trees status of the cricket pitch, number of people on the beach and in the water suggests that this photograph was taken during the late summer. • The upper beach appears to be wide at the eastern end of Jacob's Ladder Beach. • The lower sand foreshore at the eastern end of Jacob's Ladder Beach is exposed as the photo was taken at low tide. The sand foreshore appears to extend around Chit Rocks to the detached breakwaters, suggesting it is linked and possible transport could be taking place along it. • The upper beach in the lee of the breakwaters is similar to 2006. The lower sandy beach extends to the detached breakwaters to form a tombolo with the western breakwater. • Beach within groyne bays wide at western end, indicating drift from east to west, which is counter to the net drift direction. • River Sid training wall extension very clear in the photographs. • Shingle bank extends across the mouth of the River Sid, with accumulation of material in the lee of the extended River Sid training wall. • Extended training wall and outfall appear to be blocking westward movement of shingle across the mouth of the River Sid. • East Beach set-back within recessed cliff frontage; foreshore feature apparent

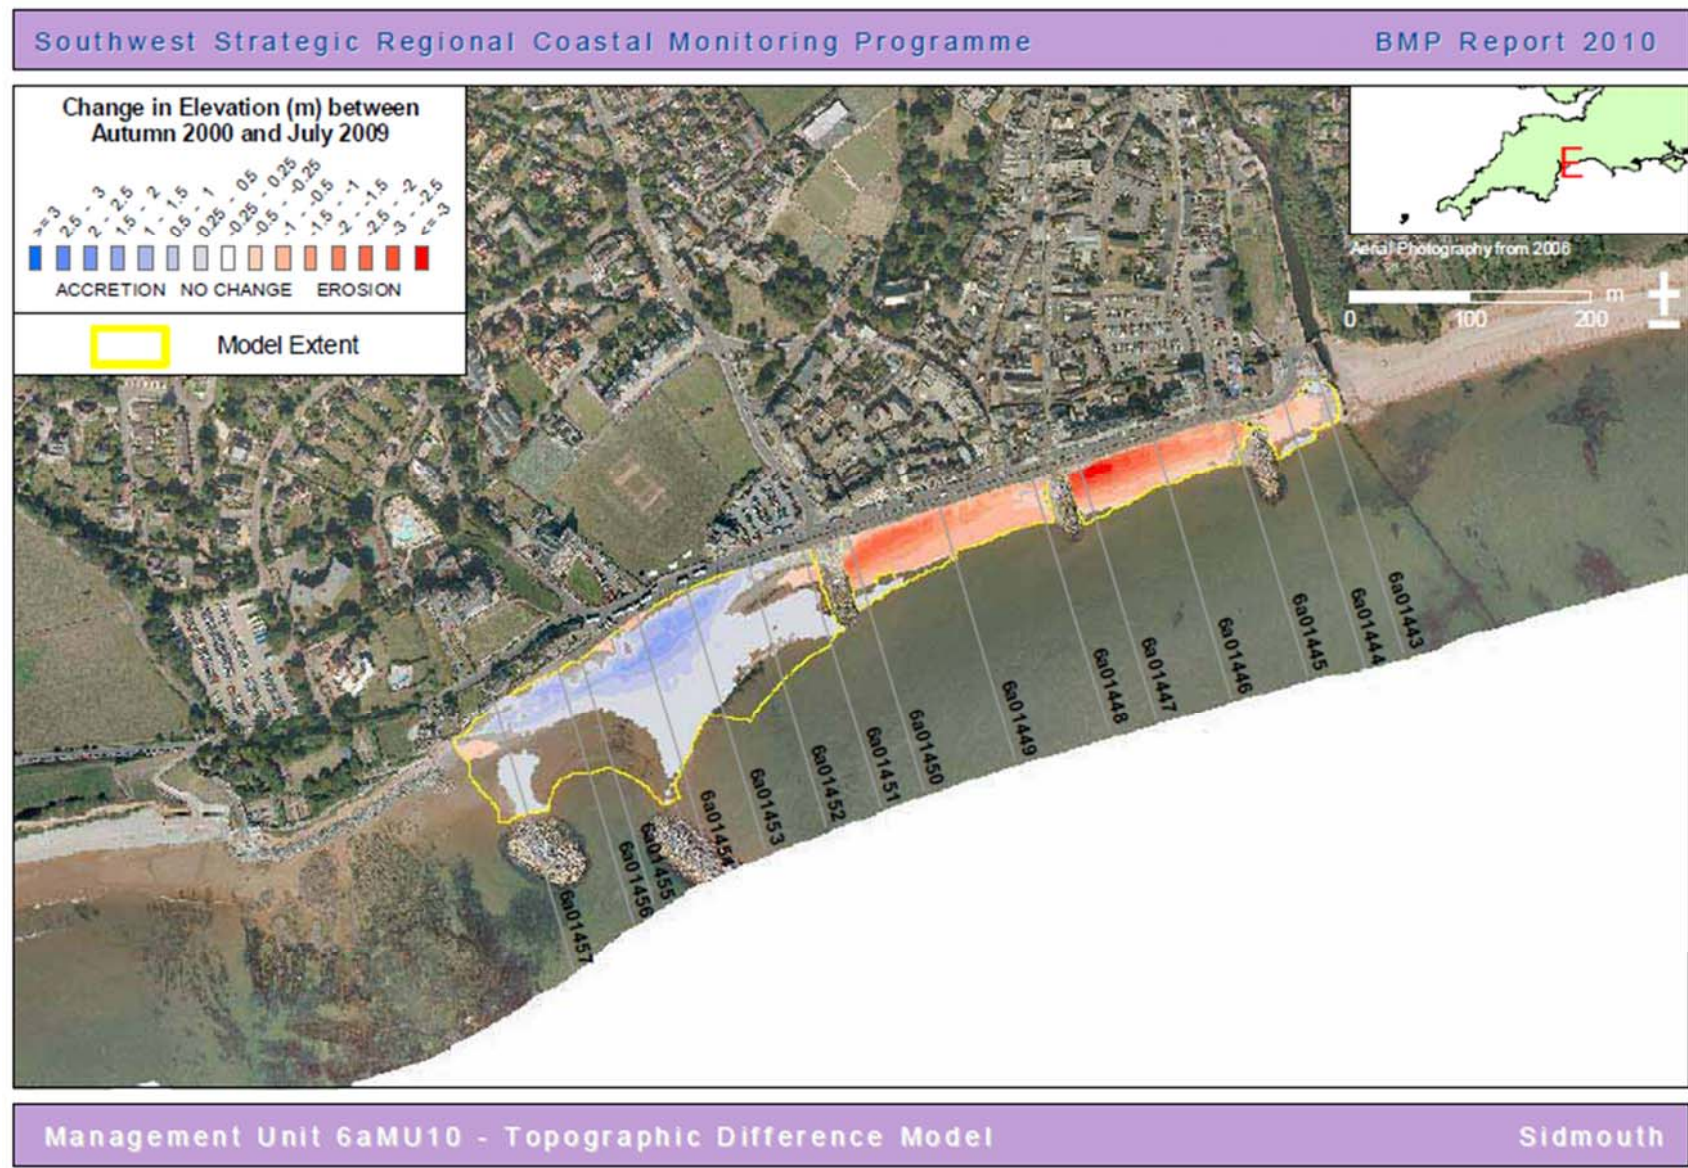
Figure 5-6 Beach elevation change at Sidmouth between 2000 and 2009 (PCO, 2010).

- Topographic difference model - 2000 Baseline to July 2009 (shown in Figure 5-6): overall, the western section of the beach gained material behind the offshore breakwaters, whilst the eastern part of the management unit was dominated by erosion downdrift of the Bedford Steps groyne. Unfortunately the model does not include East Beach.
- Changes in MHW elevation 2001 to 2007 (shown in Figure 5-7): Mean high water (MHW) retreated landwards slightly in both the far west and eastern sections of the frontage between 2001 and 2007. There was also a trend of net retreat of MHW along East Beach.

three rock groynes; suggesting, when considered as a whole frontage, there had been no net loss or gain, with a net east to west movement of material. A similar pattern of net shingle redistribution had been indicated by the more recent data (between 2002 and 2012, prior to the 2014 storm (PCO, 2010) and is illustrated in Section 5, Figure 5-6.

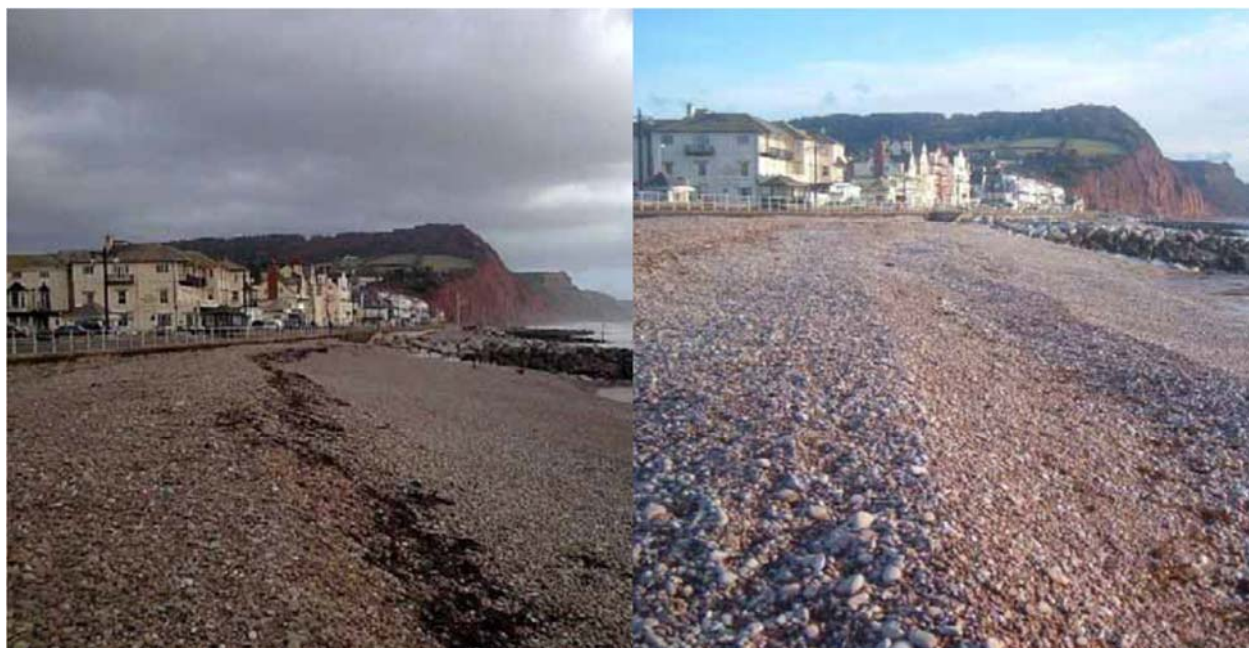
Figure 5-11 Pre-and post-storm photographs taken at 6a01453 – in lee of breakwaters, west of Bedford Steps Groyne in November 2009 (PCO, 2010) showing how the beach has built up at this location, during the same storm as illustrated in the following Figures.

- In some situations material is pushed up the beach during storms creating a steeper beach and upper beach storm ridge or berm (such as experienced at 6a01453, in the lee of breakwaters, see Figure 5-11). Elsewhere, such as experienced at profile 6a01450 (see Figure 5-12), the beach has become drawn down from the upper beach, exposing the toe of the seawall.

(a) Pre-storm (profile 6a01453 – in lee of breakwaters, west of Bedford Steps Groyne)

(b) Post-storm (profile 6a01453 – in lee of breakwaters, west of Bedford Steps Groyne)

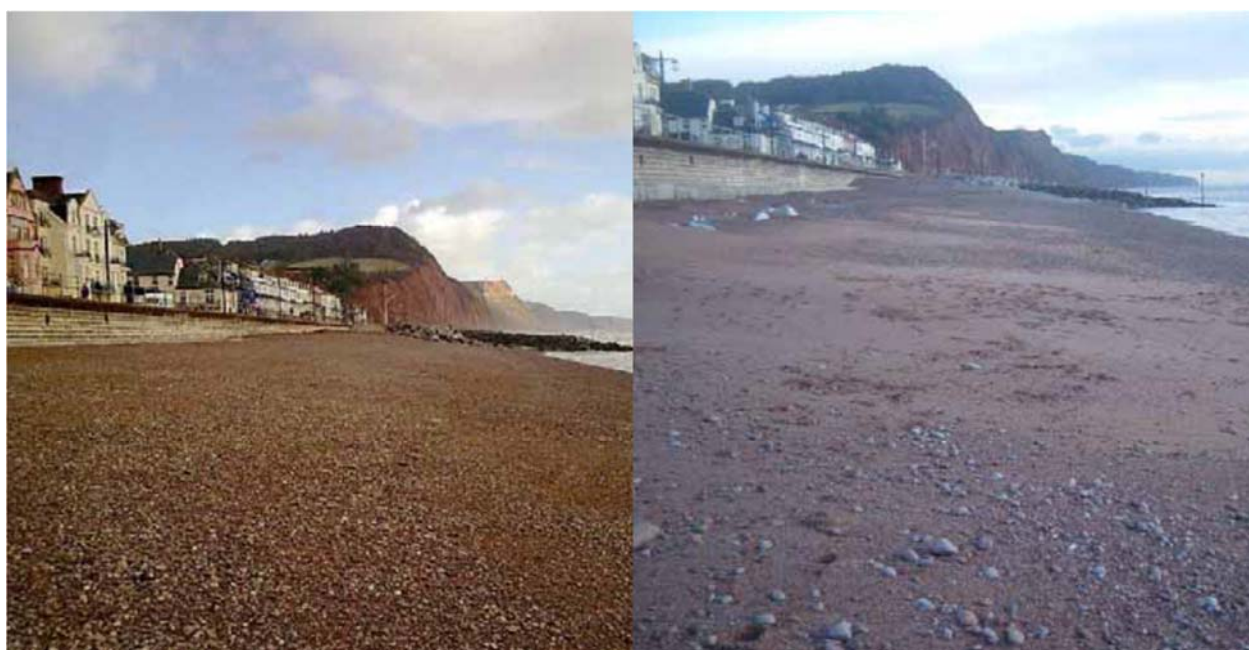
Figure 5-12 Pre-and post-storm photographs taken at 6a01450 (western end of groyne bay between Bedford Steps Groyne and York Steps Groyne) in November 2009 (PCO, 2010) showing how the beach has become stripped of shingle, exposing the toe of the seawall.

(a) Pre-storm (profile 6a01450 – western end of groyne bay between Bedford Steps Groyne and York Steps Groyne)

(b) Post-storm (profile 6a01450 – western end of groyne bay between Bedford Steps Groyne and York Steps Groyne)

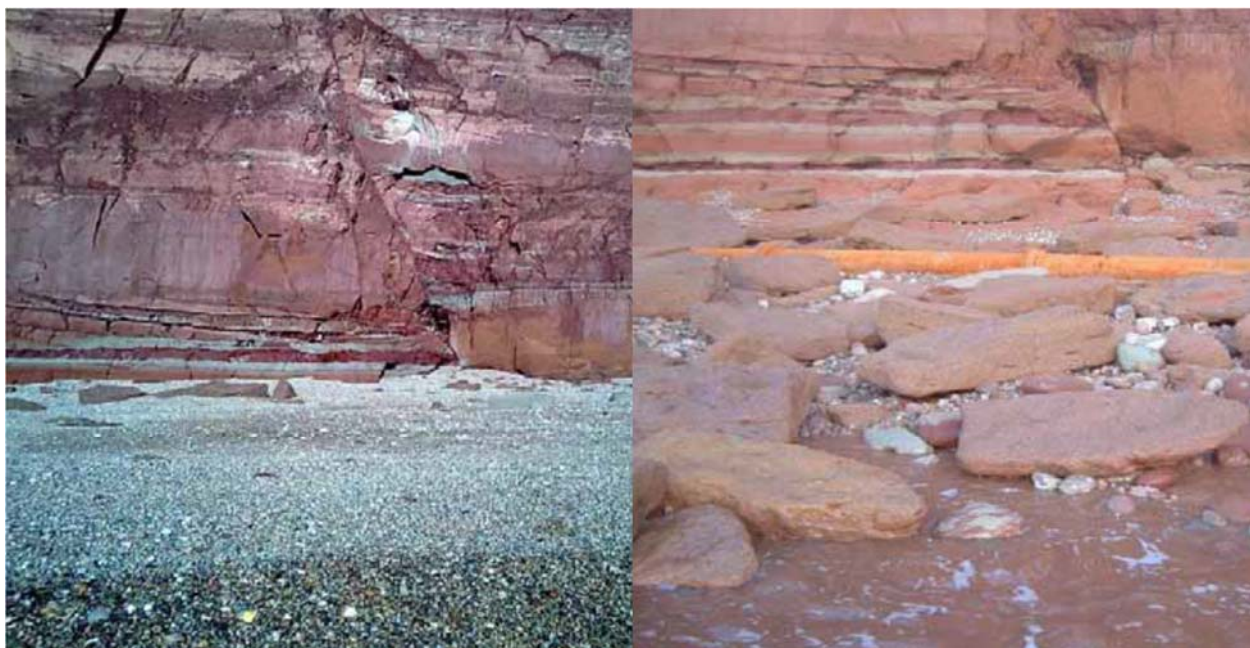
Figure 5-13 Pre-and post storm photographs taken at 6a01441 (East Beach) in November 2009 (PCO, 2010) showing how the shingle veneer beach has been removed.

- East Beach is also very dynamic and susceptible to beach drawdown; evidence collected by PCO indicates that the beach can become stripped of shingle during storms, as occurred in 2009 (see Figure 5-13). At profile 6a01442, Pennington Point, the post-storm survey for 11th July 2012 showed particular movement of the beach between MLWN and MLWS, with the formation of a berm, likely to be supplied by the cross-shore movement of material in that area. Changes here also affect the flow of the river, as shown in photographs. This change demonstrates the dynamic nature of the beach here, which was observed during various site visits undertaken for the present BMP. The photographs in Figure 5-14 and Figure 5-15 show that in December 2013 the shingle bank was narrow and low, whilst the beach around Pennington Point was high, so much so that the footings of

(a) Pre-storm (profile 6a01441)

(b) Post-storm (profile 6a01441)

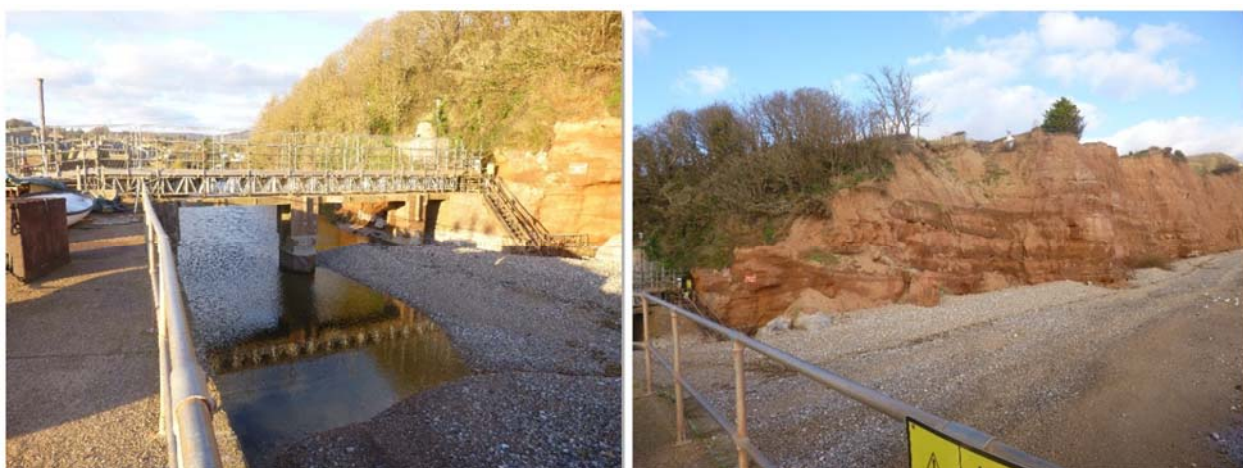
Figure 5-14 The east bank of the mouth of the River Sid, looking upstream: left, the shingle bank at Alma Bridge, and right; Pennington Point and Salcombe Hill Cliffs. Photographs taken during site visit 9th December 2013.

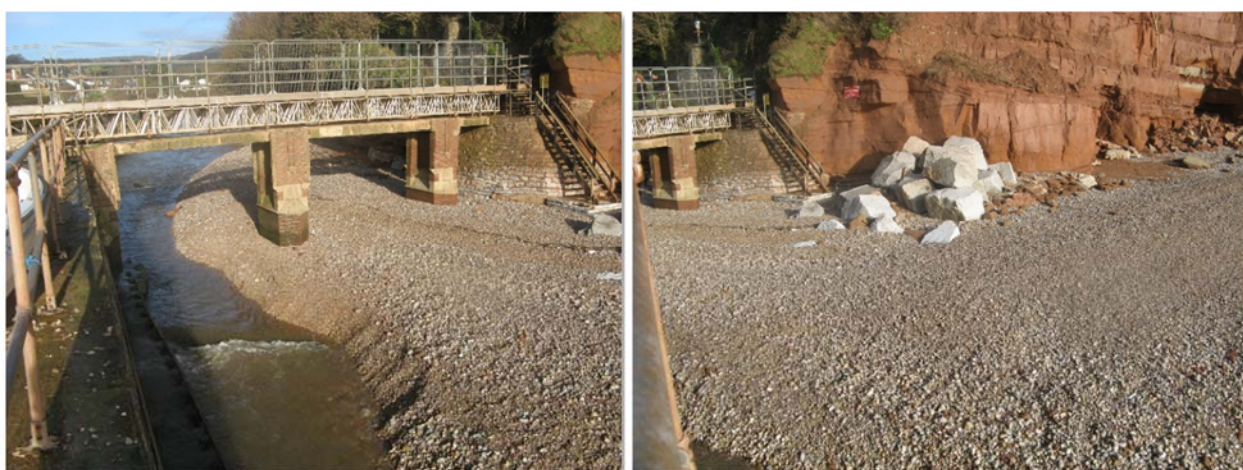
Figure 5-15 The east bank of the mouth of the River Sid, looking upstream: left, the shingle bank at Alma Bridge, and right; Pennington Point and Salcombe Hill Cliffs. Photographs taken during site visit 12th January 2014.

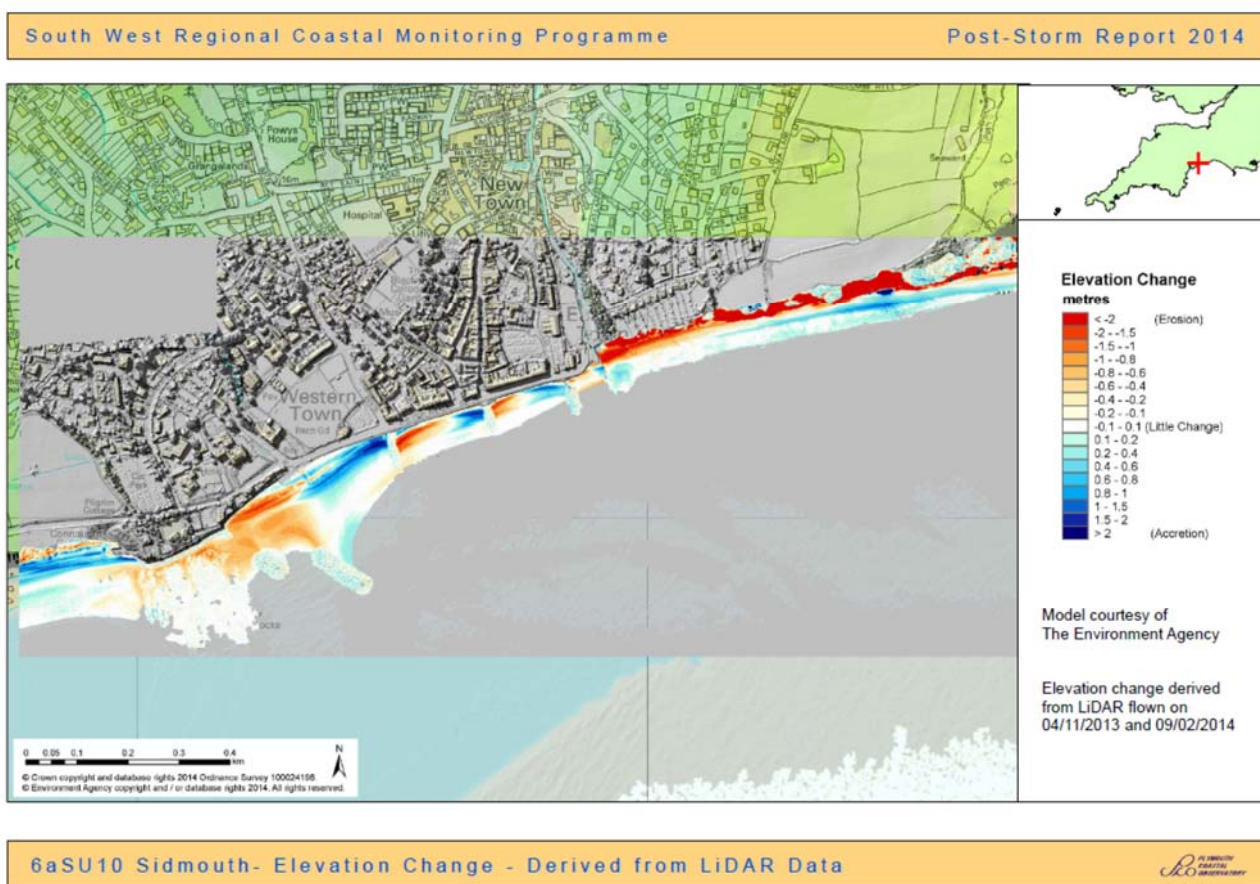
- At Pennington Point, the data indicates cliff erosion and possible upper beach erosion. There was some accumulation of sediment around Mean Low Water, but it is not possible to determine whether this is material drawn down from the upper beach, material built up against the training wall transported from alongshore, or alternatively whether it is material that has bypassed the training wall from the Sidmouth frontage. There is evidence of material built up at the terminal end of the training wall and this, together with the west to east transport evident along the frontage, suggests at least some of this material may have been fed from bypassing of the training wall. Very little change occurred to the central portion of beach at East Beach.

- Further east there was erosion of Salcombe Hill cliffs, but a storm ridge appears to have developed to the east of East Beach, which increased in size to the east. Based on the direction of transport observed along the Sidmouth frontage it is likely that some of this material may have been derived from East Beach.

Figure 5-16 Topographic difference model for Sidmouth, showing the change in elevation between November 2013 (pre-storm) and February 2014 (post storm) (PCO, 2014b).

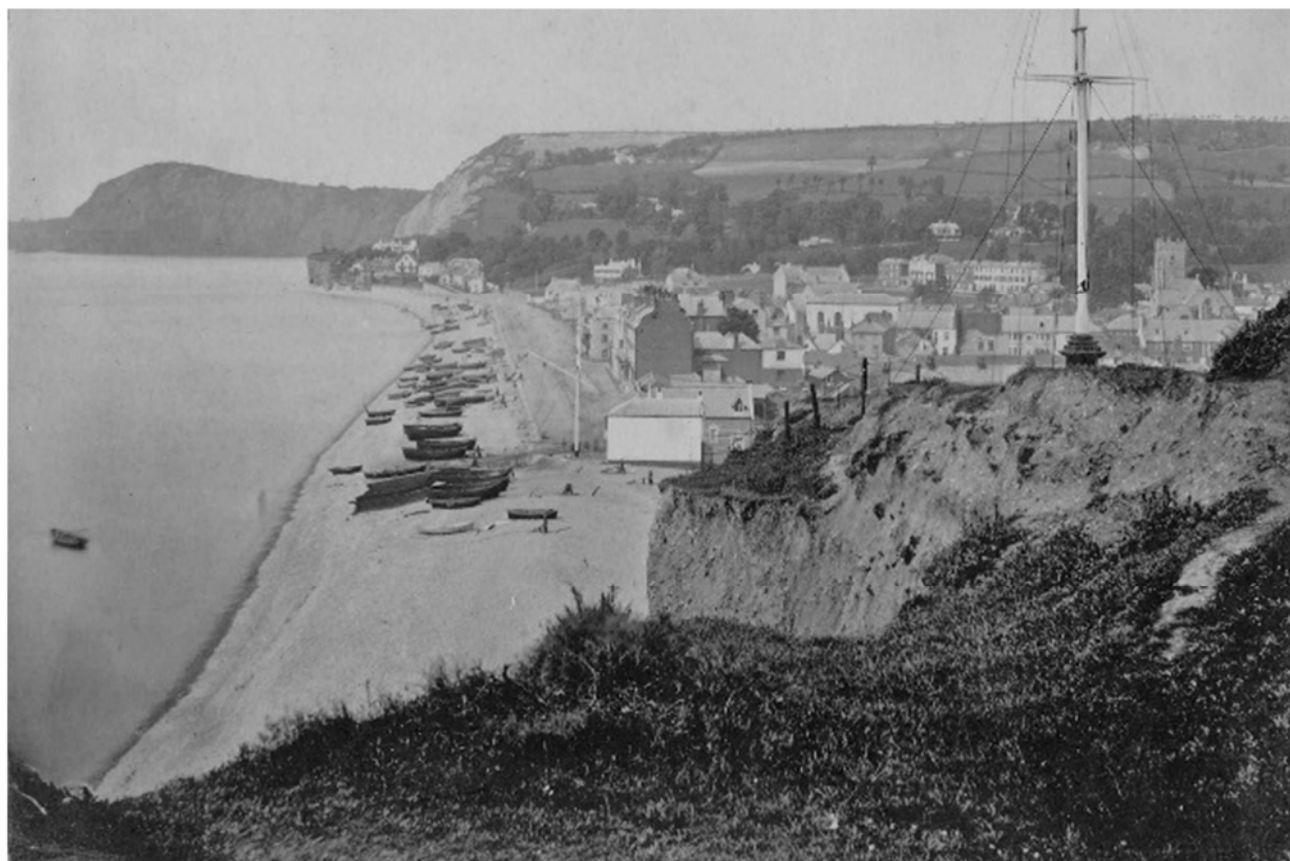
The earliest image of Sidmouth provided dates back to 1851 (refer to Appendix A) and the earliest photographs are also from the late 1800s. The image in Figure 5-17 shows the coastline in 1876, with a relatively wide beach fronting the town promenade. In the foreground of the image is Pennington Point, which appears heavily degraded with evidence of past slumping and development of vegetation. Despite the wide beach illustrated in this image, records indicate that severe storms affected the frontage in the 1820s and 1830s, prompting the construction of the first formal defences.

Figure 5-17 Historical photograph of Sidmouth in 1876 looking west from Pennington Point, showing a healthy and relatively wide gravel beach with boats; Pennington Point is in the foreground with evidence of erosion. Source: via David McCluskey, copyright Sidmouth Museum.

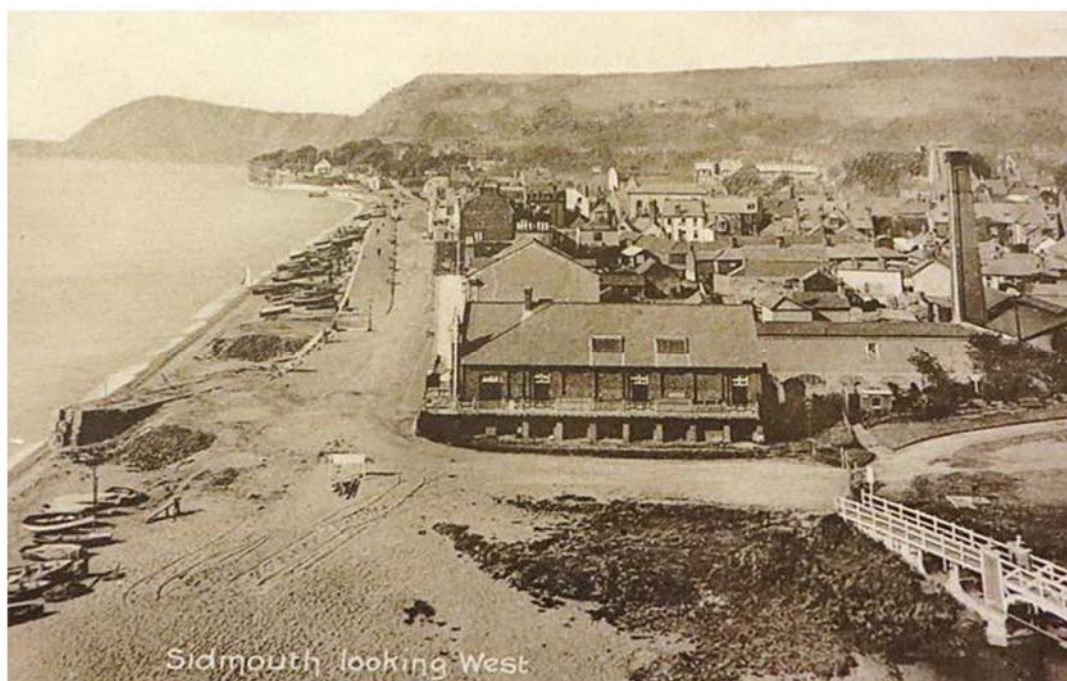
The slightly later photograph in Figure 5-18 shows the coastline in approximately 1905, with Dunning's Pier and the Alma Bridge in the foreground. The photograph shows there had been quite substantial development of the eastern end of the Sidmouth beach since 1876, with the construction of Dunning's Pier and buildings, extension of the road into the mouth of the River Sid and the upgrade of the Alma Bridge. This photograph predates the land reclamation and seawall construction at the southern end of the Esplanade. The shingle beach appears to be narrower, particularly at the western end, but this may simply reflect the state of the tide.

Figure 5-18 Sidmouth looking west in approximately 1905. Source: Mary Walden.

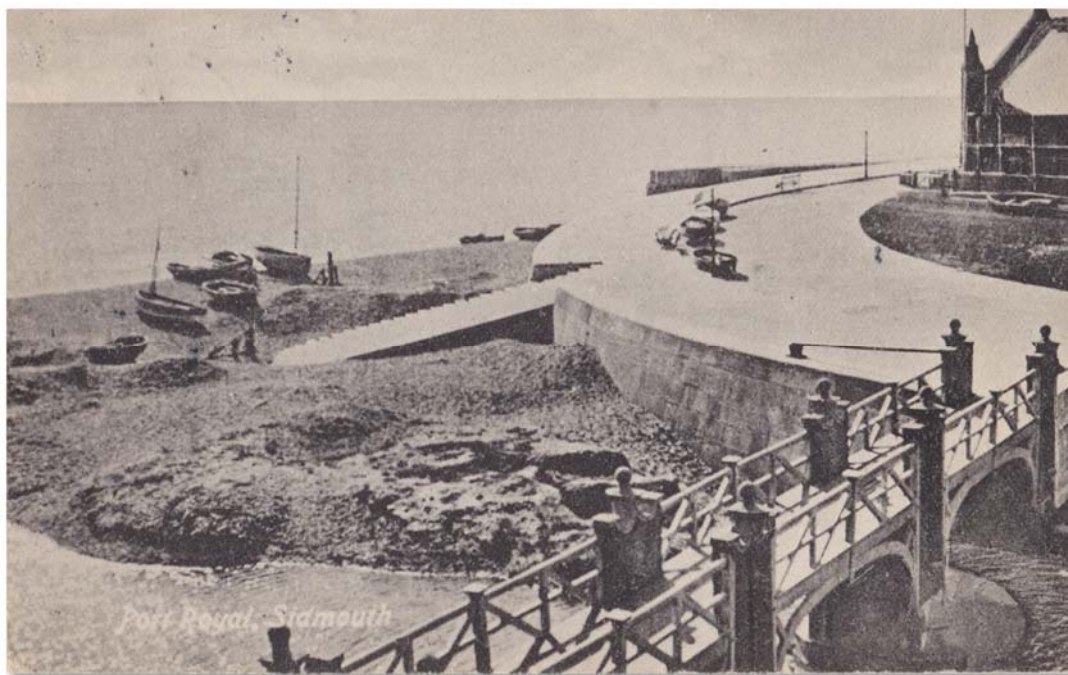
Little information has been found for the 1910s, but records indicate that by the 1920s there has been more development and construction of the seawall at the eastern end of Sidmouth Beach. The photograph from postmarked 1921 (see Figure 5-19) shows how the land on the western bank of the River Sid has been reclaimed to create the promenade and an access ramp has been constructed. It is notable that this photograph predates construction of the River Sid training wall.

Figure 5-19 Eastern end of Sidmouth beach with new seawall and ramp, image postmarked 1921. Source: Mary Walden.

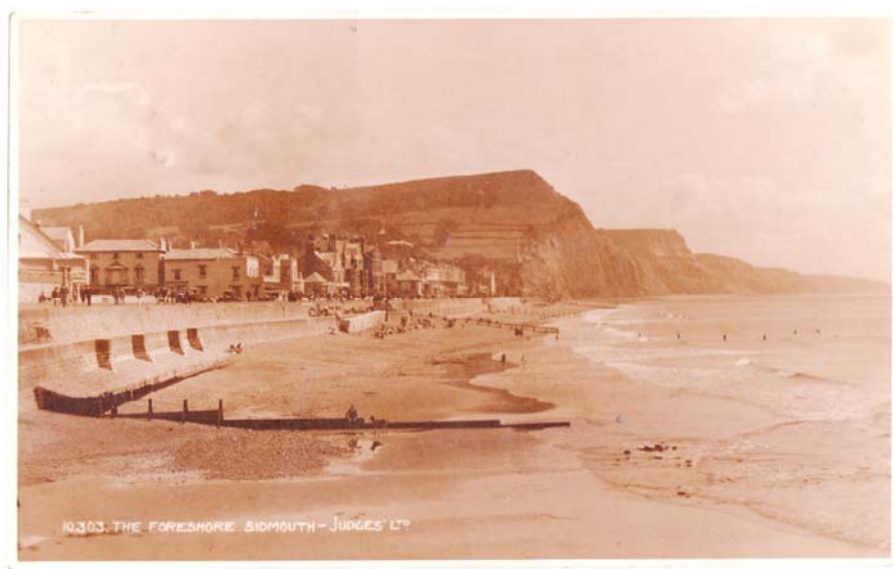
Records from the 1920s and 1930s (refer to Figure 5-20, Figure 5-21, Figure 5-22 and Figure 5-23) seem to indicate that the shingle beach fronting the town and East Cliff lowered and narrowed considerably over this period (which concurs with conclusions by Laver, 1981 who determined that beaches in the 1920s were lower than in the 1970s). The photographs show that the timber groynes and the face of seawall were exposed and beach levels either side of the training wall were low. Photographs shown in Figure 5-20 and Figure 5-23 appear to indicate debris at the toe of the cliffs along East Beach, indicating cliff failures, and records indicate that rock falls and collapses of weathered material from the cliff top occurred along East Cliff in 1925, 1927, 1928 and 1930.

Figure 5-20 The beach at Sidmouth looking east, image postmarked 1927. The upper shingle beach appears to be narrow and levels are low, based upon exposure of the seawall and timber groynes. Source: Mary Walden.

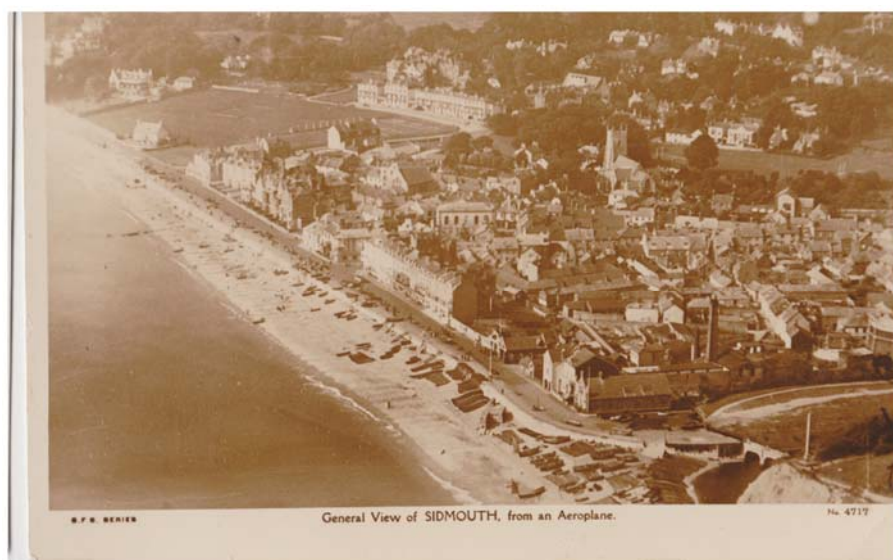
Figure 5-21 Aerial view of Sidmouth beach, looking west, image postmarked 1930. Source: Mary Walden.

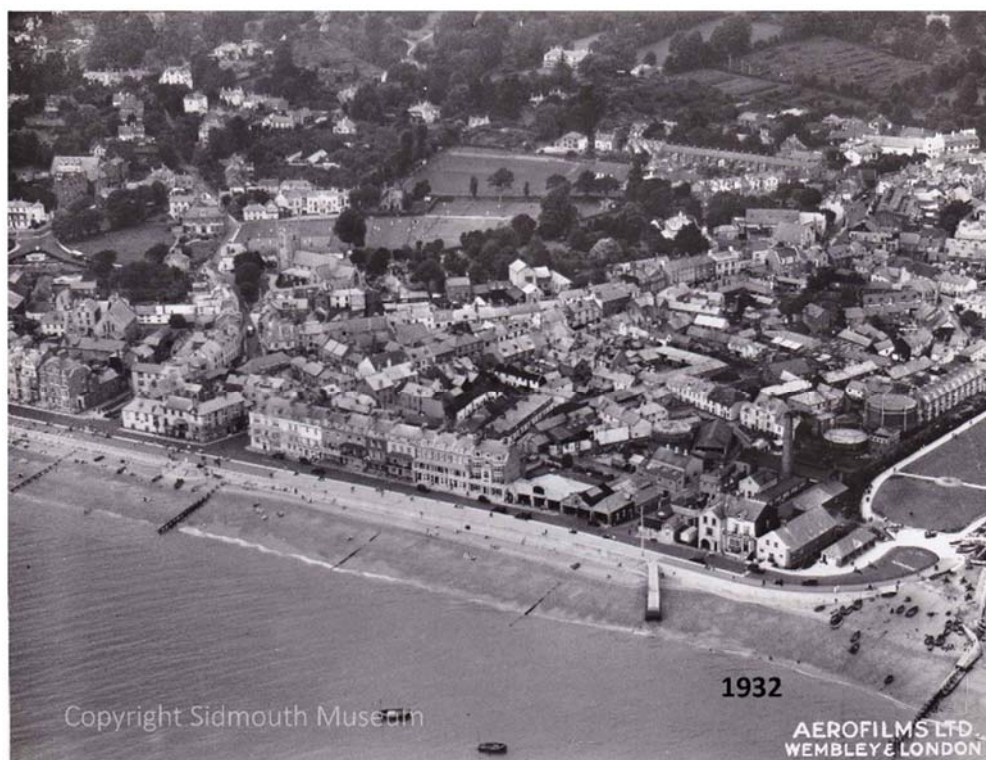
Sometime between 1921 and 1928 (see online historical photos from Francis Firth), a new training wall was constructed at the eastern end of Sidmouth Beach. The wall was positioned some distance away from the existing promenade, so that the channel now exited to the sea further to the east and the upper beach was fixed between the promenade and training wall. The photograph from 1932 (see Figure

5-22) shows an outfall extending from the training wall, so it is possible that they were constructed at or around the same time.

Figure 5-22 Aerial image of Sidmouth Beach in 1932 showing low and narrow beach, with new training wall and outfall structures at the eastern end of the beach. Source: David McCluskey, Sidmouth Museum.

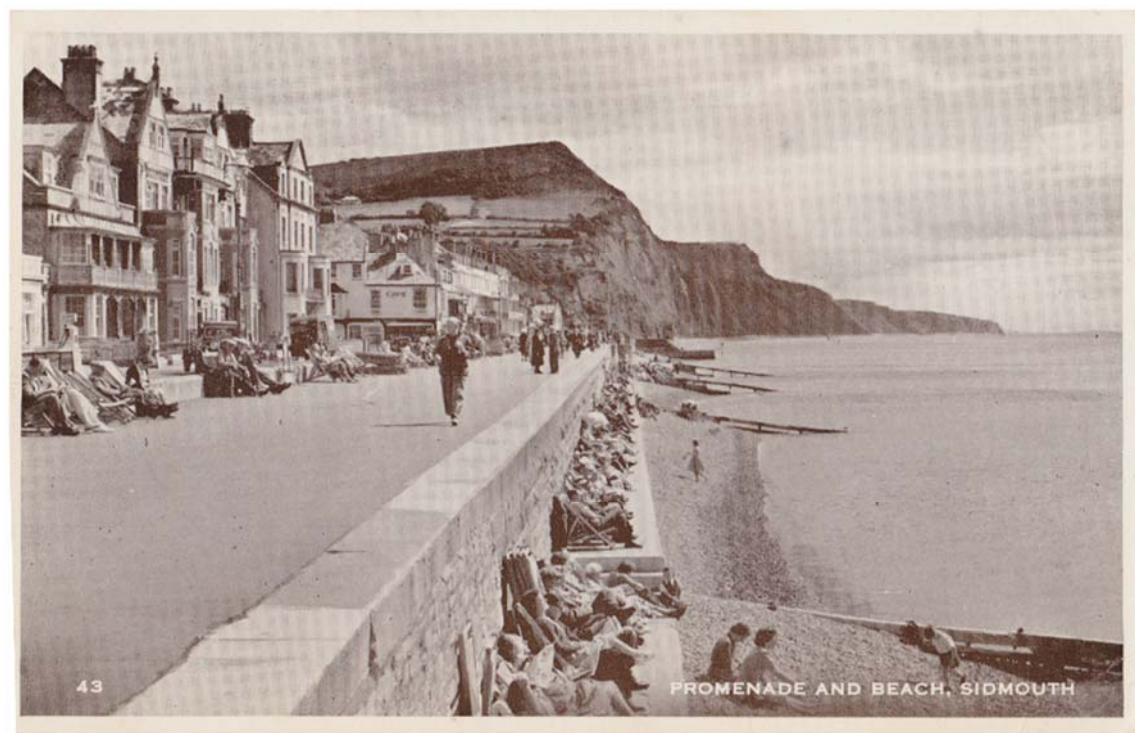
There are limited records from the 1940s and 1950s, but a photograph from 1955 (refer to Figure 5-25) suggests beach levels were low and the upper shingle beach very narrow, at the time of this photograph. Build-up of shingle indicates that net drift was from west to east, although this may simply be indicative of the most recent conditions.

Figure 5-25 Sidmouth beach, looking east, image postmarked 1955. Source: Mary Walden.

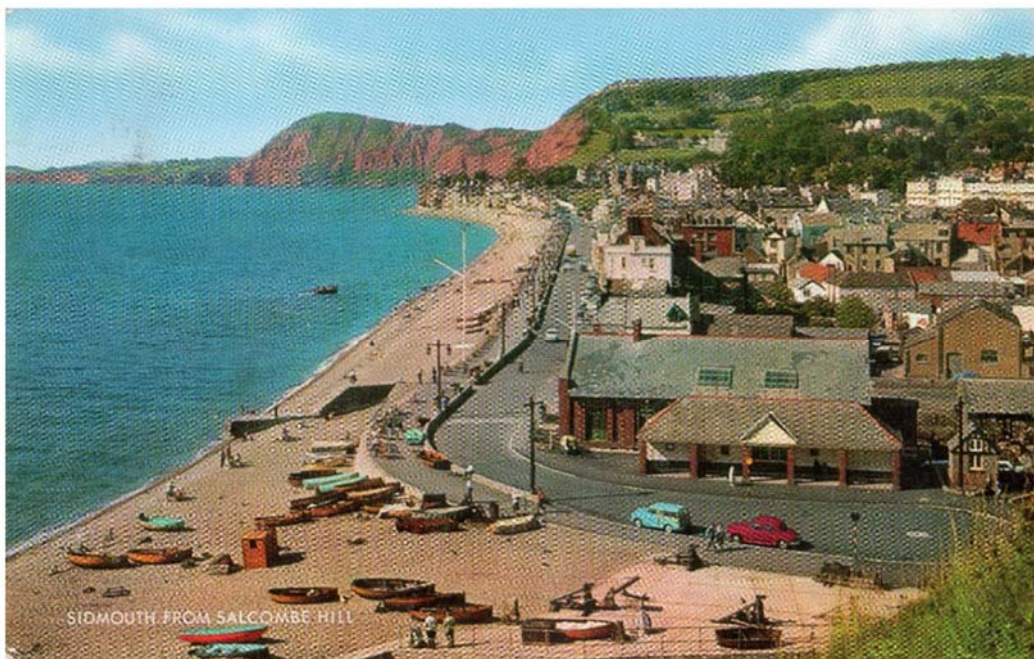
Personal recollections of residents and photographs dating from the 1960s and 1970s suggests the decade was characterised by healthy beaches and stable cliffs. A postcard from 1966 (see Figure 5-26) and photograph of the beach in 1969 (Figure 5-27) supports these recollections and it is noted that beach levels at the eastern end of the beach between Dunnings Pier/East Pier and the training wall were high during this time. There is some evidence to suggest that the 1980s were also characterised by wider beaches (see Figure 5-28, Figure 5-29 and Figure 5-30), when again beach levels at the eastern end of the beach between Dunnings Pier/East Pier and the training wall appear to be high and the beach here is wide.

Figure 5-26 Sidmouth beach from Salcombe Hill, posted 1966. Healthy beach levels. Source: Mary Walden.

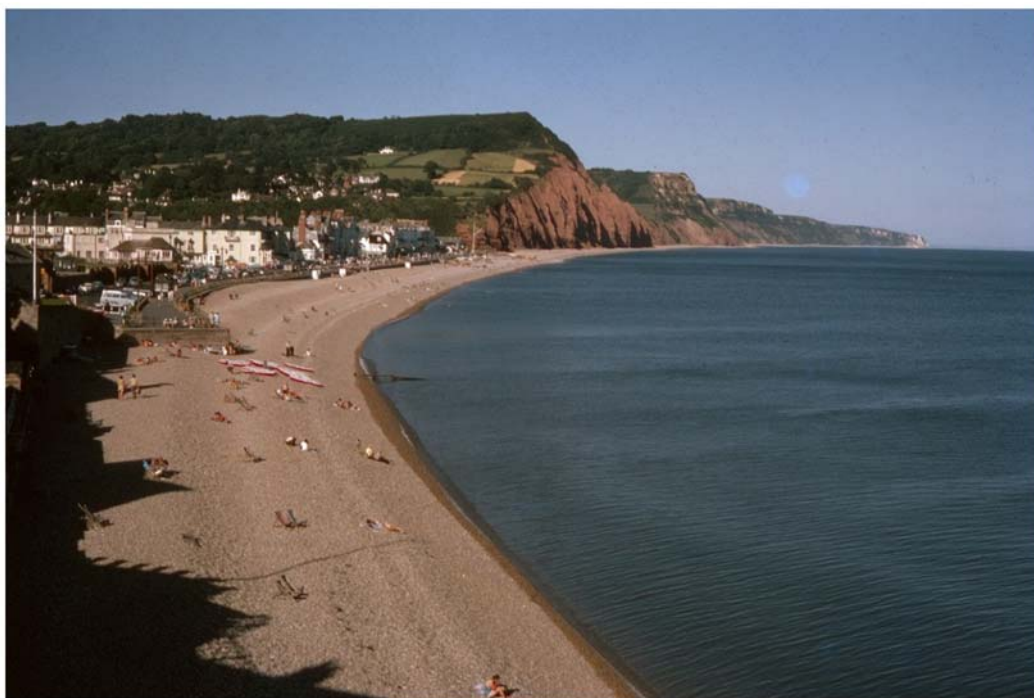
Figure 5-27 Sidmouth looking east in 1969, showing a wide beach and healthy beach levels at Sidmouth and East Beach. Source: Robin Bettridge.
