Sidmouth & East Beach Management Plan

Prepared for
East Devon District Council

January 2016

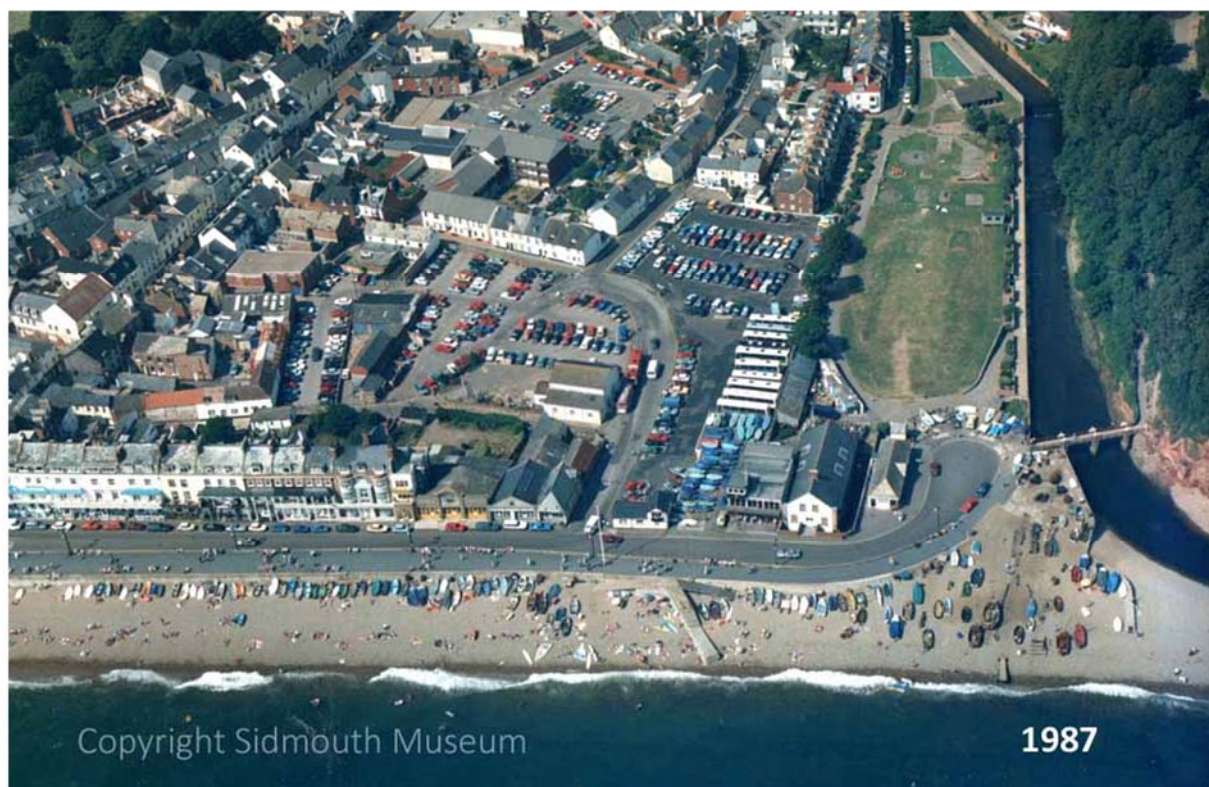
Figure 5-28 Aerial image of Sidmouth beach in 1987, showing healthy beach levels. Source: David McCluskey, Sidmouth Museum.

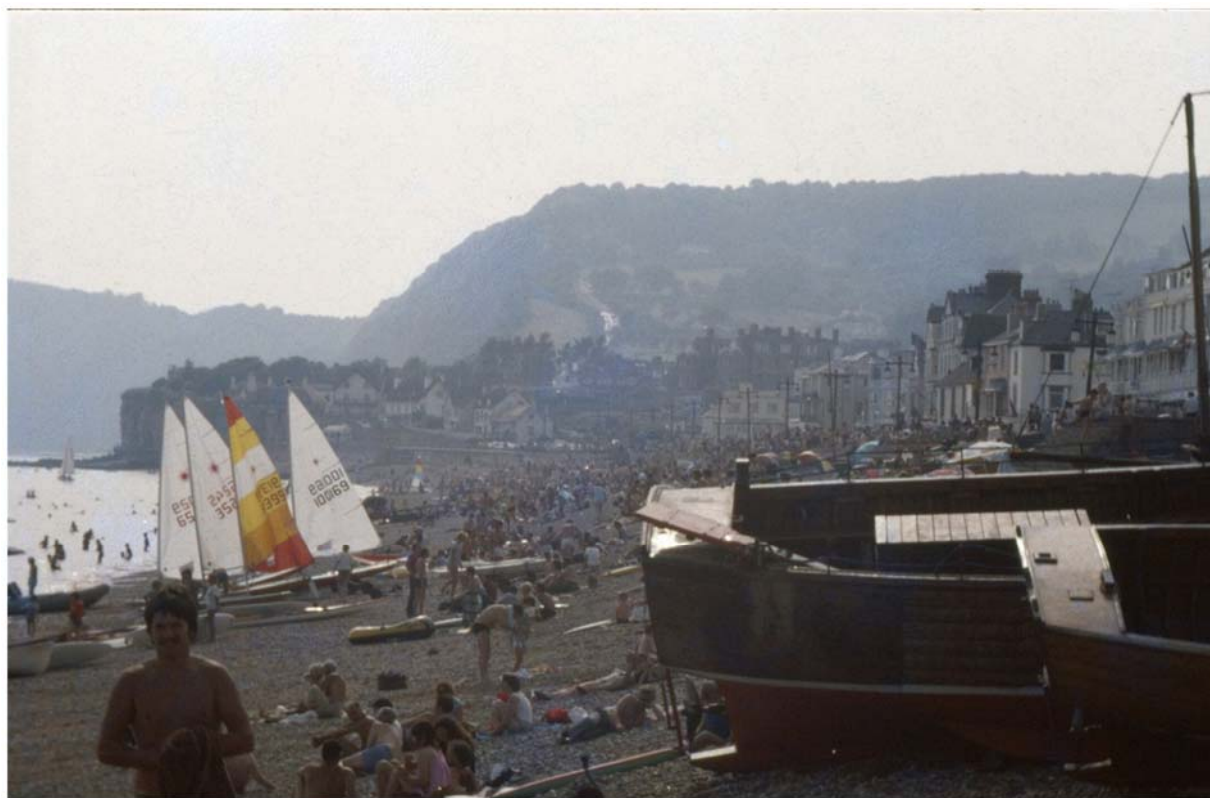
Figure 5-29 Photograph of Sidmouth beach, looking west, in 1983, showing a wide beach. Source: Robin Bettridge.

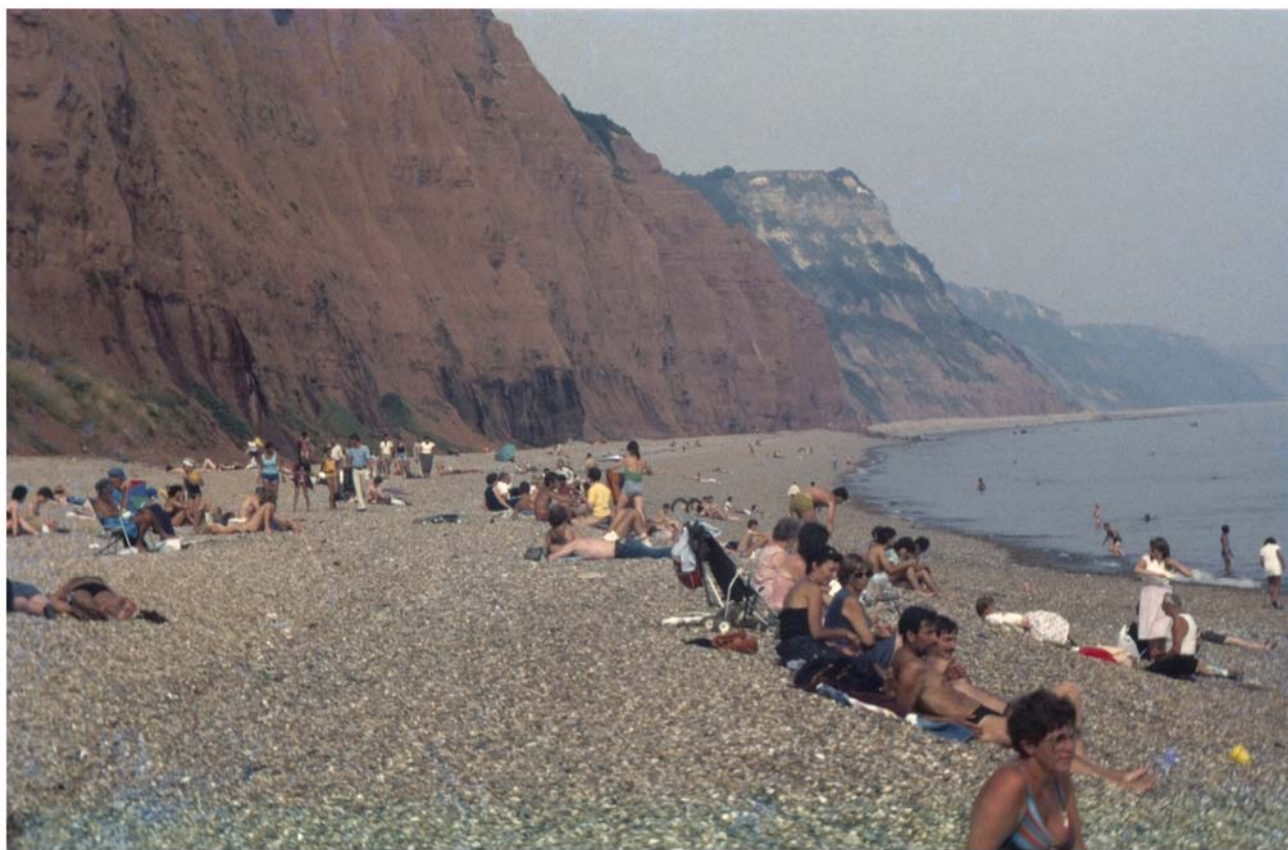
Figure 5-30 Photograph of East Beach, looking east, in 1983, showing wide beach and healthy beach levels. Source: Robin Bettridge.

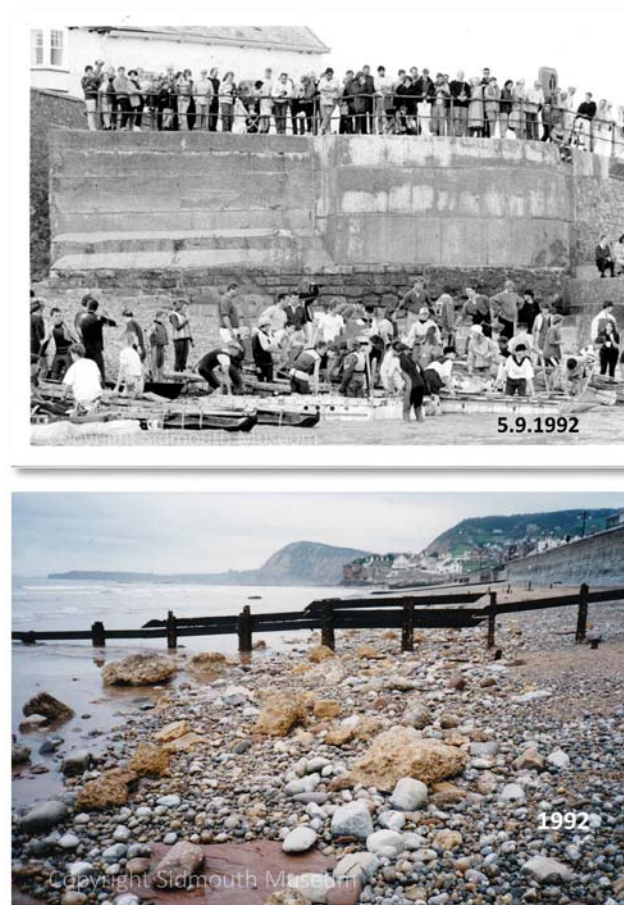
During the early to mid-1990s, beach levels at Sidmouth dropped substantially, exposing the footings of the seawall and timber groynes once again (see Figure 5-31).

Figure 5-31 Sidmouth beach in the early 1990s showing very low beach levels. Source: David McCluskey; Sidmouth Museum.

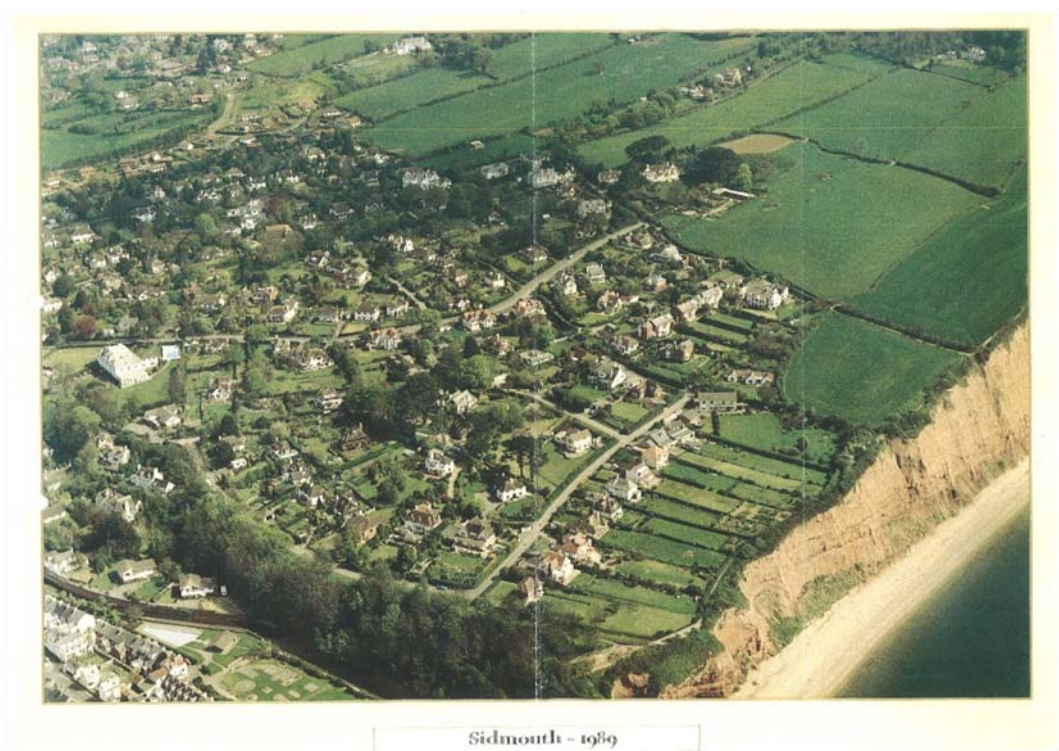
Along East Beach, photographs from 1989 and 1992 (Figure 5-32 and Figure 5-33) suggest that beaches had not suffered to the same extent as those along the Sidmouth frontage and that although talus was present at the toe of the cliffs, this was vegetated, suggesting that the beaches were preventing normal waves from reaching and removing this material. The 1992 photograph seems to show collapse of the cliff at Pennington Point and historical aerial photographs (discussed earlier in this report in Section 5.2), also provide evidence of cliff failure at the back of East Beach in the early 1990s, which would explain the presence of talus, but this may have been followed by a period of relative stability. It should be noted, however, that talus can become vegetated fairly rapidly and may therefore only indicate a year or so of stability.

A comparison can also be made between Figure 5-32 and Figure 5-24, which were taken from a similar position but 52 years apart, and suggest that between these two photographs (dating from 1937 and 1989) there had been significant retreat of the cliff top, resulting in loss of land and deposition of a large and partially-vegetated debris apron at the cliff toe.

Figure 5-32 East Cliff, 1989. There is vegetated talus at the toe of the cliffs and a healthy fronting beach. This suggests a period of stability, which the beach being wide enough to prevent reworking of the talus by waves. Source: Cliff Road Action Group (CRAG). A comparison can be made to Figure 5.24 that shows retreat of the cliff top and formation of a debris apron at the cliff toe between 1937 and 1989.

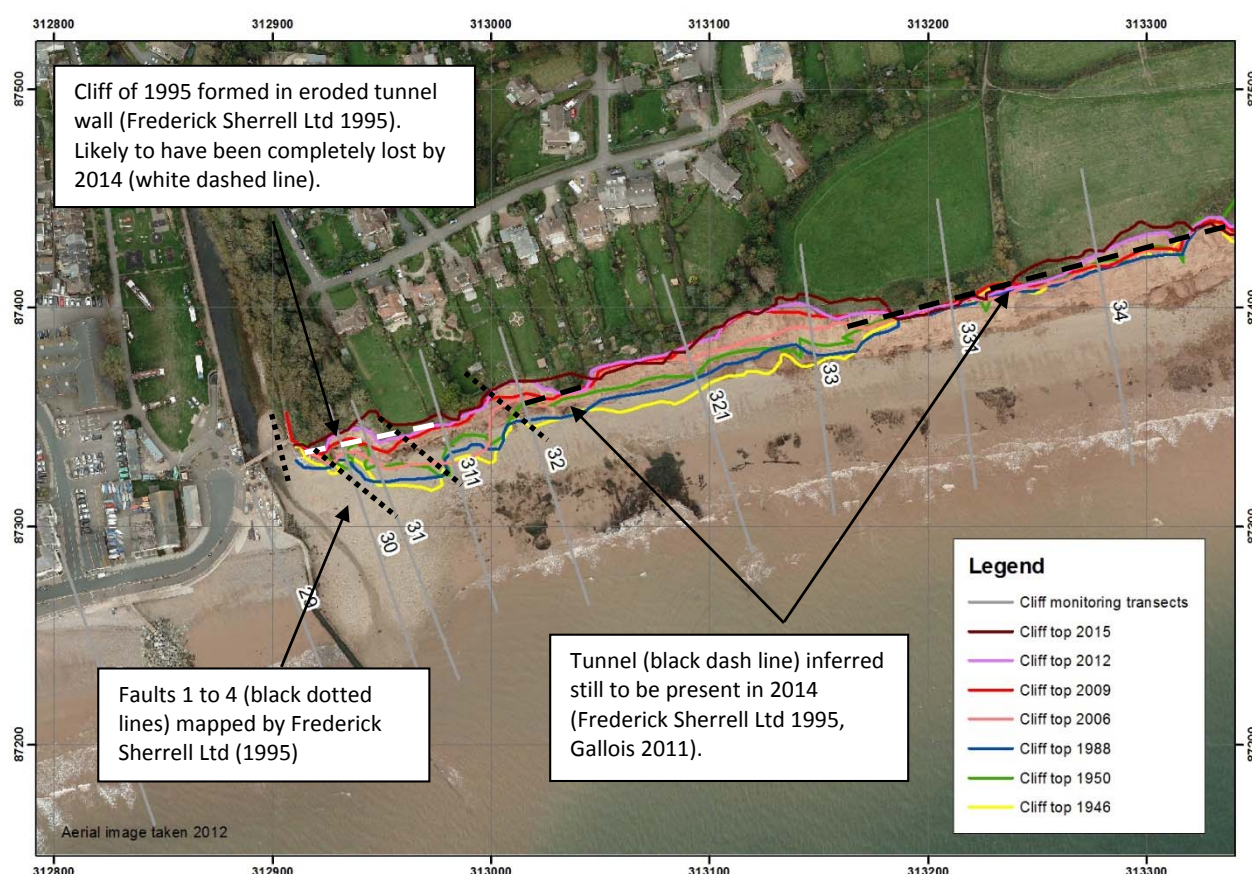
Geological logging indicated that the location of many of the landslide embayments in this western section of CBU 7 were associated with the presence of geological faults that are orientated between approximately N-S and NW-SE. The information on faults and tunnel remnants have been superimposed on the aerial photograph and cliff recession data (Figure 6-2), which highlights several clear relationships:

- the embayment at transect 30 (Pennington Point) relates to mapped Fault 1;
- the embayment at transect 31 relates to mapped Fault 2;
- the embayment at transect 311 relates to mapped Fault 3;
- the embayment at transect 32 relates to mapped Fault 4, but may also be coincident with a section of tunnel that was revealed by a landslide in 2010 (Gallois 2011); and
- the embayment between transects 33 and 331, which appears to have widened towards the east, is coincident with the western limit of the tunnel.

As the majority of the tunnel in the western 250m of East Cliff had been eroded by the 1950s the rapid cliff recession of Pennington Point and East Cliff experienced in the last c.25 years is unrelated. However, rapid retreat east of transect 33, associated with an eastwards-widening embayment does appear to be associated with the entrance to the remaining section of the tunnel, suggesting it does have a localised impact that can be expected to progress towards the west.

Figure 6-2 Cliff positions at East Cliff determined from aerial photos

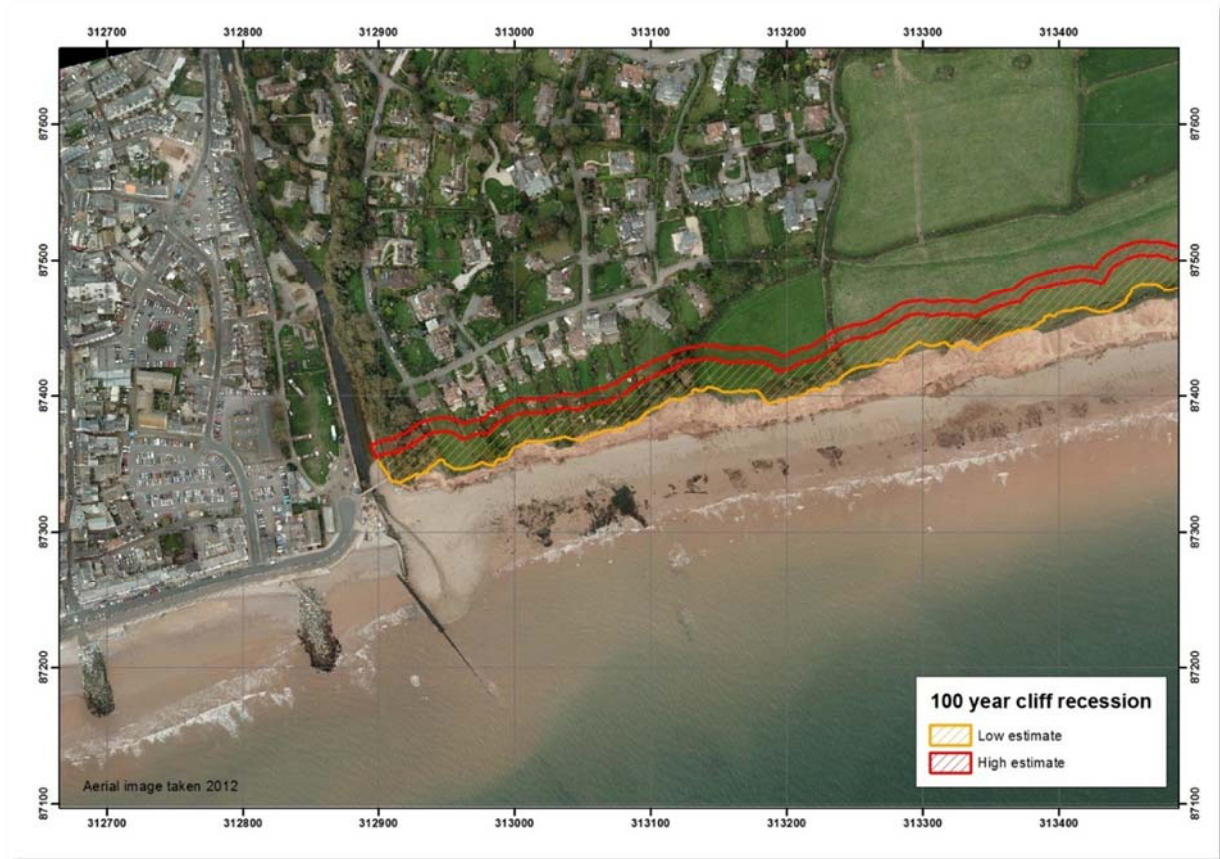
A 100 year projection is presented in Table 7-2 for a lower estimate, which is simply a projection of the historical rates factored up by 10% to account for climate change, and an upper rate which includes additional headscarp recession based on the historical magnitude and frequency. The values presented are shown plotted in Figures 7-1 and 7-2 for East Cliff and Peak Hill respectively.

Figure 7-1 Cliff recession projection for 100 years at East Cliff. Note the projection is made from the 2015 cliff top, but are overlain on the 2012 image.

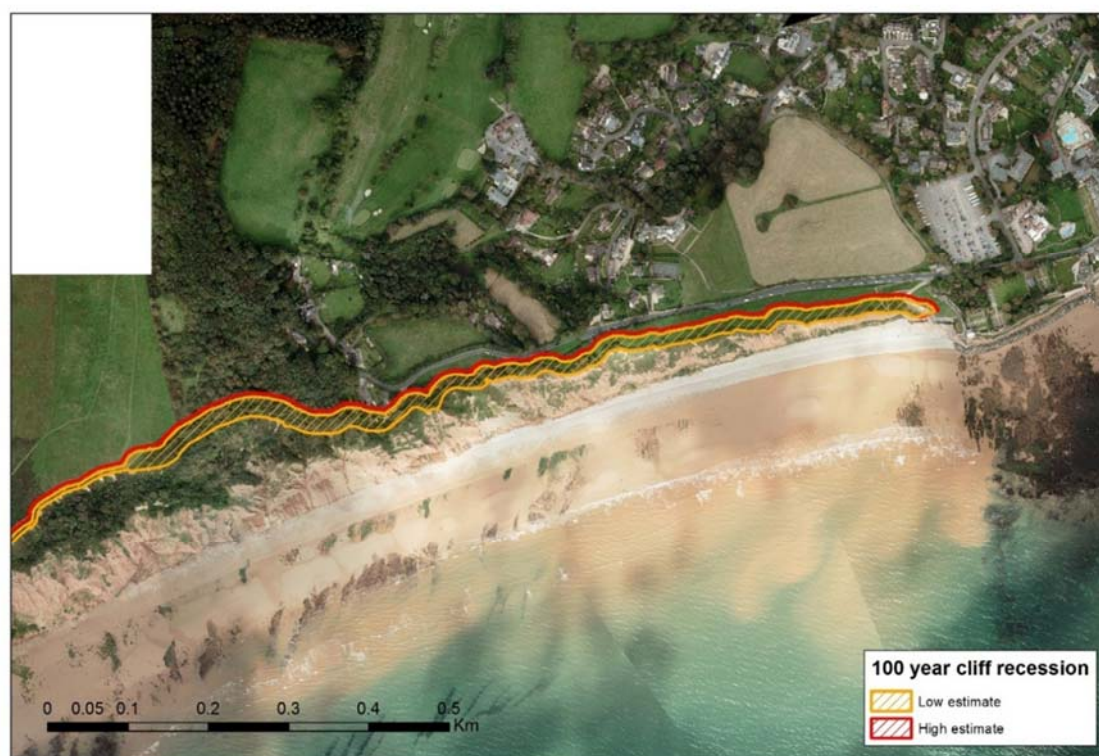
Figure 7-2 Cliff recession projection for 100 years at Peak Hill mapped. Note the projection is made from the 2012 cliff top and overlain on the 2012 image.
