Sidford Interim Conservation Area Review

SIDFORD

Prepared for East Devon District Council by John Fisher BA, MA, MRTPI
with contributions from Town and Parish Councils and Amenity Societies in East Devon

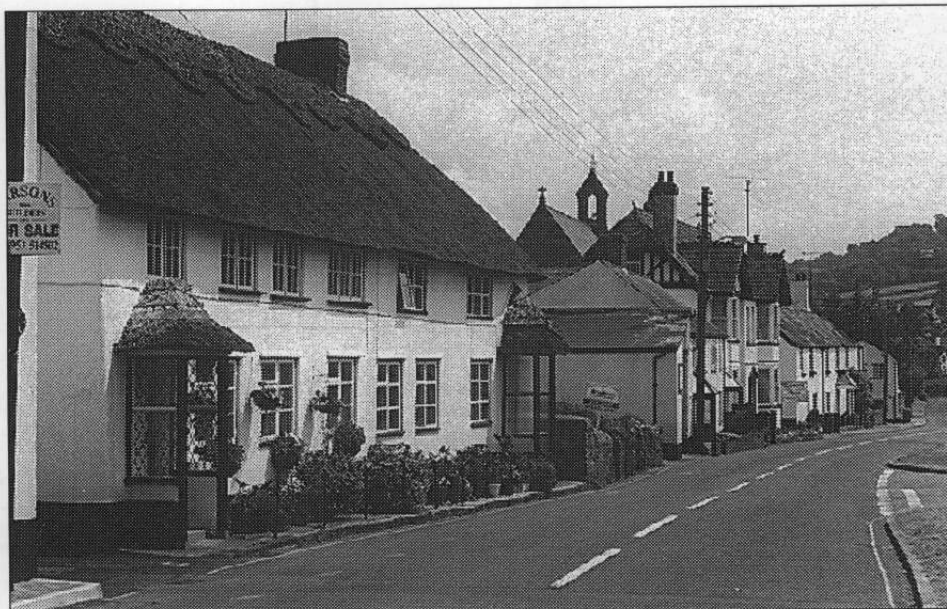
(Above & below) Church Street, the north side presents many attractive frontages with painted render and thatch or slate predominant

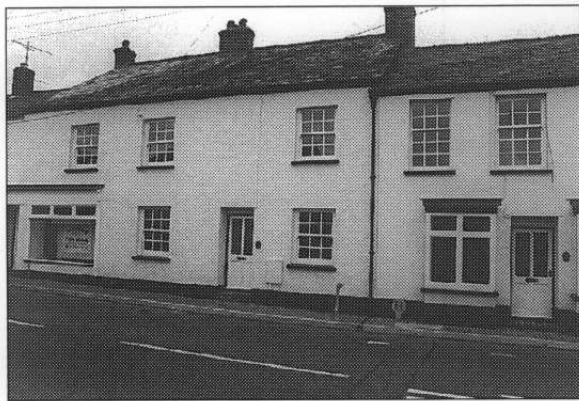
Church Street; recently improved frontages where inherent character has been respected

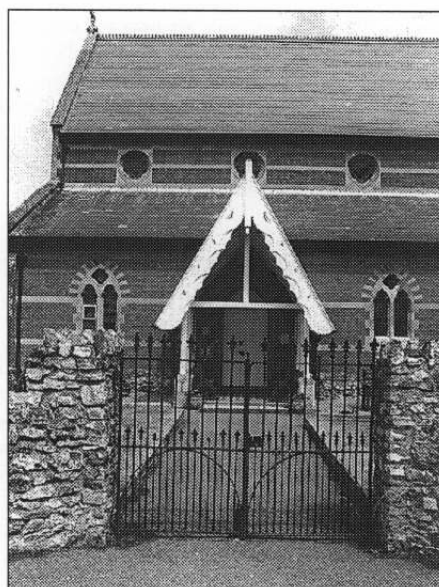
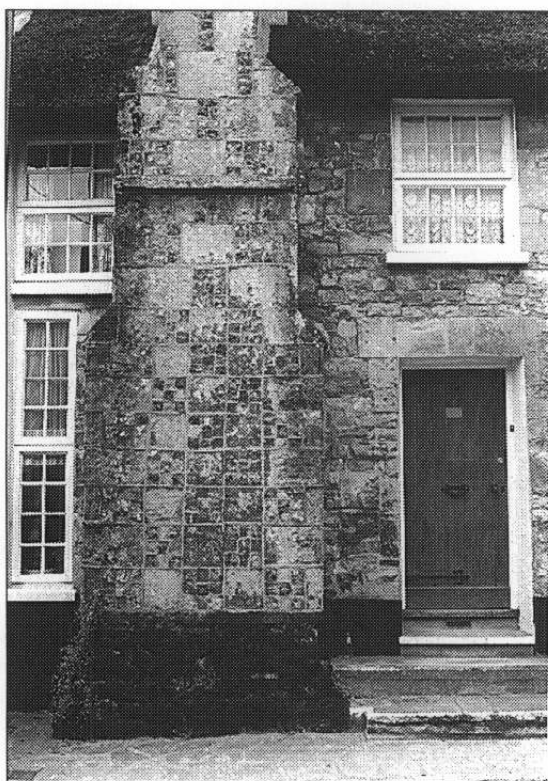
The massive forward projecting stacks with attractive stonework detail are a particular feature of the cottages in School Street as is some fenestration.
