Defence Assessment Report

Sidmouth & East Beach Management Plan

Prepared for
East Devon District Council

May 2015

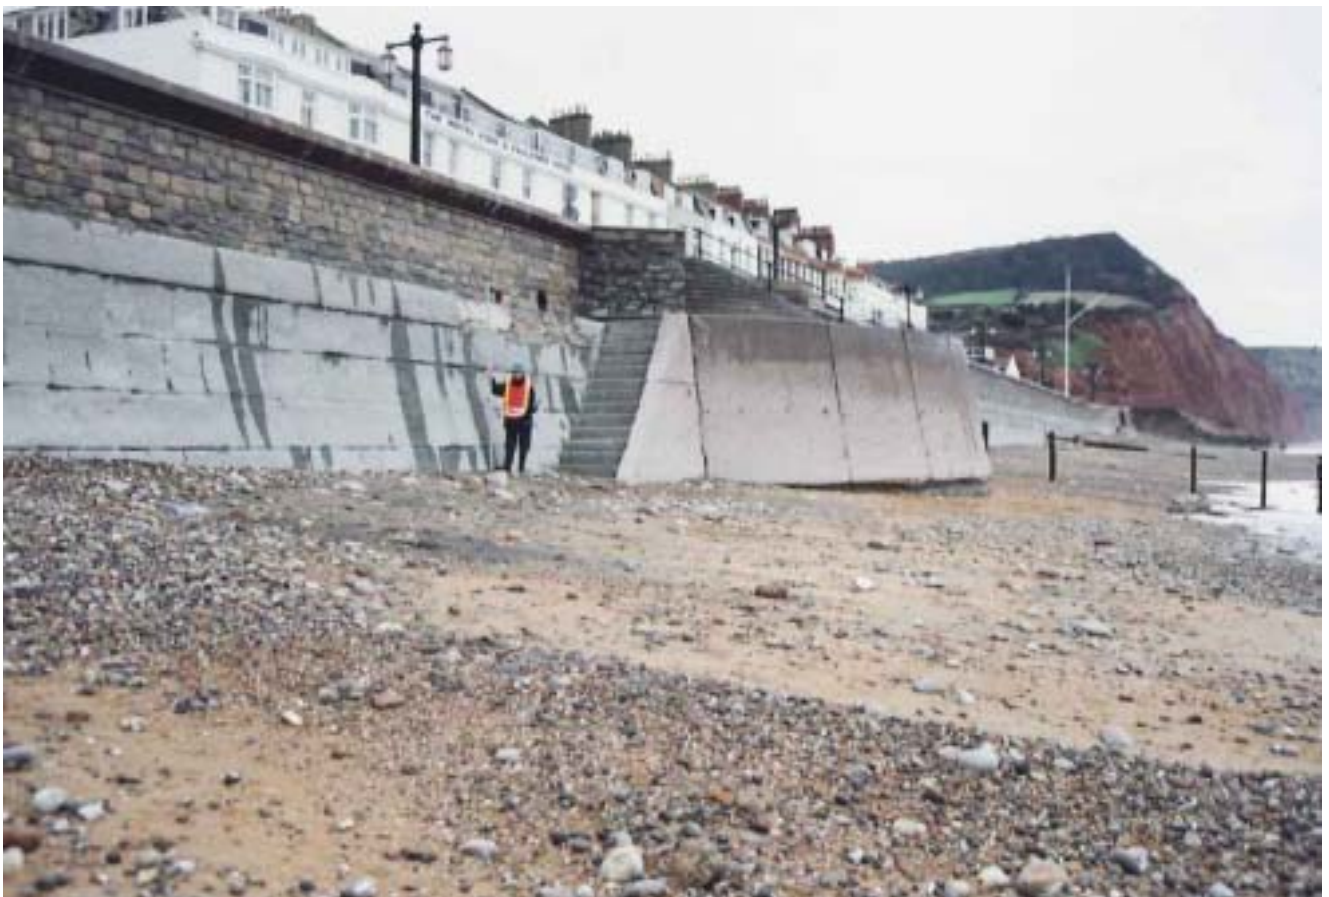
In January 1993 further lowering of beach levels along the frontage occurred, prompting East Devon District Council (EDDC) to take immediate measures to secure the sea wall from collapse. Posford Duvivier (1993) states that there were outstanding objections to the Phase II scheme (although does not provide details) which would have provided a solution to these issues, so 'Emergency Works' were required to be undertaken instead. The beach lowering can be seen below in Figure 2-6.

Figure 2-6 January 1993 following beach lowering at Sidmouth (from EDDC records)

The works consisted of a low level rock revetment at the foot of the seawall for approximately 400m extending between West Pier and York Steps. Concrete access steps were provided at the existing York, Bedford and Belmont step locations to maintain access for beach users. Repairs to the seawall were also undertaken, mainly pointing to the existing stonework.

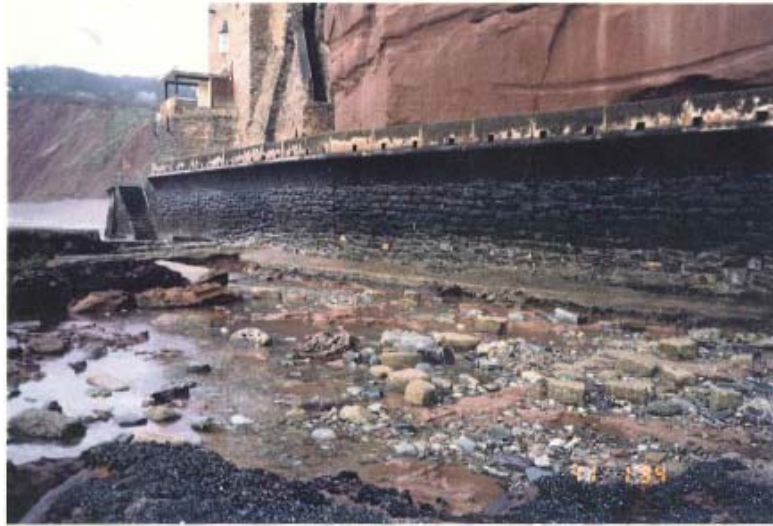
In January 1994 an inspection was carried out of the Connaught Gardens frontage which revealed that there was insufficient shingle and sand adjacent to the seawall to prevent erosion. Adjacent to the seawall, the rock platform known as Chit Rocks had lowered, exposing the foundations of the wall which consisted of a concrete apron along most of its length. There is evidence to show there was undermining of this apron. Figure 2-8 below shows the 1957 seawall and the erosion observed during the January inspection (Posford Duvivier, 1994).

Figure 2-8 1957 seawall and the encountered erosion during the 1994 January inspection (from Posford Duvivier, 1994)

Signs of scour were present on the seawall promenade with minor holes and pitting in the concrete. Cracking was observed in the crest wall which sits upon the seawall recurve (refer to Figure 2-8). The cracks were seen directly above rectangular promenade drainage outlets in a number of locations. Concrete coping damage had occurred at a couple of locations. Concrete spalling has occurred in the crest wall at expansion joint locations. There was evidence to suggest these had been filled with mortar, which does not allow expansion and may lead to further spalling. Some expansion joints did not contain the original bitumen sealant or a suitable replacement. This was also evident in the promenade slab expansion joints where bitumen sealant was either missing or the joint filled with mortar.

In 1994, a rock revetment was constructed in front of the 1957 seawall extending from the western end of the Phase II works (start of Clifton Walkway – see Section 2.8) for 155m to Jacobs Ladder beach. For amenity and technical reasons, a concrete apron was constructed to protect the seawall return into the adjacent bay to the west (Jacobs Ladder Beach return) for approximately 21m to protect the toe of the wall. In addition, stone repointing was undertaken to the existing seawall masonry. Figure 2-9 shows the typical construction detail for the 1957 seawall and the rock revetment (Posford Duvivier, 1994).

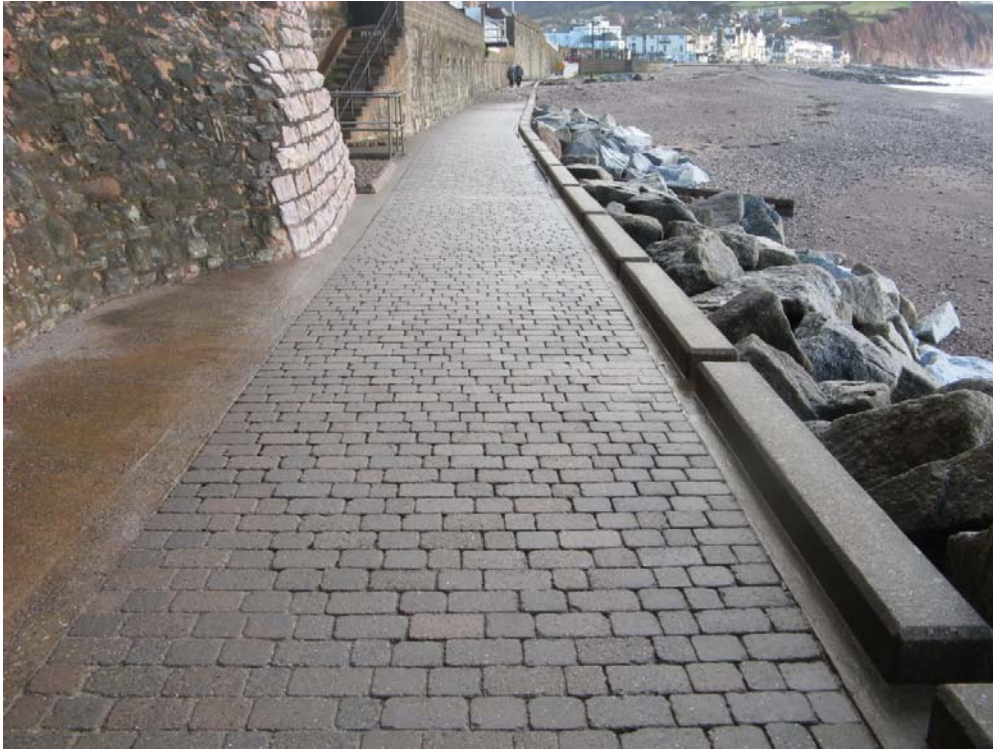
This frontage contains a rock revetment with a block paved, reinforced concrete walkway above and a masonry seawall which protects a number of properties behind (Figure 3-3). The reinforced concrete walkway, constructed in 1999, sits above a rock revetment installed in 1995 as part of the Phase II works. It is uncertain when the masonry wall was built but it existed in the historical photo shown in Figure 2-1 in 1947 (67 years ago). In addition, within this frontage length there are two offshore breakwaters. Further photos are included in Annex B.

Figure 3-3 Frontage 2 masonry wall, walkway and revetment

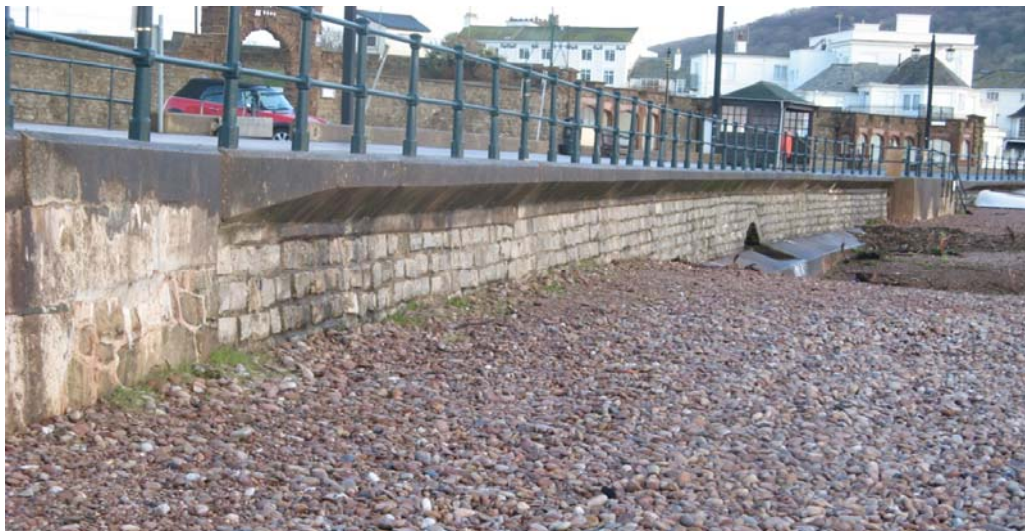
Frontage 3 extends between West Pier and Bedford Steps groyne. This frontage contains the original masonry Esplanade seawall which has had various maintenance works over the years, most notably the construction of a lower level seawall in front of the existing wall with a down toe constructed into bedrock in 1920. A reinforced concrete coping and masonry facing was installed during the Phase I works. Hand railing was added and promenade improvements made during the Phase II works. The beach has been recharged (Phase II) and recycled (Phase III) and a large outfall through the seawall exists. Bedford Steps rock groyne forms the eastern end of this frontage which was built during Phase III to reduce the distance between the offshore breakwaters and York Steps groyne (which resulted in severe beach profile depletion moving eastwards). Figure 3-5 shows the seawall and outfall along this frontage length. Further photos are included in Annex C.

Figure 3-5 Frontage 3 seawall and outfall and a shingle beach

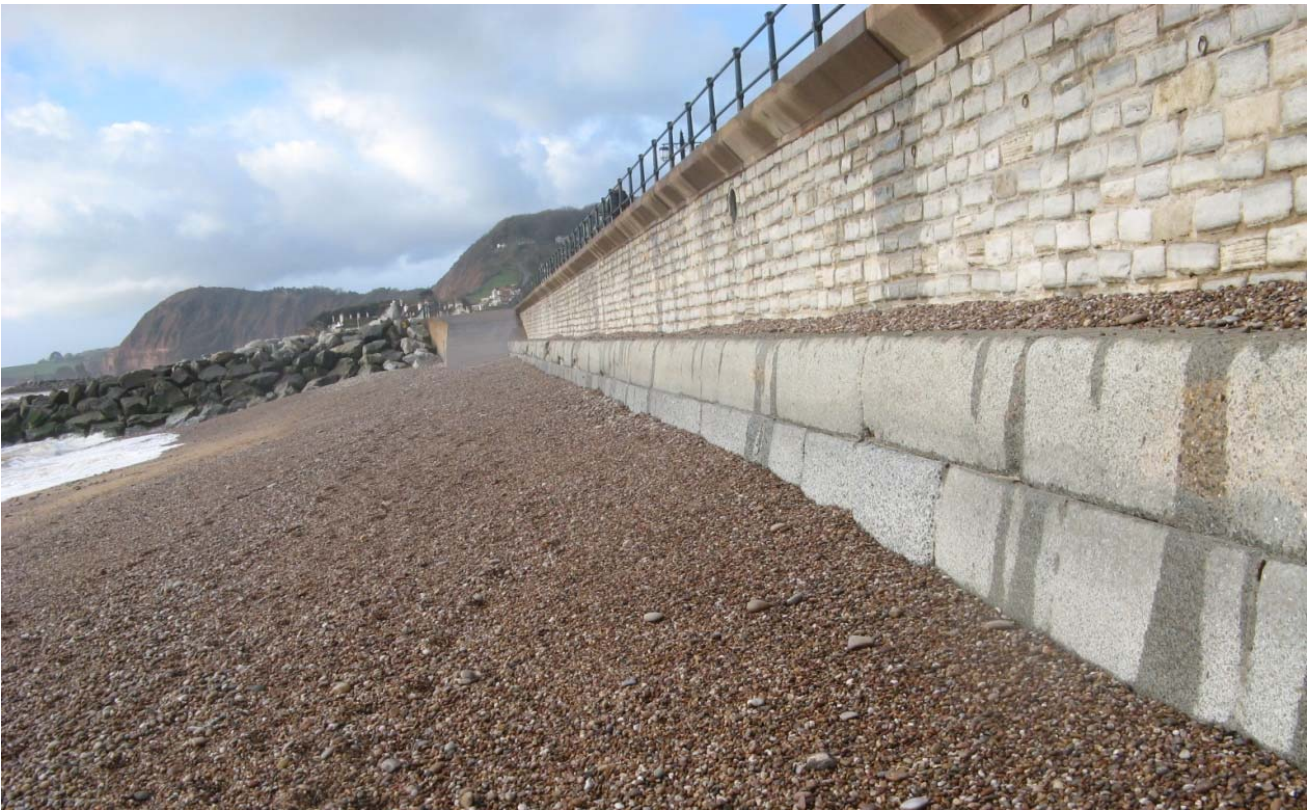
Frontage 5 extends between York Steps and East pier groyne and includes the esplanade seawall and a rock groyne built during the Phase II works. The seawall has the mass concrete apron and down toe constructed into bedrock (thought to be between 1953 and 1957); reinforced concrete coping and masonry facing (Phase I); and beach recharge/recycling (Phase II). However, the frontage does not include the revetment which was placed in front of the apron along the other frontages. Figure 3-7 shows the York Steps groyne and the esplanade seawall and lower level seawall (apron). Further photos are included in Annex E.

Figure 3-7 Frontage 5 seawall and concrete apron with shingle beach

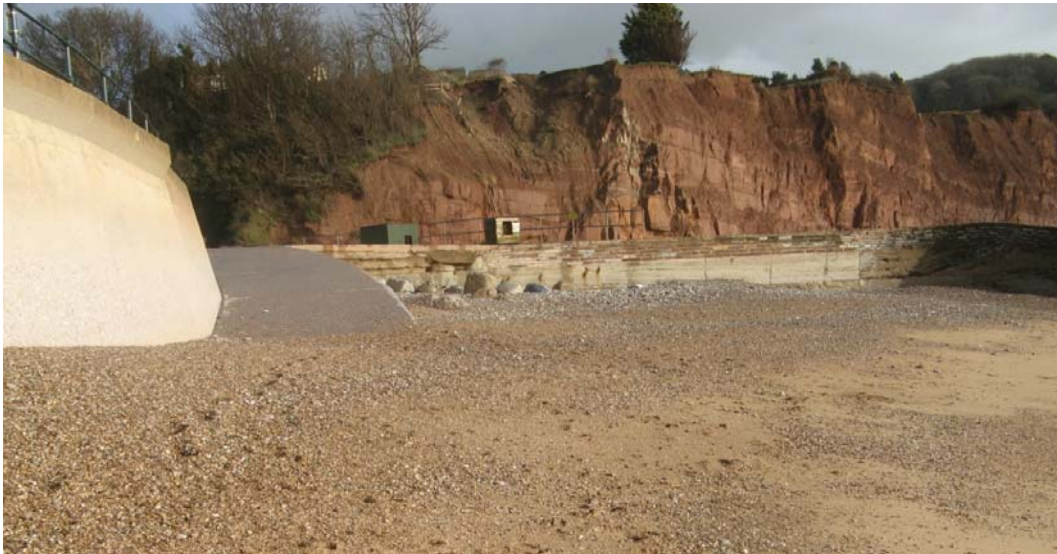
The frontage also includes a river training wall which was initially built in 1918 and has been maintained and repaired over the years. The river training wall was extended during the Phase II scheme. Figure 3-8 shows the river training wall on the right and the seawall on the left. Adjacent to the river training wall is an outfall owned by South West Water. The frontage also includes a discrete section of sheet pile wall which runs along the toe of the wall section which extends between the river training wall and the River Sid wall (fronting the River Sid). Further photos are included in Annex F.

Figure 3-8 Frontage 6 seawall (left) and river training wall (right)

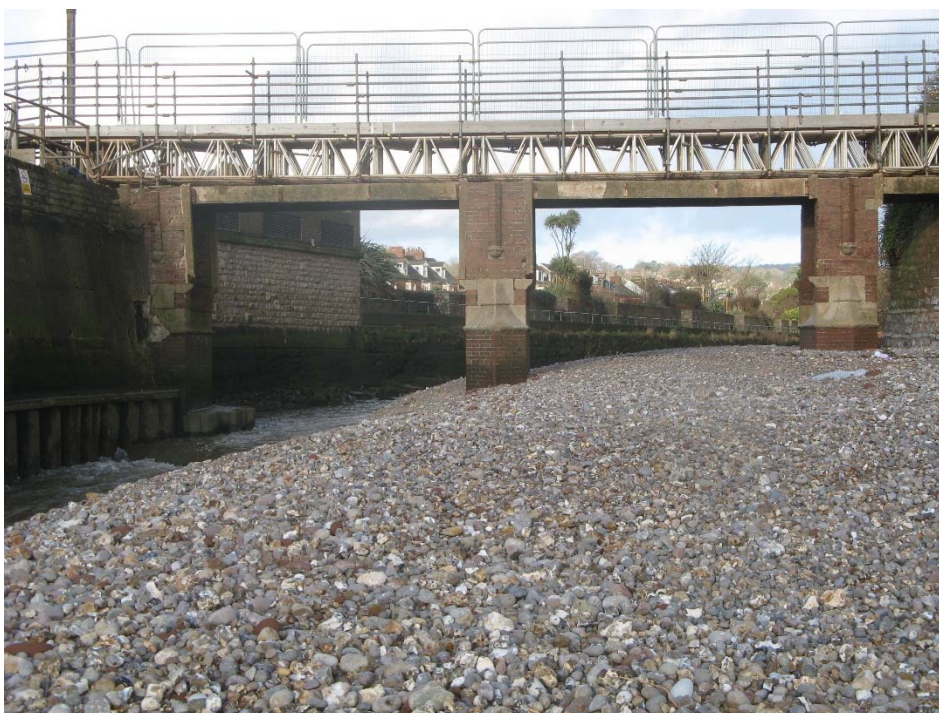
Frontage 7 extends between Alma Bridge and Ham Weir along the River Sid and includes natural cliffs on one side of the bank and what is suspected to be a mass concrete wall with walkway on the other river bank. At the upper extent of the frontage is Ham Weir. Structural improvements to Ham Weir and the River Sid wall were made during the 1963 Sidmouth Improvement Scheme (Devon River Board, 1963). This included raising the heights of the existing flood walls. The assessment of Alma Bridge will be limited to the pier footings. Figure 3-9 shows Alma Bridge and the River Sid river wall in the background.

Figure 3-9 Frontage 7 river wall in the west background and Alma Bridge in the foreground

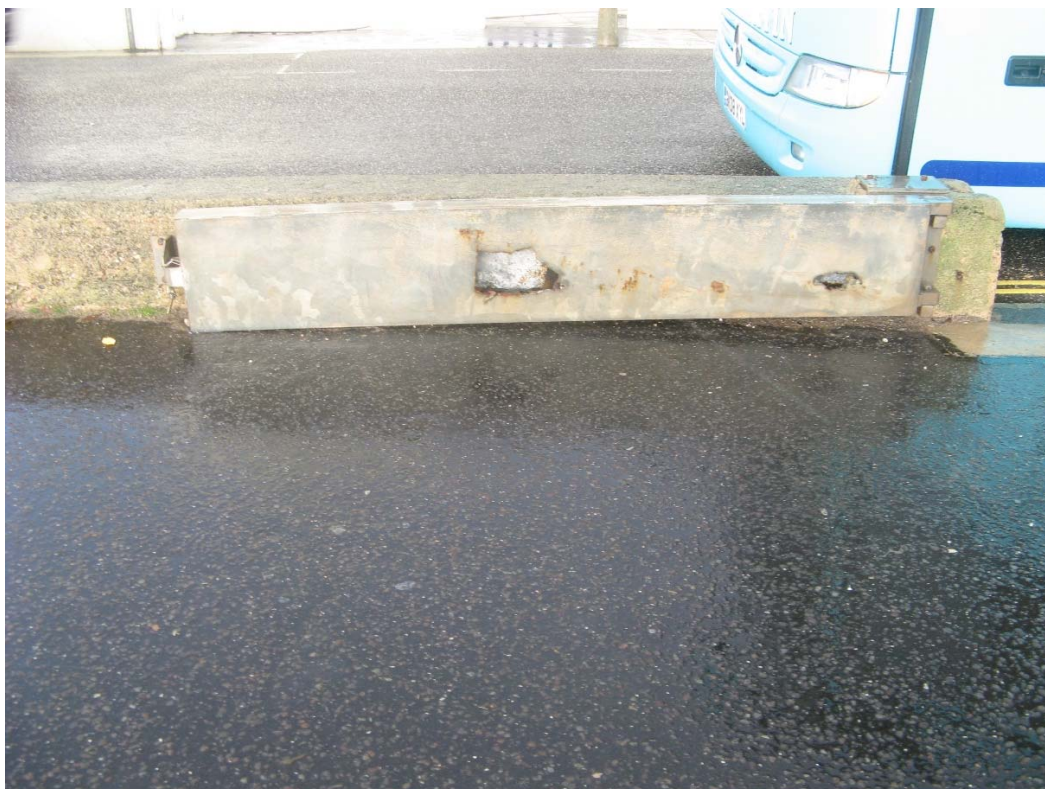
- During the site visit of 13th January, a further defence was observed on the promenades rear face where there is a low level concrete wall with intermittent flood barriers, as shown in Figure 3-10.

The flood barriers are thought to be mild steel since they are suffering extensive corrosion. The barriers function is unclear since they do not appropriately seal and many gaps exist in this defence. This suggests they are not realistically providing an improved standard of flood protection. Furthermore, the overtopping threshold is higher at the promenade front face for aware pedestrians = 0.1 l/s/m when compared to the rear face, which could be perceived as having a limiting overtopping for vehicles driving at slow speeds = 10 l/s/m (EurOtop, 2007).

The flood barriers will help direct water away from properties and likely behave as more of a 'splash wall' to reduce overtopping on the highway (where there is a higher threshold). It is thought these barriers do prevent shingle from reaching the highway surface during events that lead to overtopping. This may expedite the ongoing shingle clearance (known to be a maintenance activity) on the promenade and improve road safety, but these flood barriers cannot be perceived as offering any improvement to the standard of protection against coastal flooding.

Figure 3-10 A low level concrete wall with intermittent flood barriers is located along the landward edge of the promenade at Sidmouth

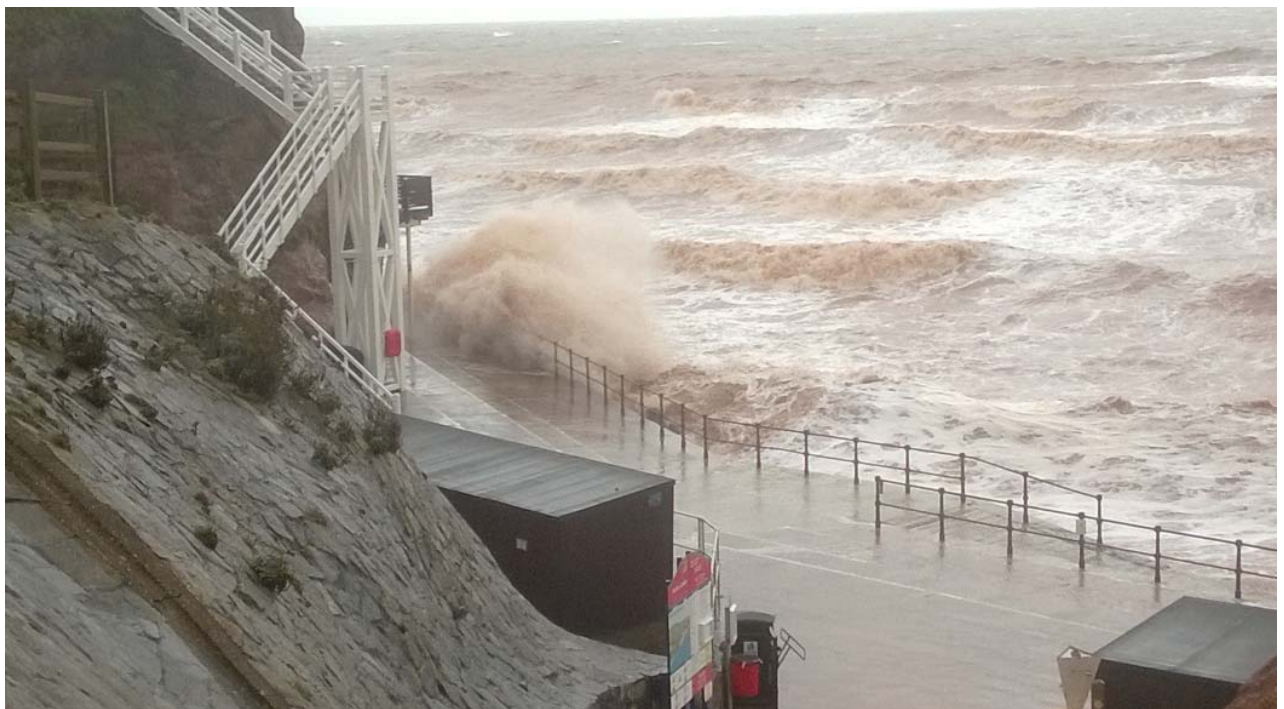
Further to the analysis above, images were obtained from the recent storms on 3rd February 2014. These events were estimated to be extreme, in the order of 1 in 100 to 1 in 200 return period events. Figure 4-1 demonstrates the results of the overtopping analysis well. It can be seen that Frontage 2 is extensively overtopping during this event, whilst Frontage 3 is not overtopping due to the high beach levels. In the distance of the photo it can be seen that Frontages 4 to 6 are leading to overtopping with impulsive conditions, this is due to the lower beach levels when compared to Frontage 3. This further validates the results of the overtopping analysis. Figure 4-2 shows Frontage 1 extensively overtopping during the storm, further validating the overtopping analysis.

Figure 4-2 Overtopping during February storms of Frontage 1

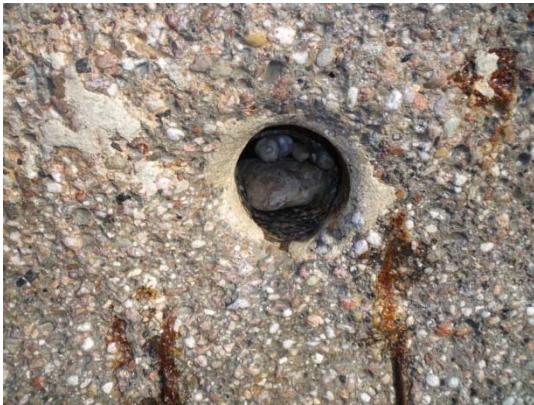
Figure A3: Blocked outfall

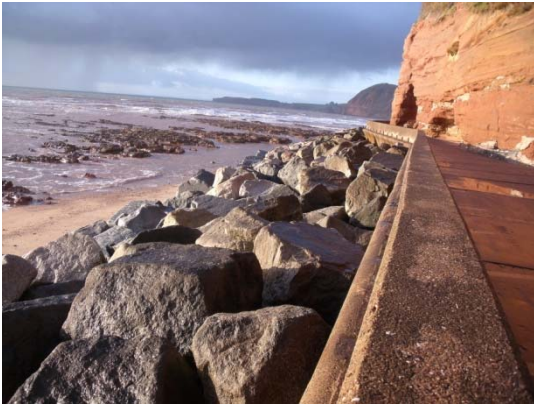
Figure A13: Revetment in front of seawall

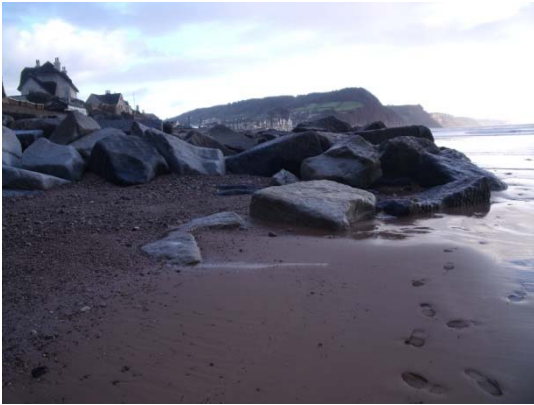
Figure A15: West groyne flank, displaced rocks

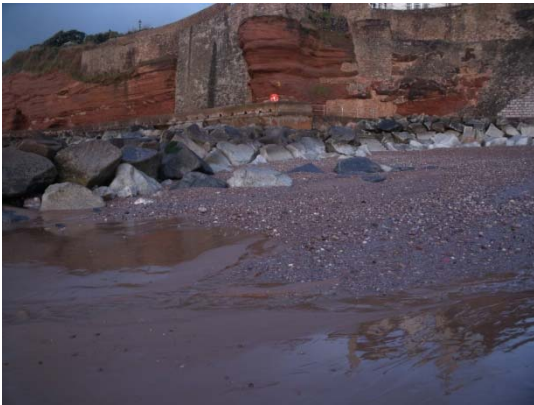
Figure A17: East groyne flank, displaced rocks

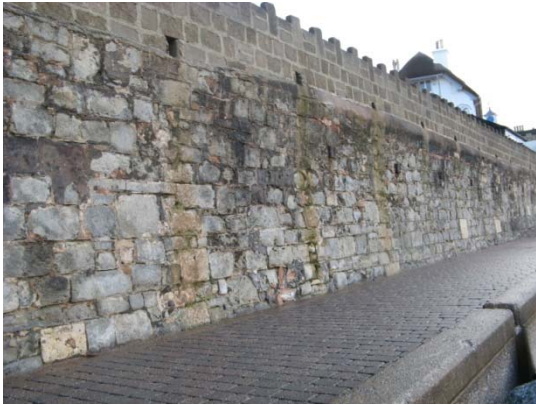
Figure B1: Masonry seawall

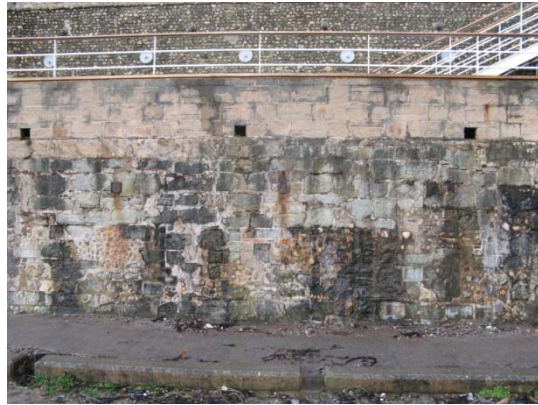
Figure B2: Masonry seawall

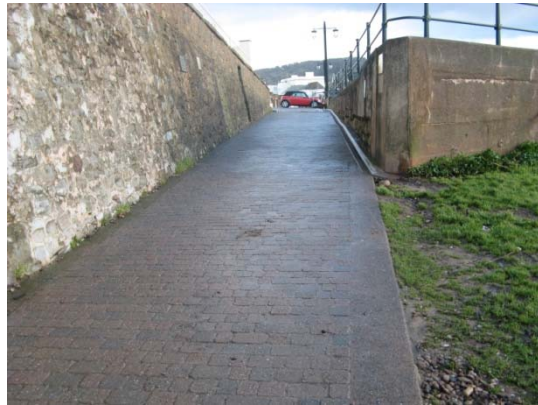
Figure B4: Walkway access ramp

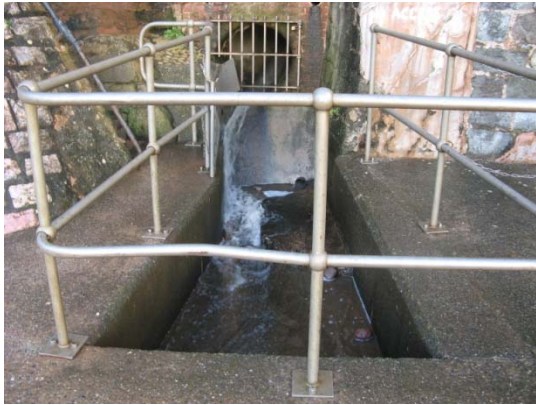
Figure B5: Outfall and screen

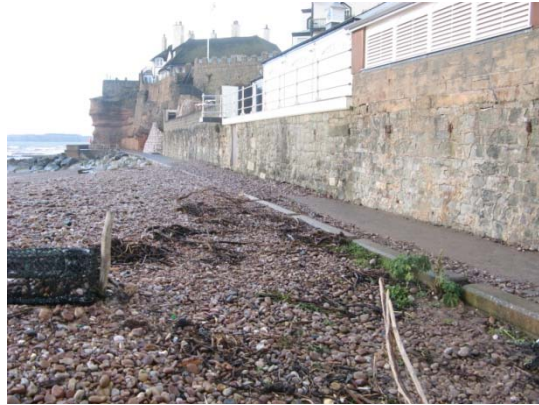
Figure B6: Debris and shingle on walkway

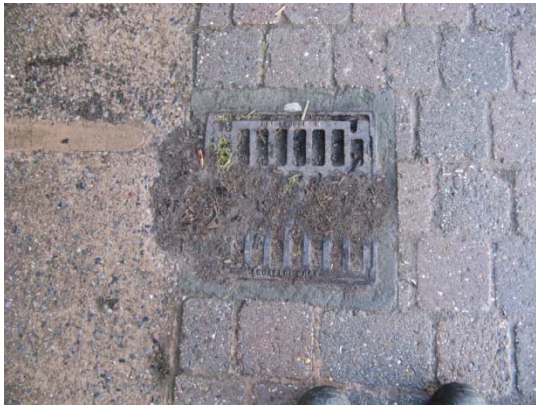
Figure B7: Blocked gully

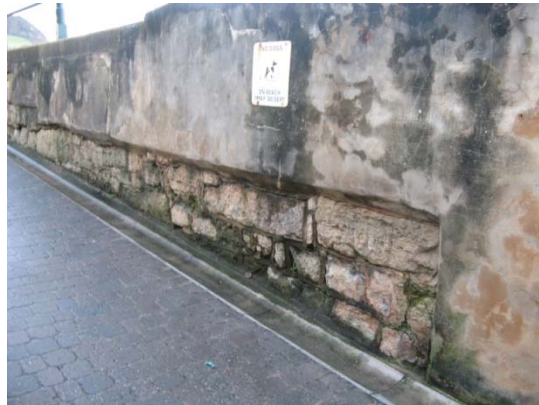
Figure B8: West Pier access ramp

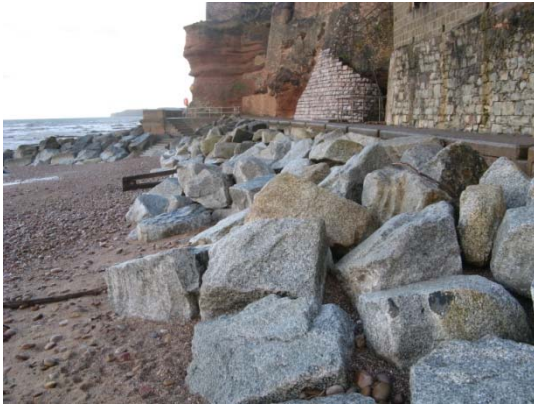
Figure B11: Rock revetment

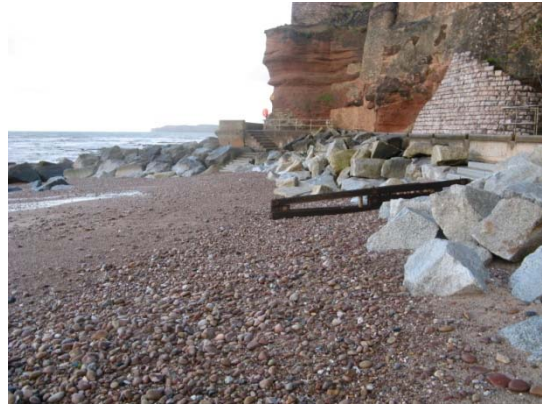
Figure B12: Rock revetment

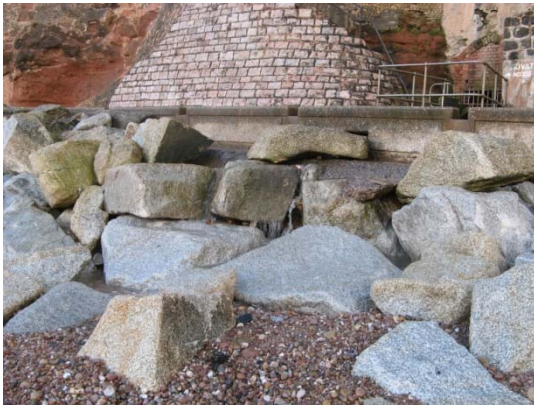
Figure B13: Displaced rocks and shingle infill at toe

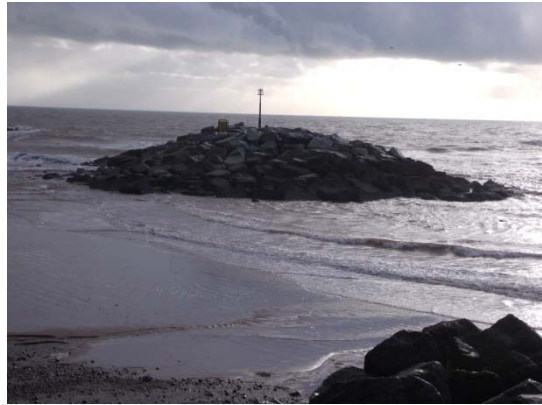
Figure B16: Western breakwater

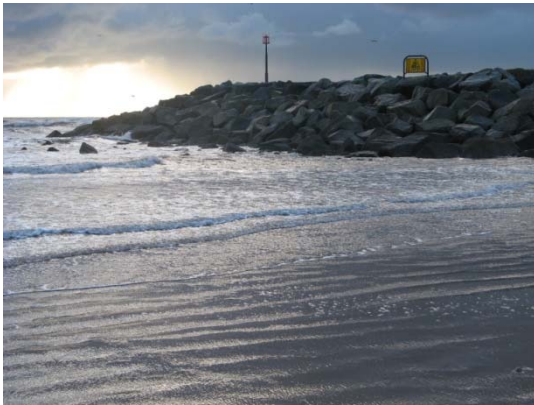
Figure B17: Displaced rocks on western breakwater

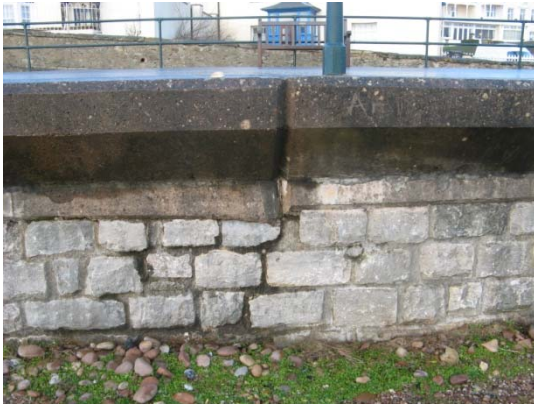
Figure C1: Masonry wall with RC coping

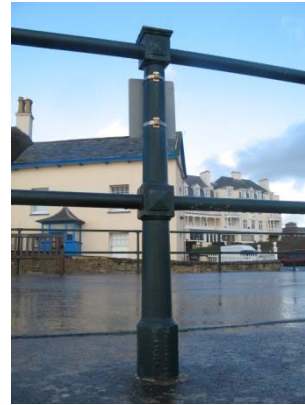
Figure C2: Hand railing free of corrosion

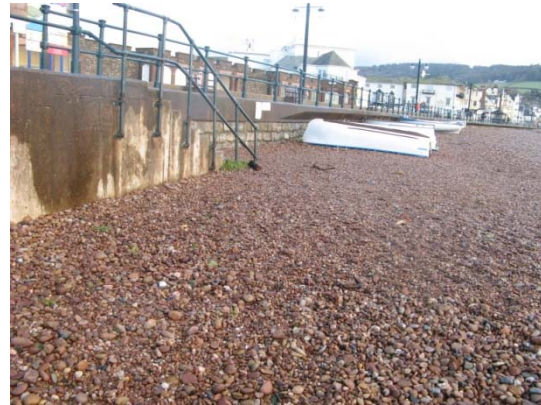
Figure C4: Access stairs and moored boats

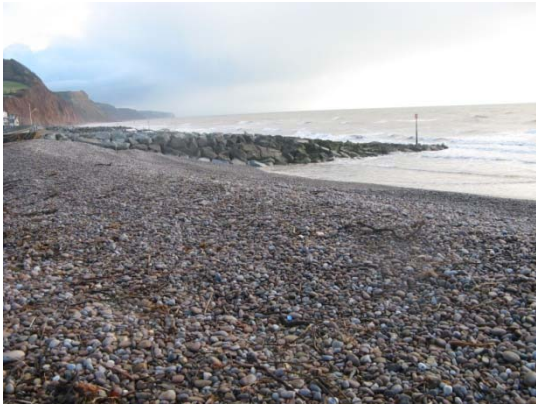
Figure C7: Bedford Steps rock groyne

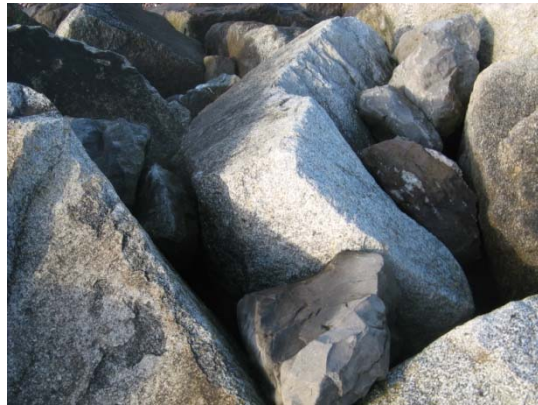
Figure C10: Small rocks used to plug voids

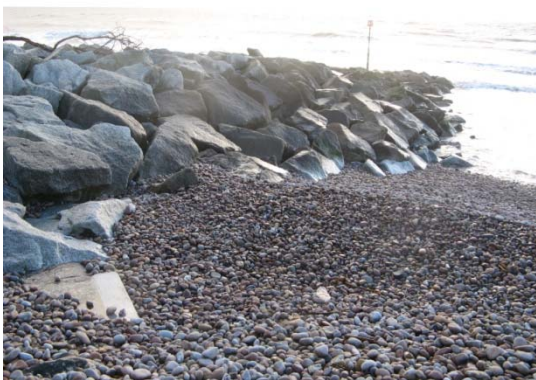
Figure C11: Rock groyne West flank

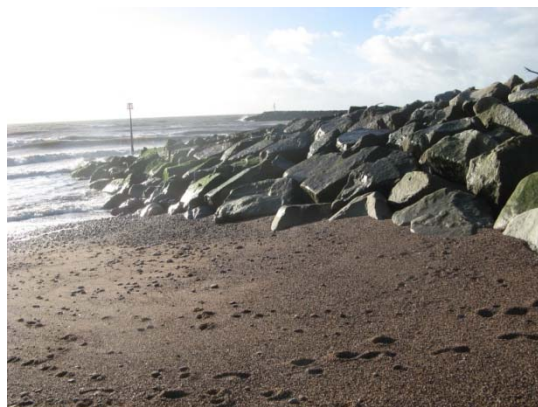
Figure C12: Rock groyne East flank

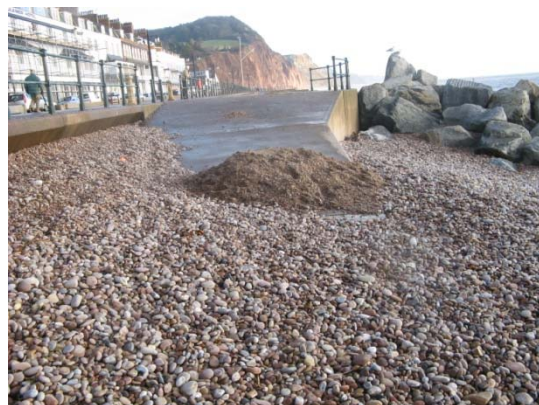
Figure D6: Access ramp

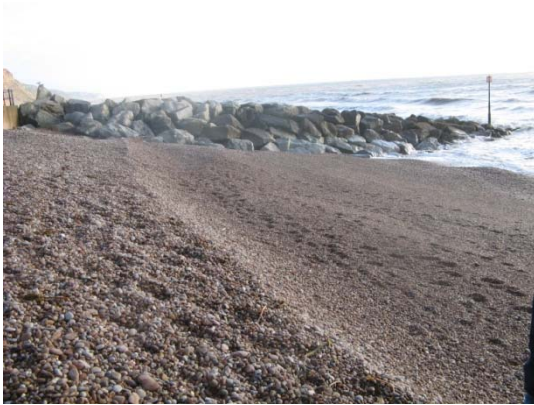
Figure D7: Rock groyne

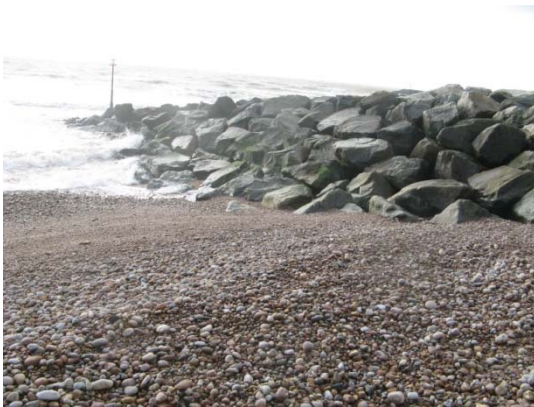
Figure D9: Rock groyne East flank

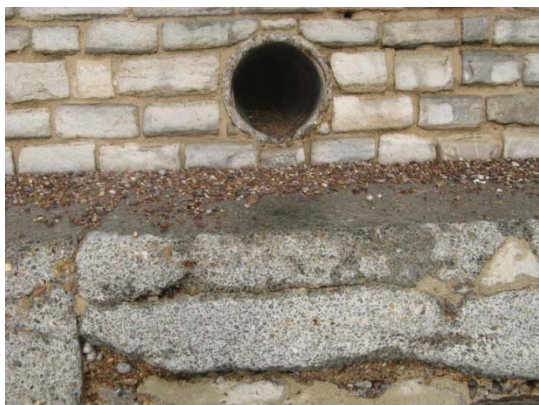
Figure E5: Blocked outfall

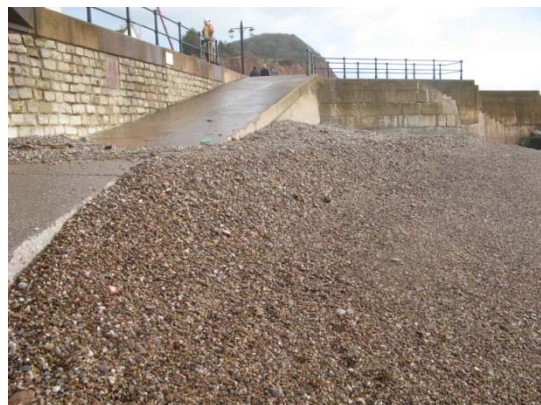
Figure E6: East Pier ramp

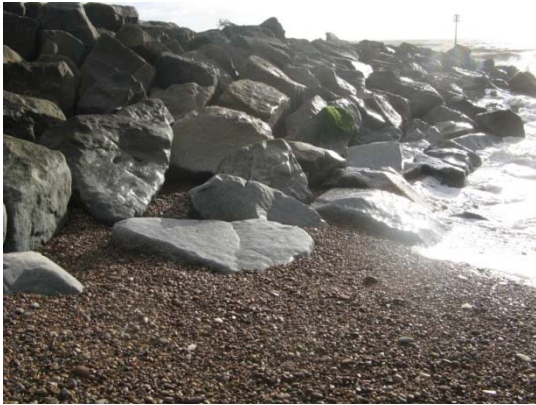
Figure E7: Rock groyne West flank

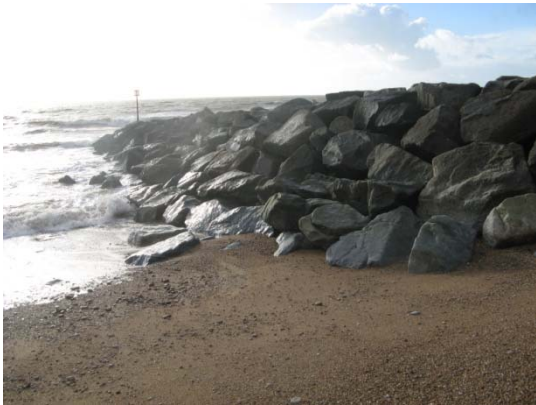
Figure E9: Rock groyne East flank

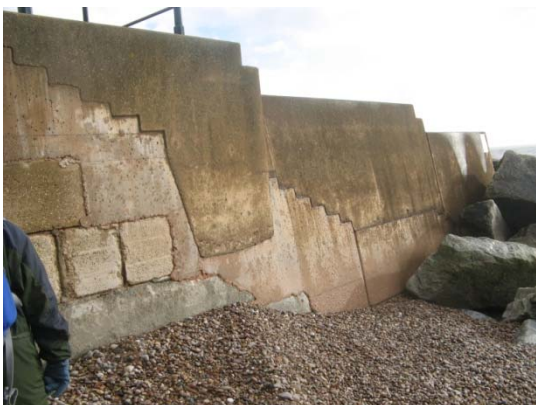
Figure E11: East Pier

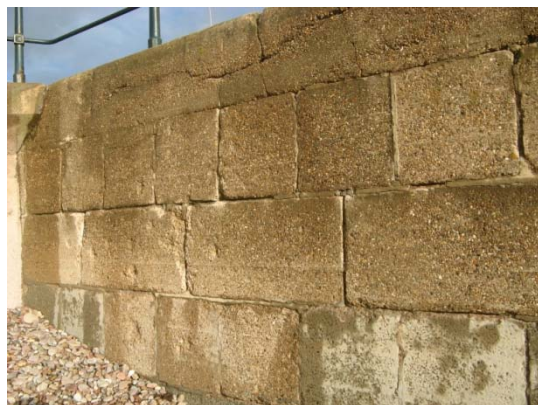
Figure E12: East Pier concrete block joints

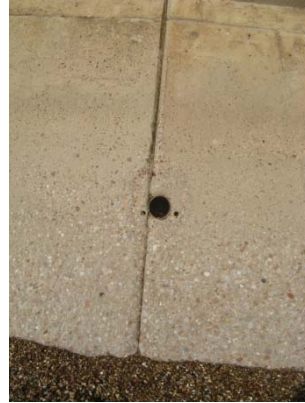
Figure F2: RC wall construction joint

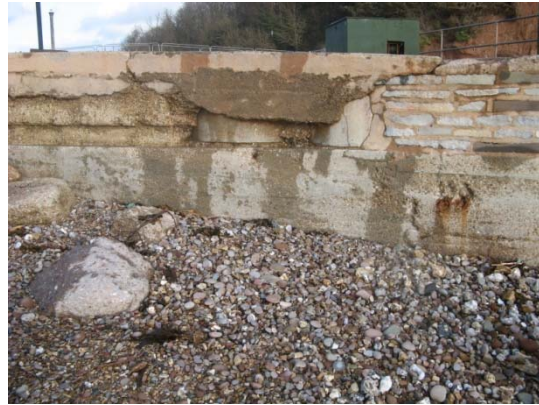
Figure F6: Exposed manhole ring

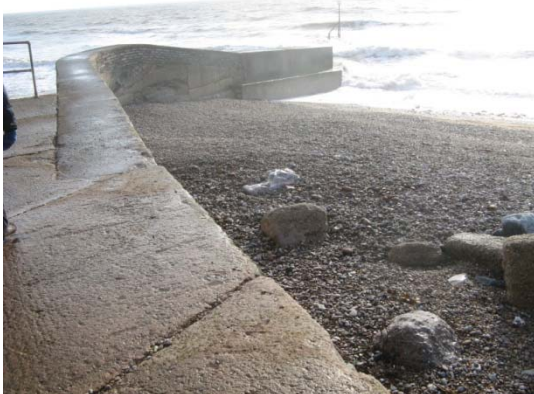
Figure F9: West groyne flank, no hand railing

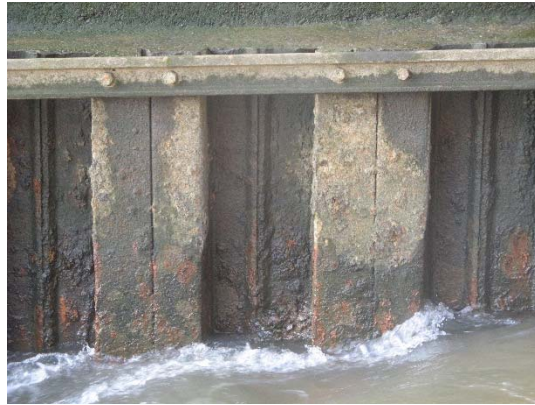
Figure F12: Sheet pile close up

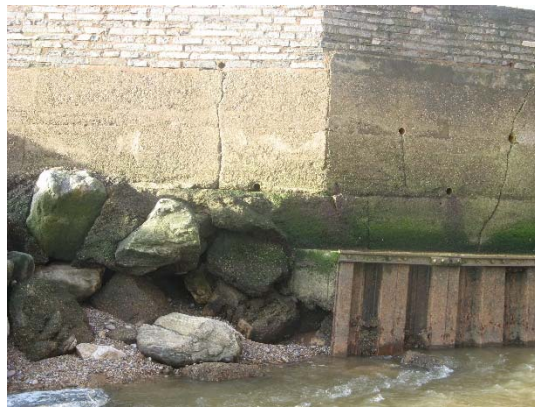
Figure F13: Sheet pile wall mass concrete scour

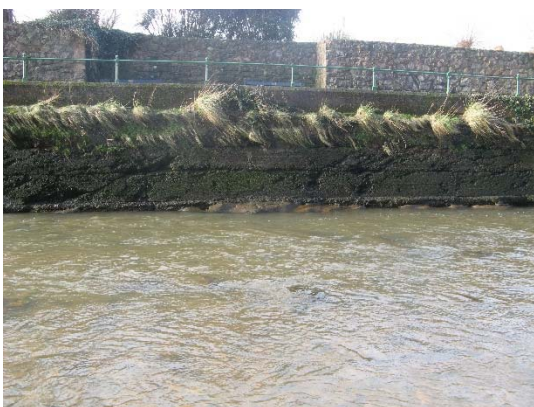
For the river wall, the main risks are the existing scour holes increasing in width/depth such that the wall spanning the hole suffers a slump failure, or the increase in pressure due to the reduced contact area causes a bearing pressure failure of the rock mass. In order to assess these risks the following information would be usefully acquired:

Figure G9: River wall undermining

1. Construction details of the existing wall.
2. Flow rates, velocities and water depths for a range of flow conditions (both high and low).
