Defence Assessment Report

Sidmouth & East Beach Management Plan

Prepared for
East Devon District Council

May 2015

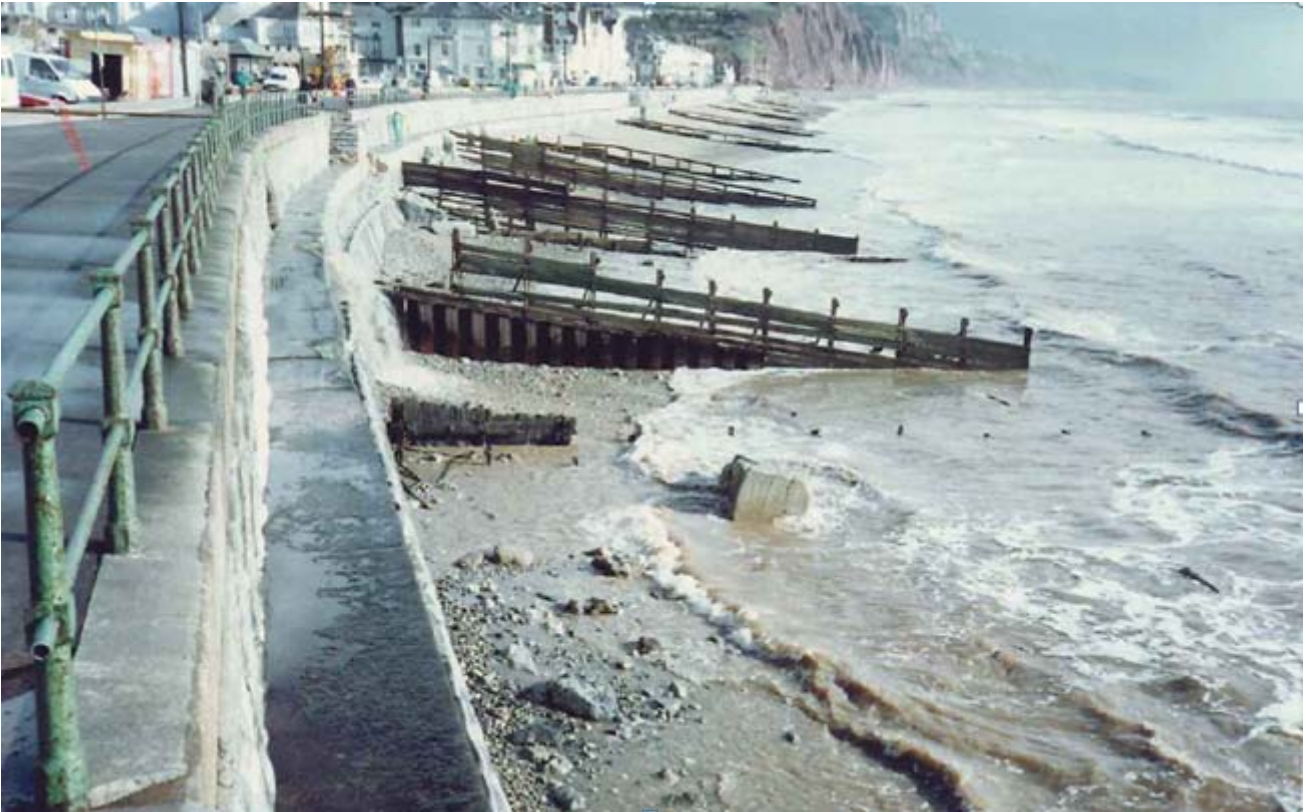
Following the series of storms there was extensive damage to the frontage. Substantial volumes of shingle moved to beaches to the east of Sidmouth and were drawn down seaward of the low water mark. The seawall was badly abraded in areas and masonry facing blocks were worn away exposing concrete. Some blocks has also been pulled away. The old wall was exposed in areas where breaches occurred and showed signs of weakness. In some areas, the seawall coping had been lifted. The lowering of the beach, which prior to the storms had been almost to the top of the seawall, also exposed derelict timber groynes. Figure 2-3 shows the Sidmouth frontage following the storm event.

Figure 2-3 Sidmouth beach frontage after the 1990 storms (image from Posford Duvivier, 1990)

The existing groynes exposed by the lowering of the beach comprising of bullhead railway rails and timber planking were deemed to have reached the end of their working life and were no longer effective due to the combined effects of severe abrasion, marine borers and undermining.

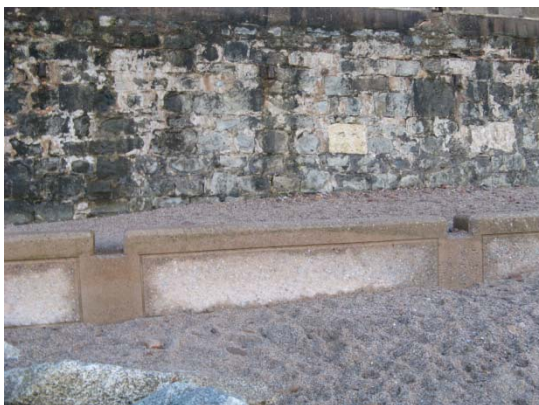
Figure B10: Walkway edging

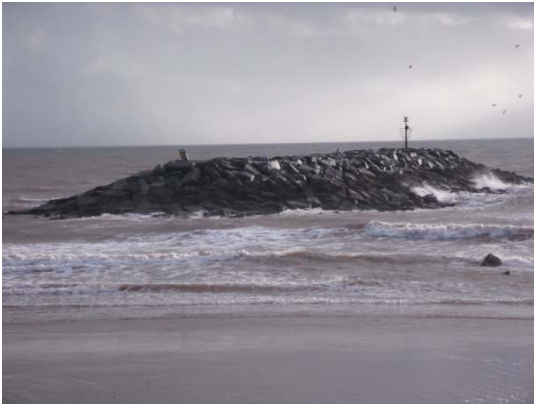
Figure B15: Eastern breakwater

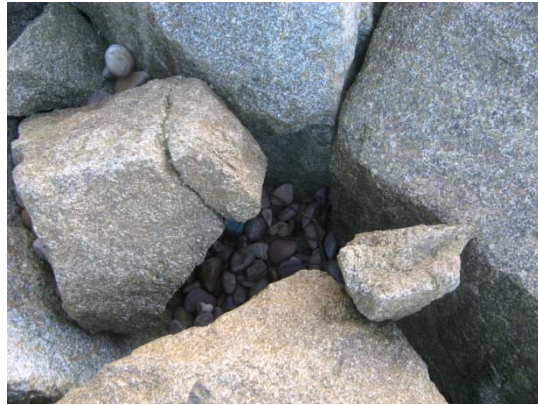
Figure C8: Single infilling and small rocks

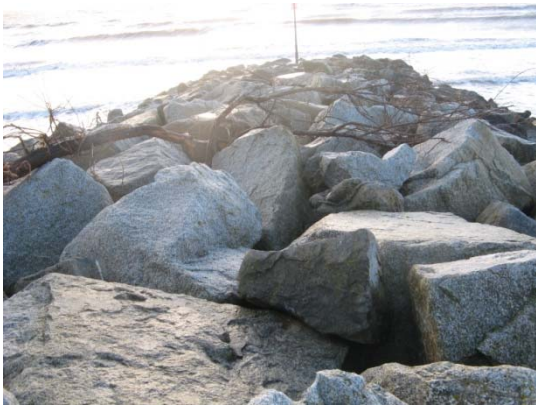
Figure C9: Consistent crest

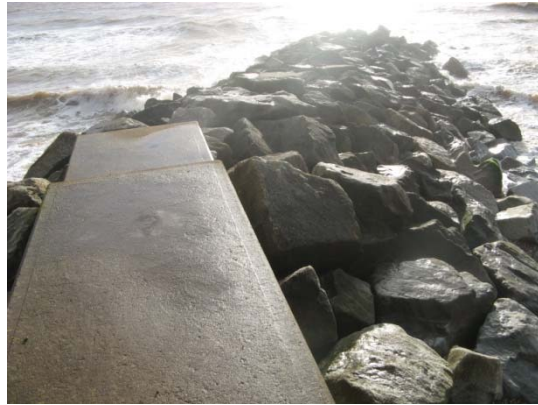
Figure E8: Rock groyne crest

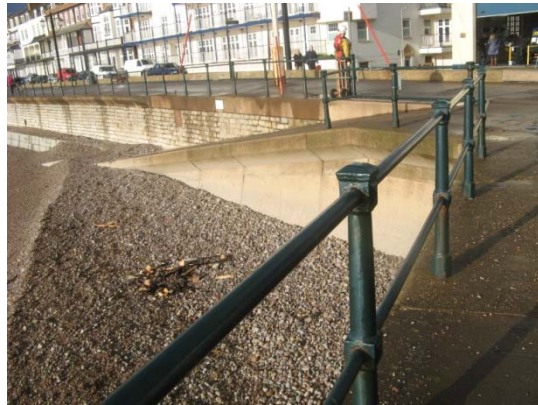
Figure E10: Concrete slipway

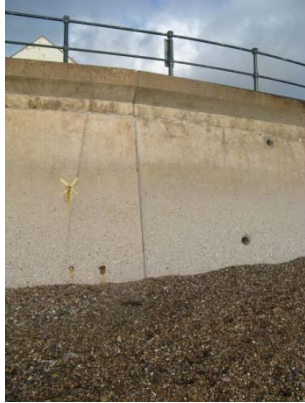
Figure F1: RC faced seawall

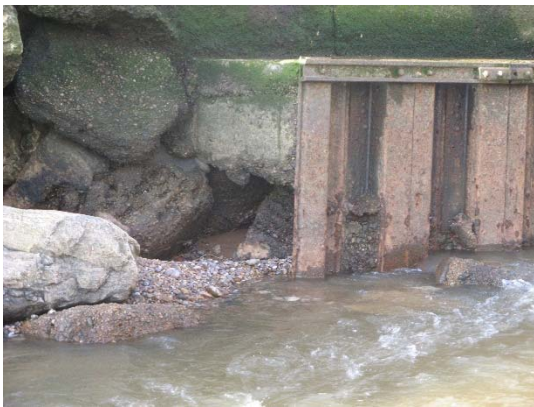
Figure F13: Sheet pile wall mass concrete scour

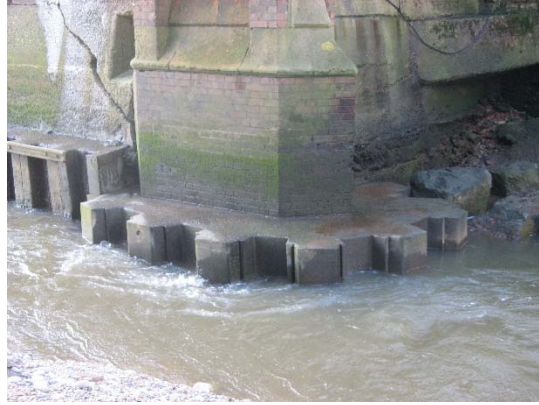
Figure G2: Bridge Footings

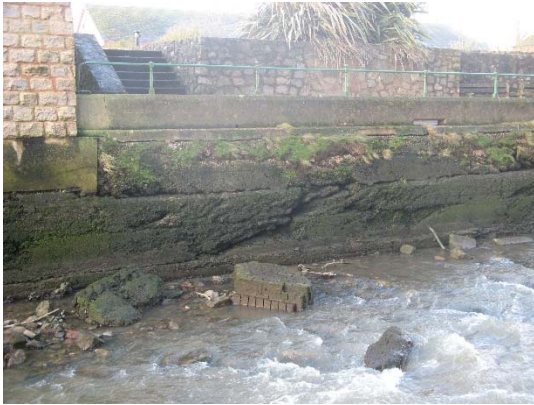
Figure G5: River wall

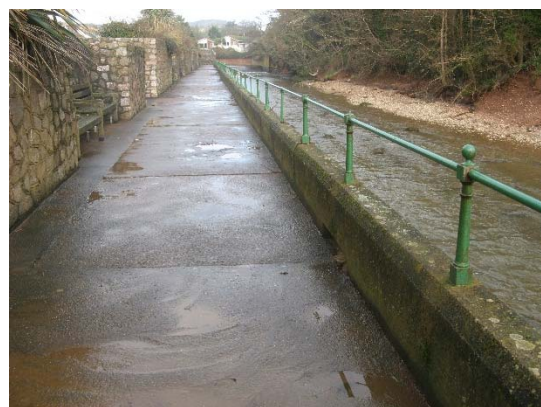
Figure G10: River wall walkway
